# Hawkhurst Parish Council Health and Safety Report

June 2022

Observations from audit of HPC facilities using HSE Slips and trips hazard spotting checklist and HSE Checklist for village and community halls.

Conducted by Cllr Paul Green and Cllr Simon Paish on Thursday 9<sup>th</sup> June 2022, conditions clear and dry, And 16<sup>th</sup> June 2022 conditions hot clear and dry.

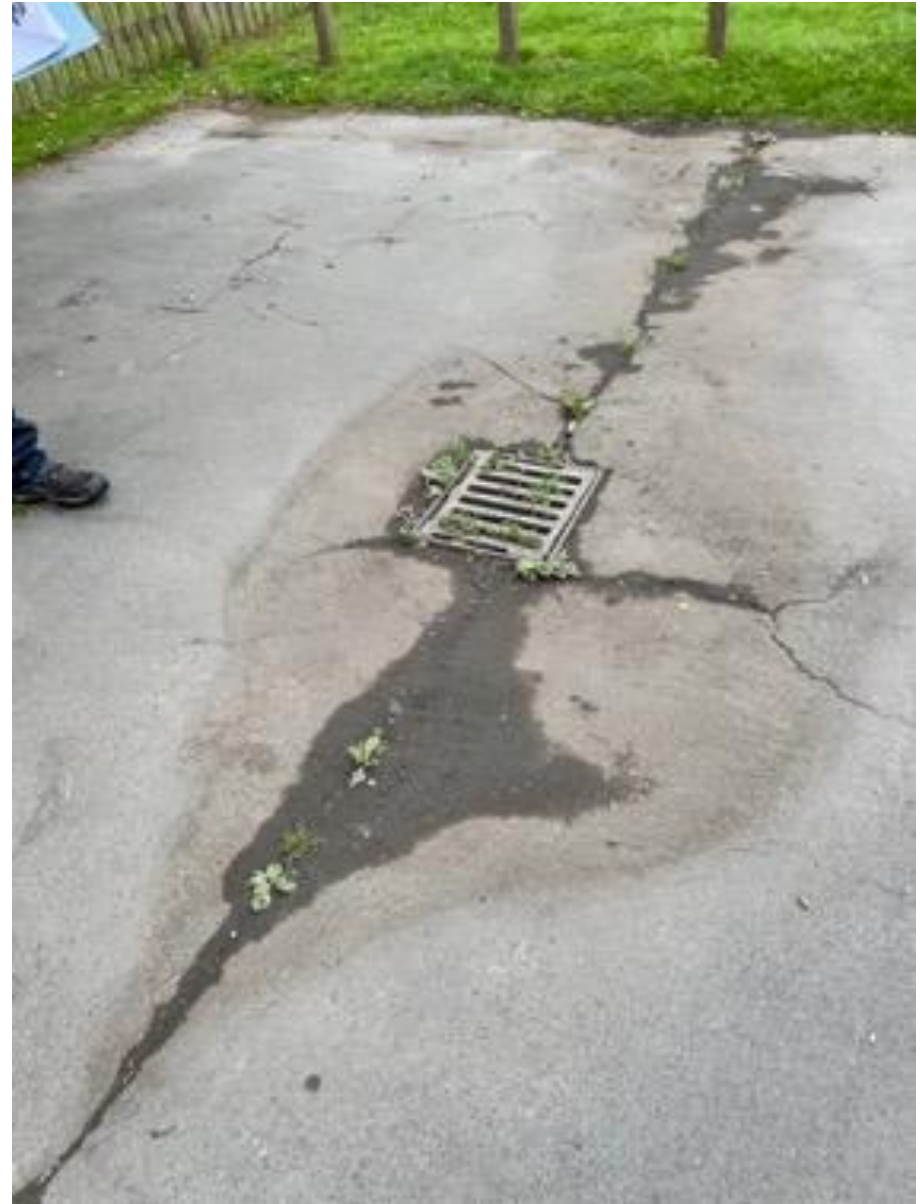
Slope in surface around stormwater drain. Drain cover slightly proud of surface. Evidence of blocked drain and puddle forming on surface

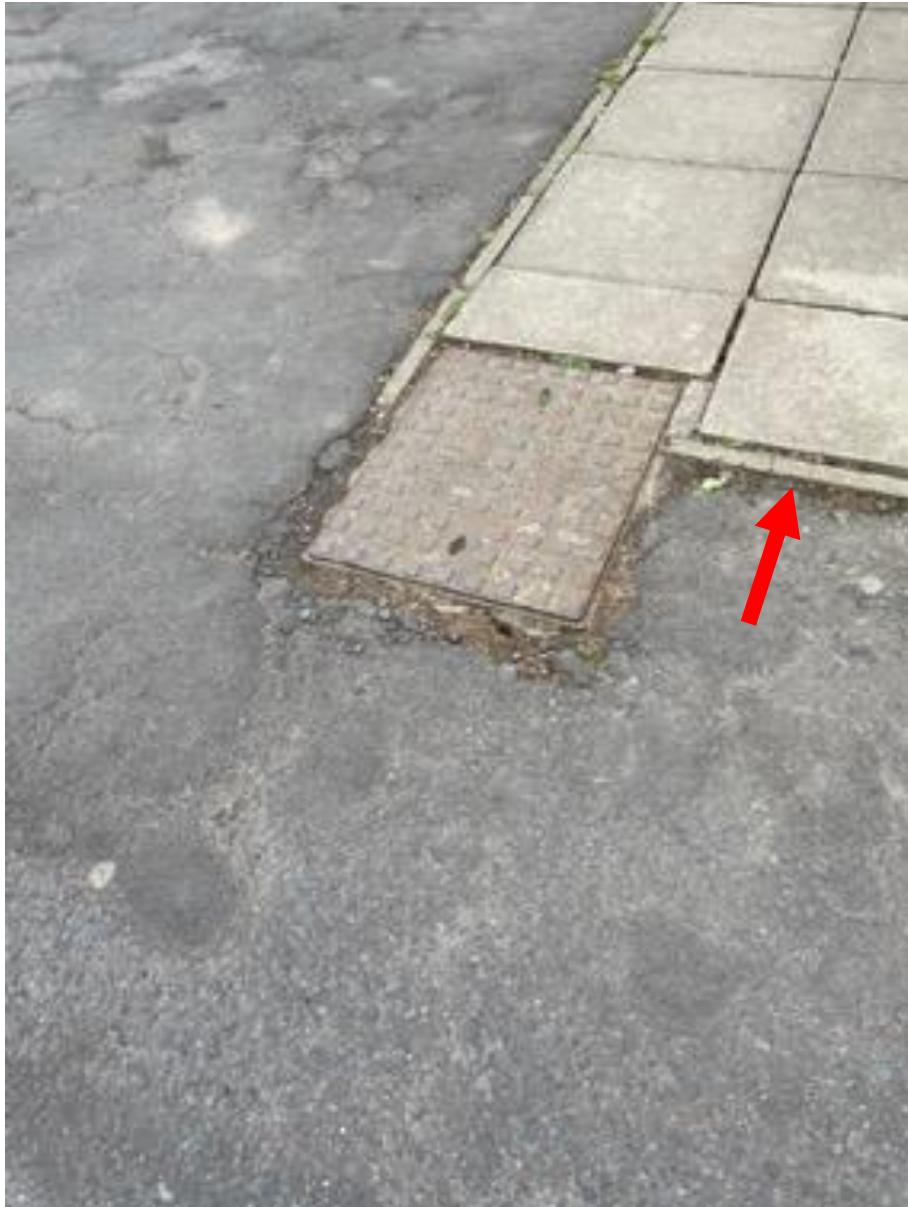
By NE corner of building - Slightly raised curb and manhole cover

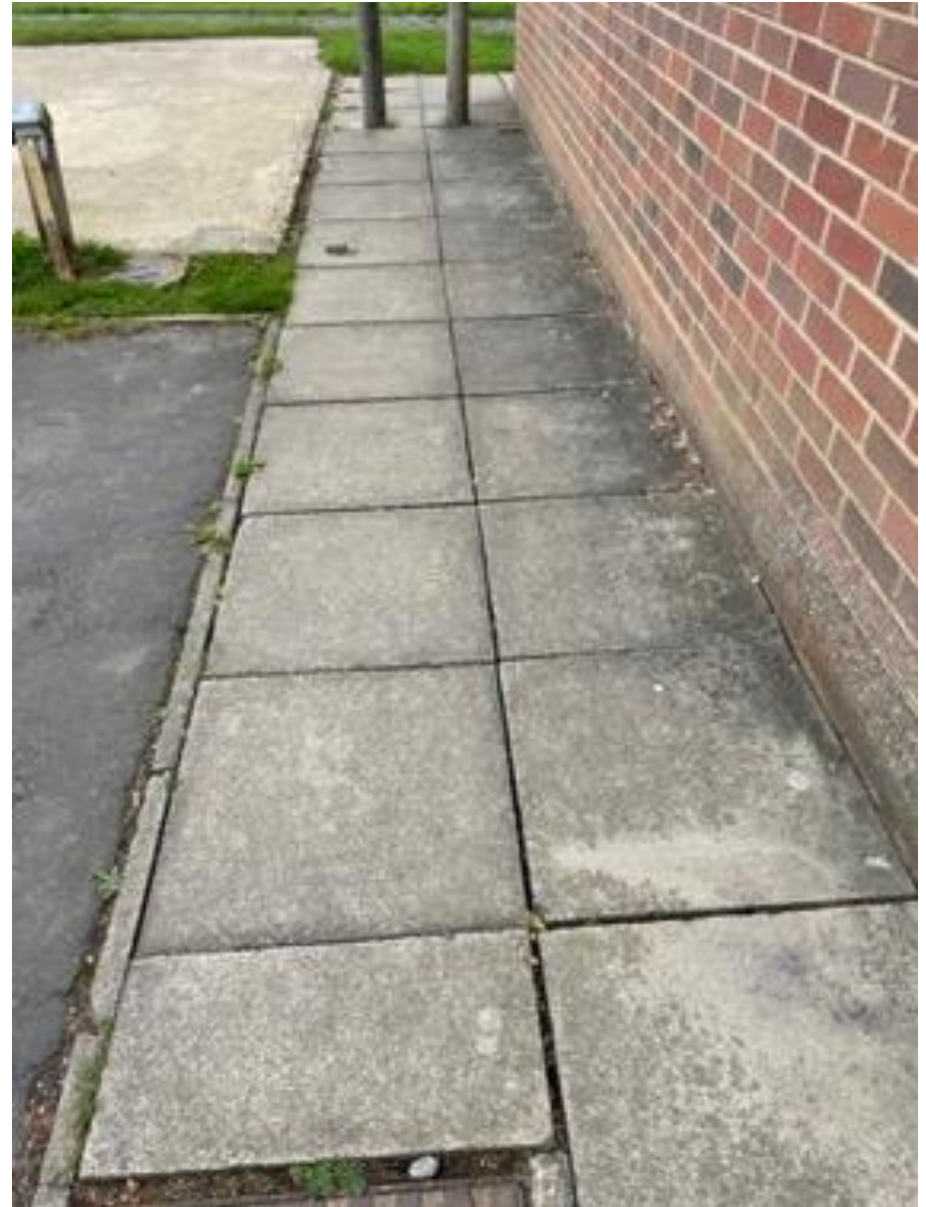
Footway along E end of building  
Loose / rocking slabs in footway

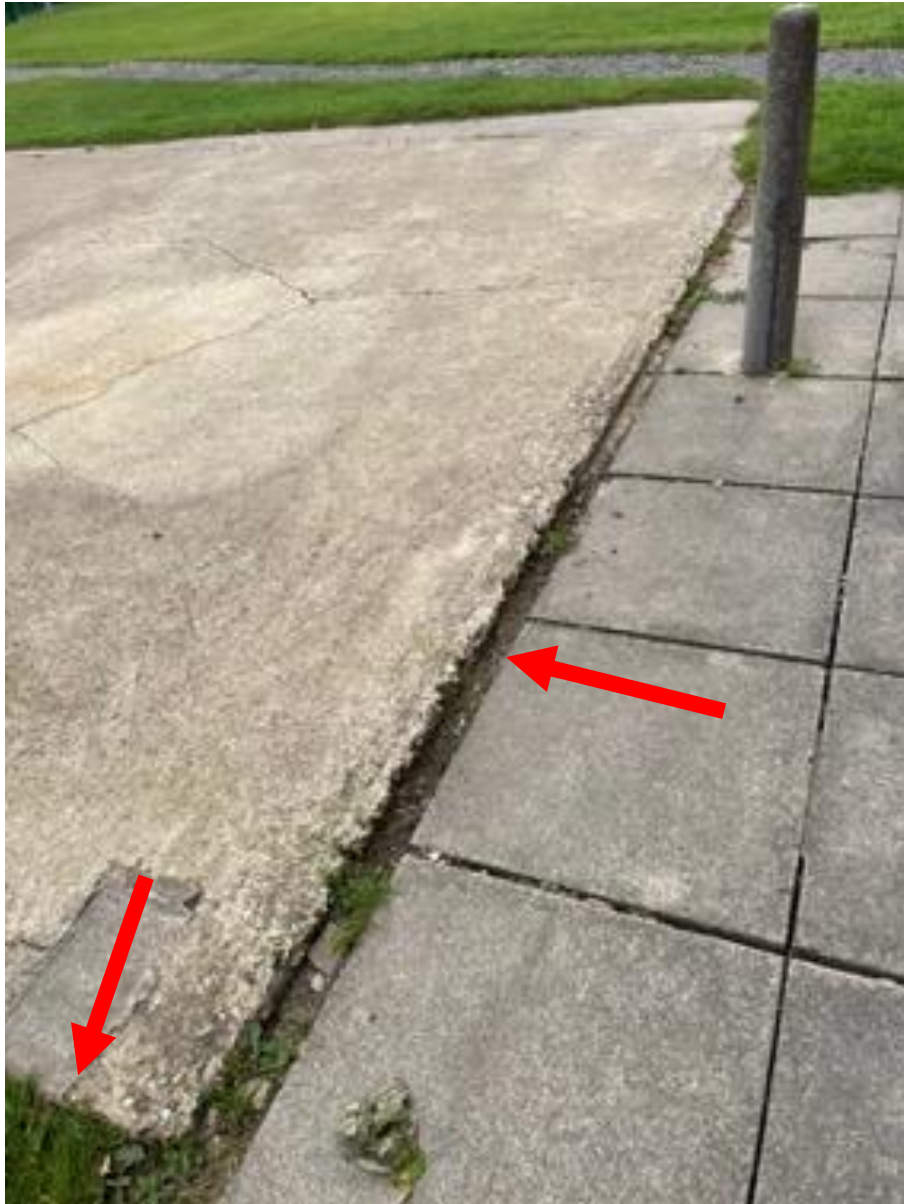
Raised edge to corner of concrete base

Raised edge to concrete base along edge of footway

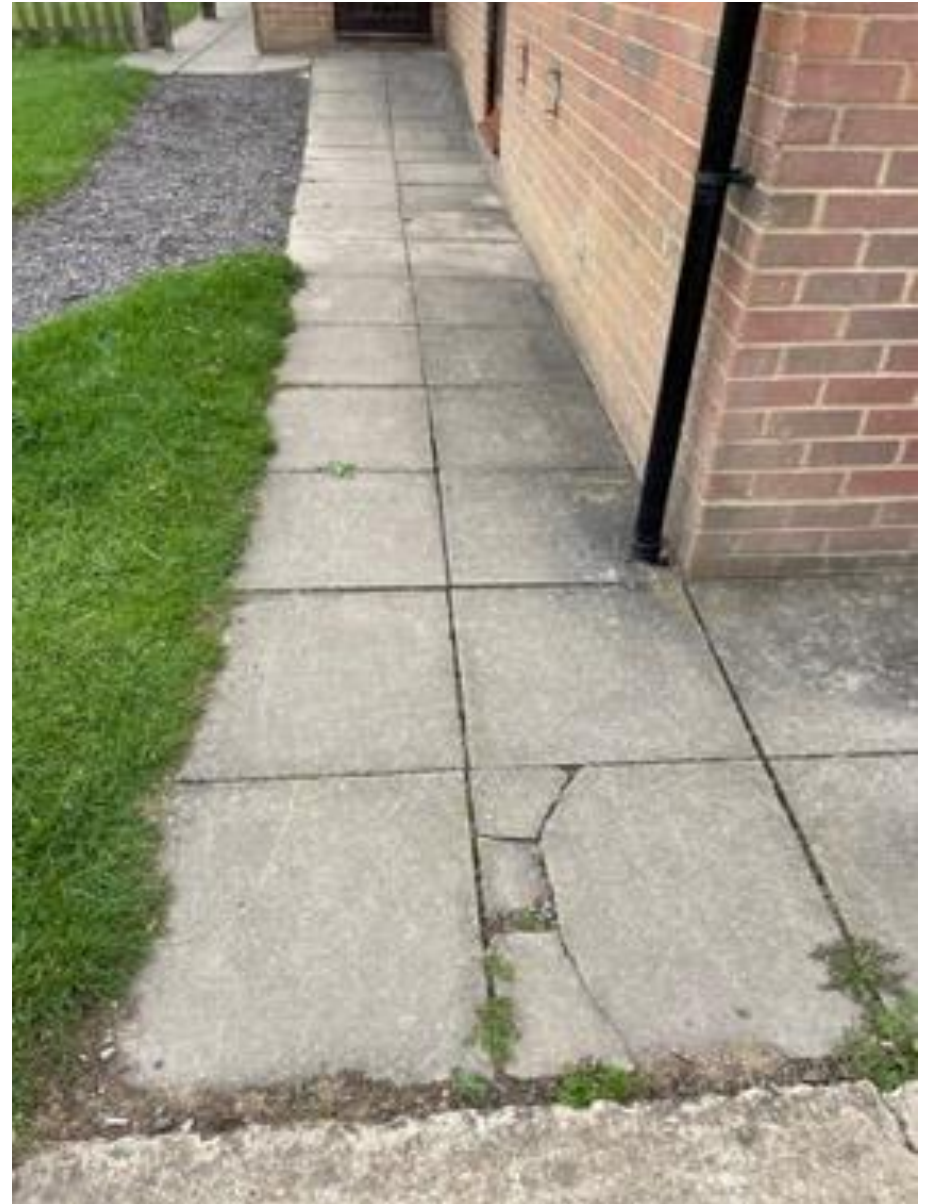
By SE corner of Building – Cracked slab

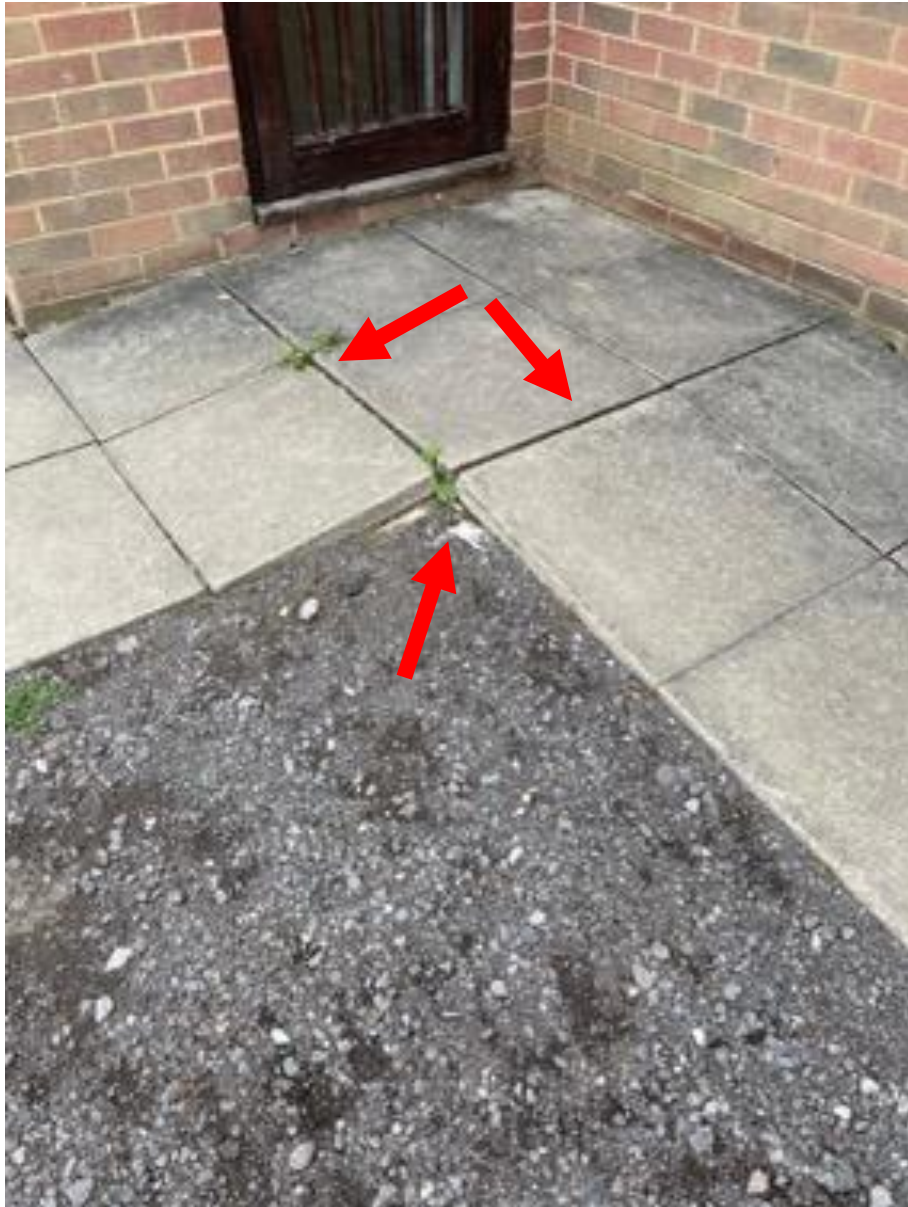
By Changing room entrance slope in footway / large gaps between slabs / Raised edge

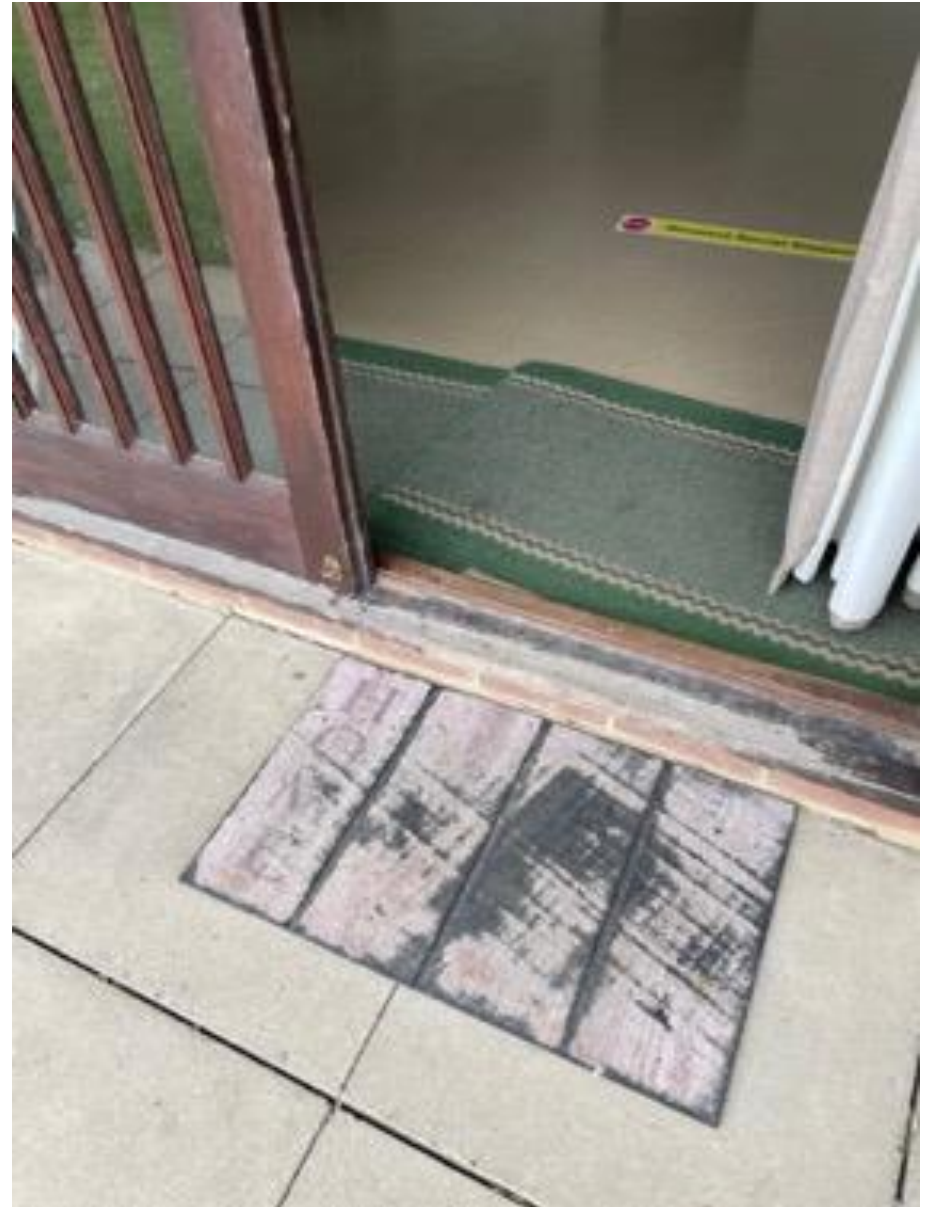
Sports pavilion entrance - threshold and small worn mats

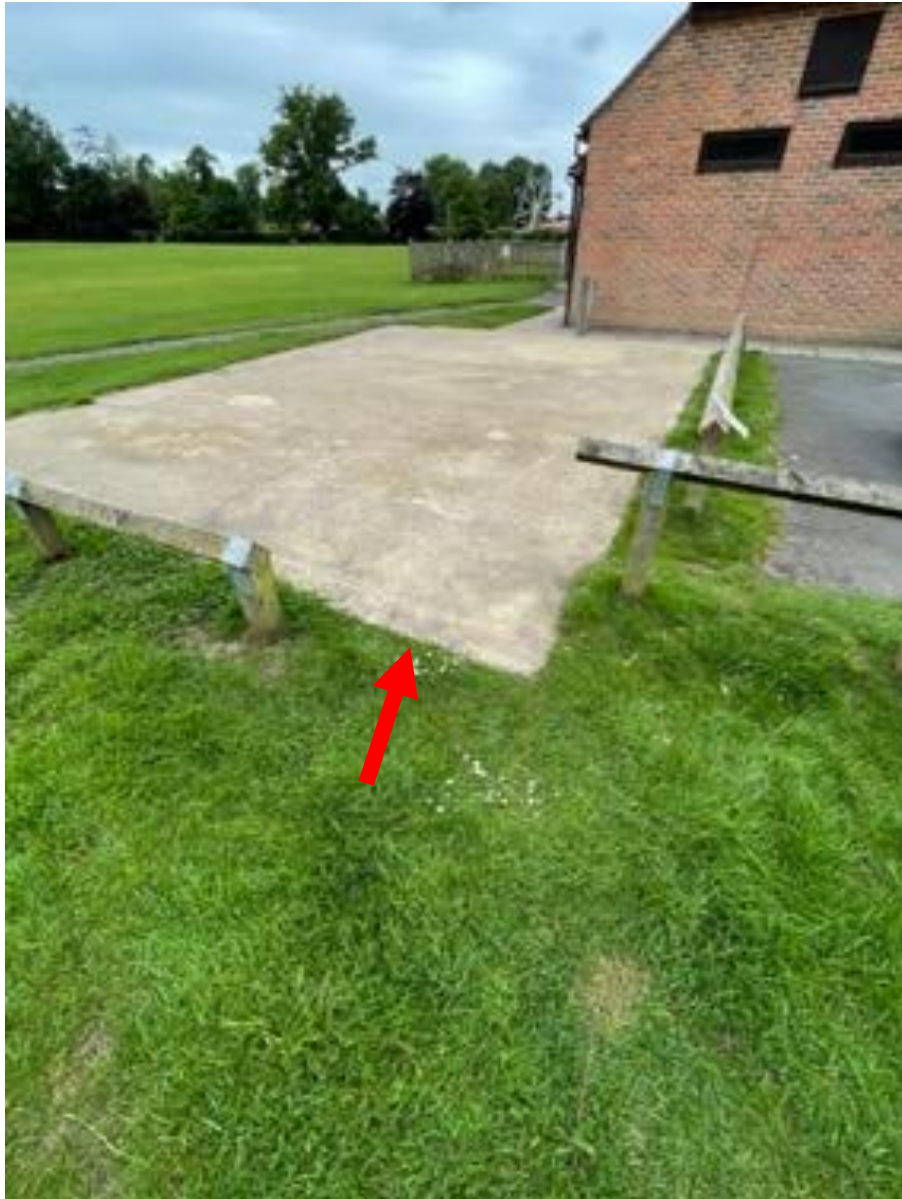
There is a large step between the concrete slab and a footway to the ground on the east side

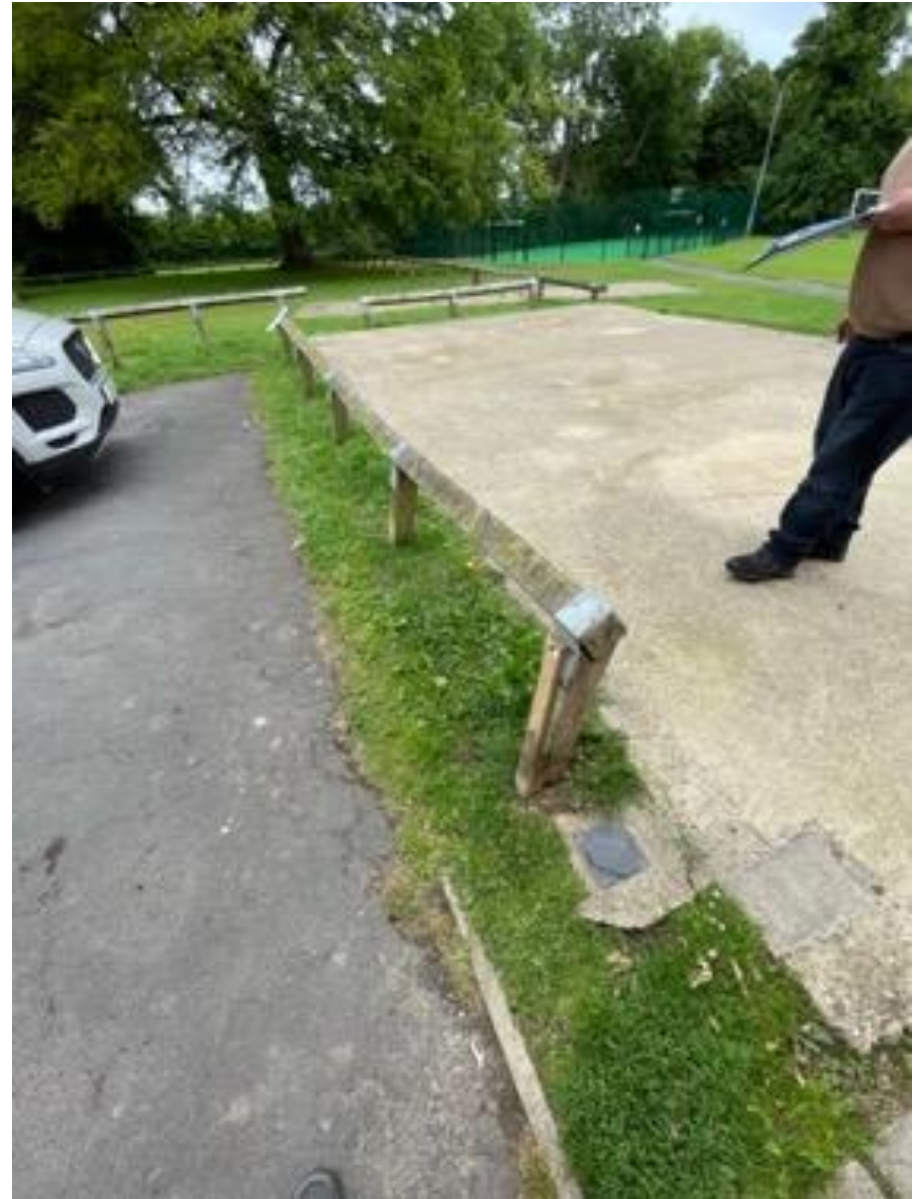
Raised edges to concrete slab and broken rail fencing

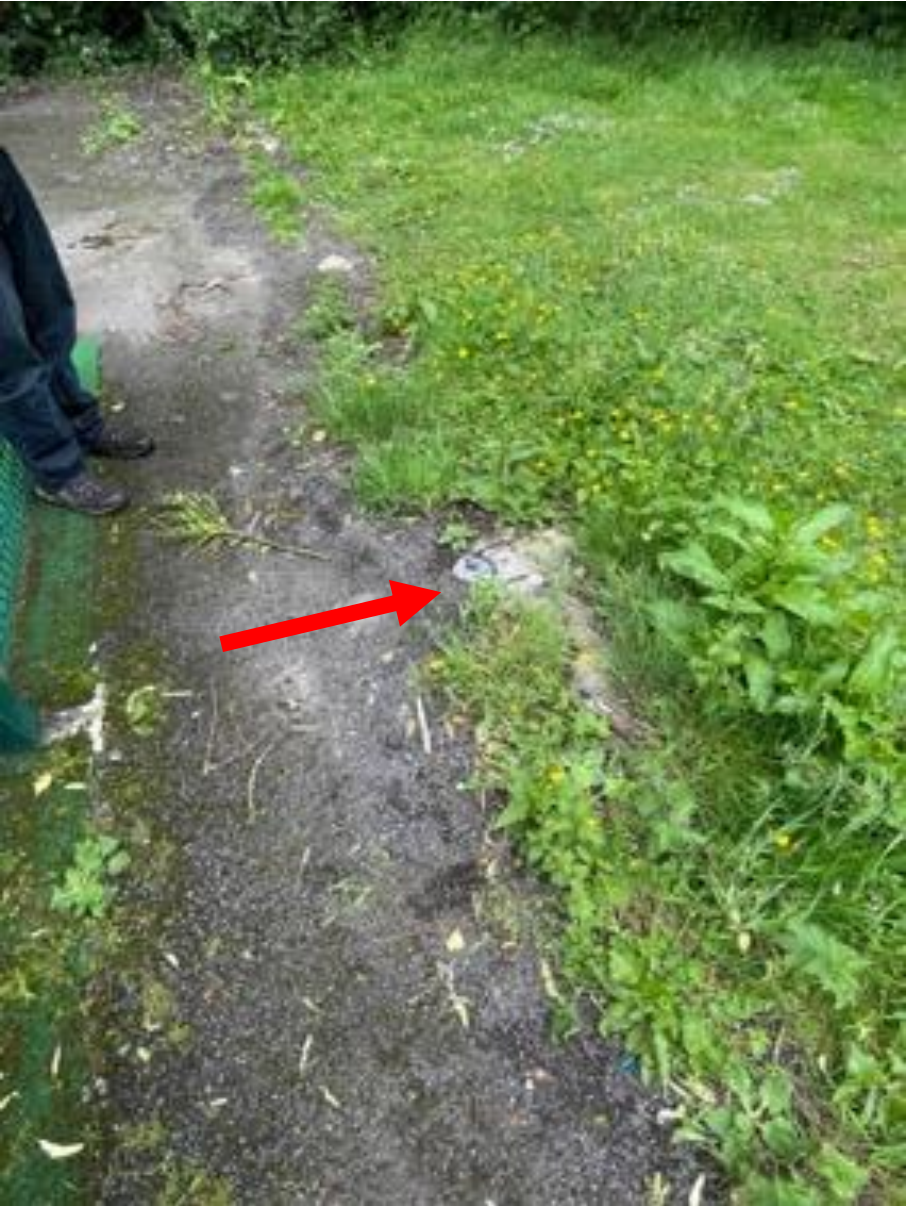
There are the remains of a post

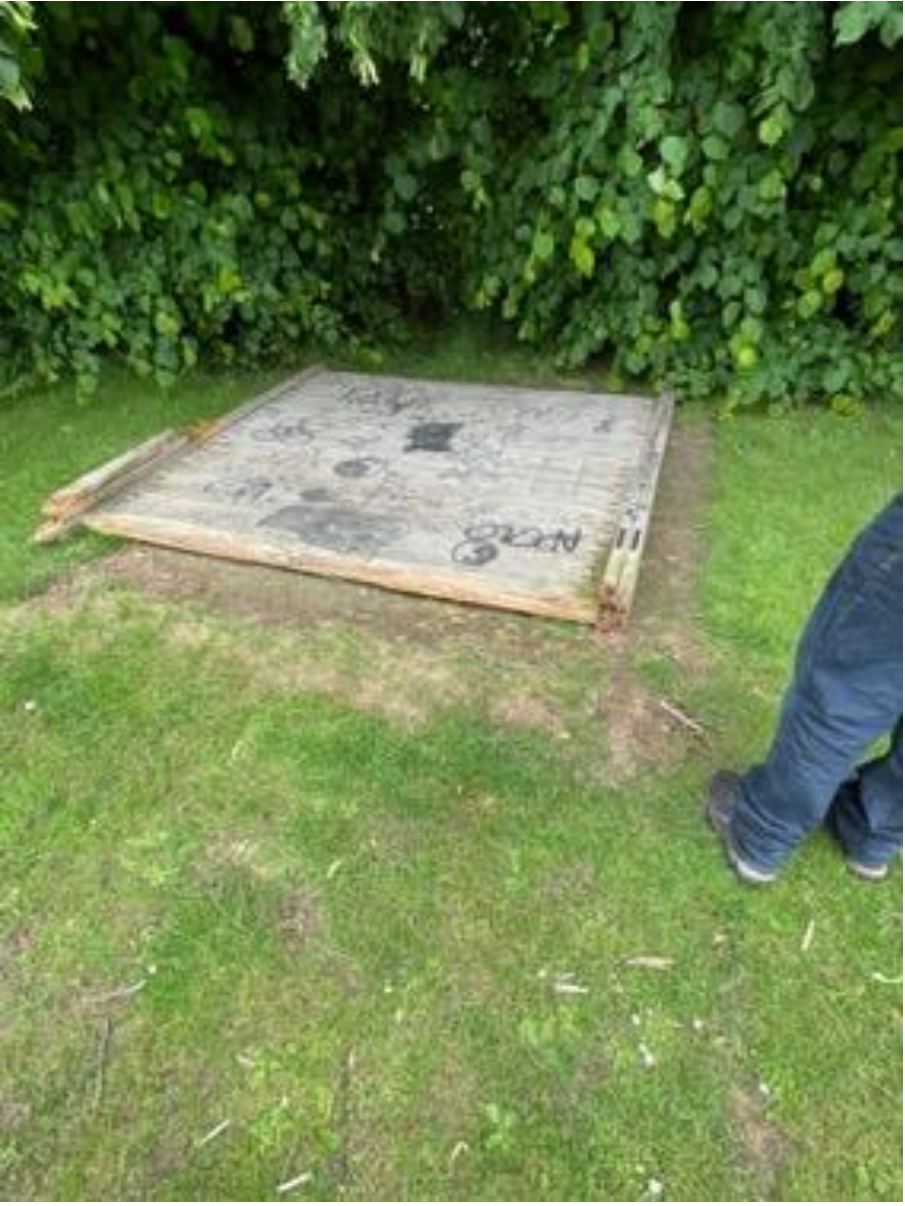
Wooden board broken and left on surface

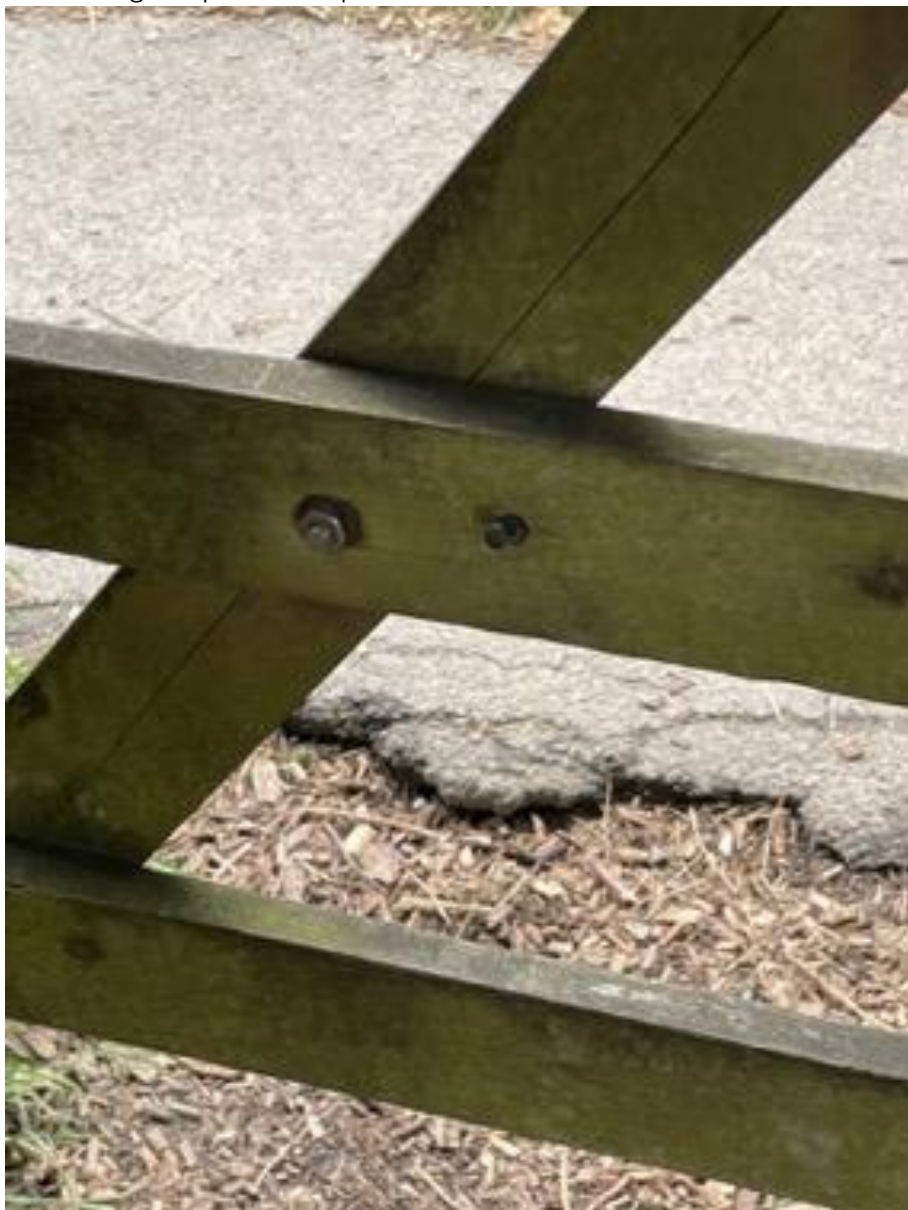
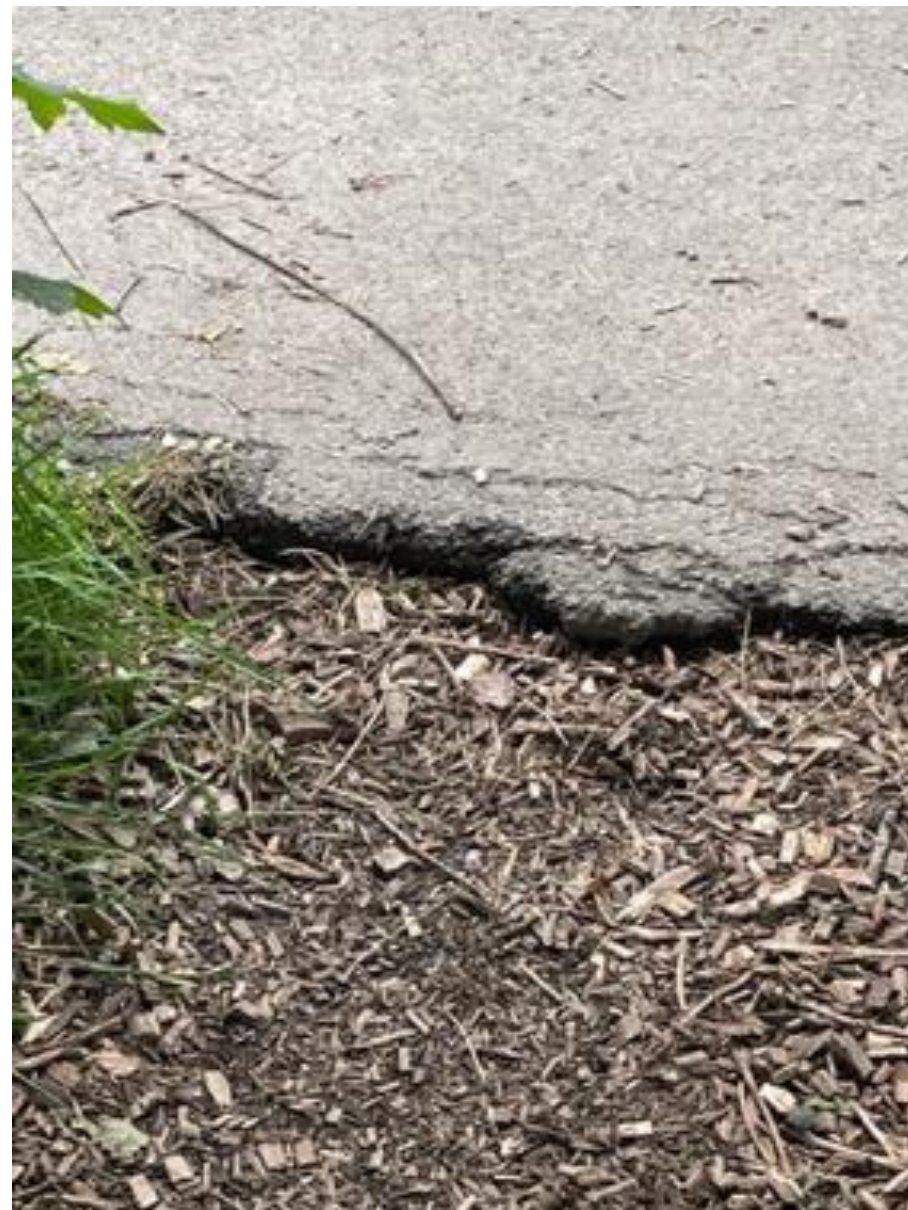
Entrance gate at SW corner of playing field.  
Raised edge to public footpath

The side entrance that goes out onto the Hastings Road is dangerous because of the erosion of the pathway. A simple repair using black could be sufficient to rebuild the path and eliminate the trip hazard and address the drainage from the road.

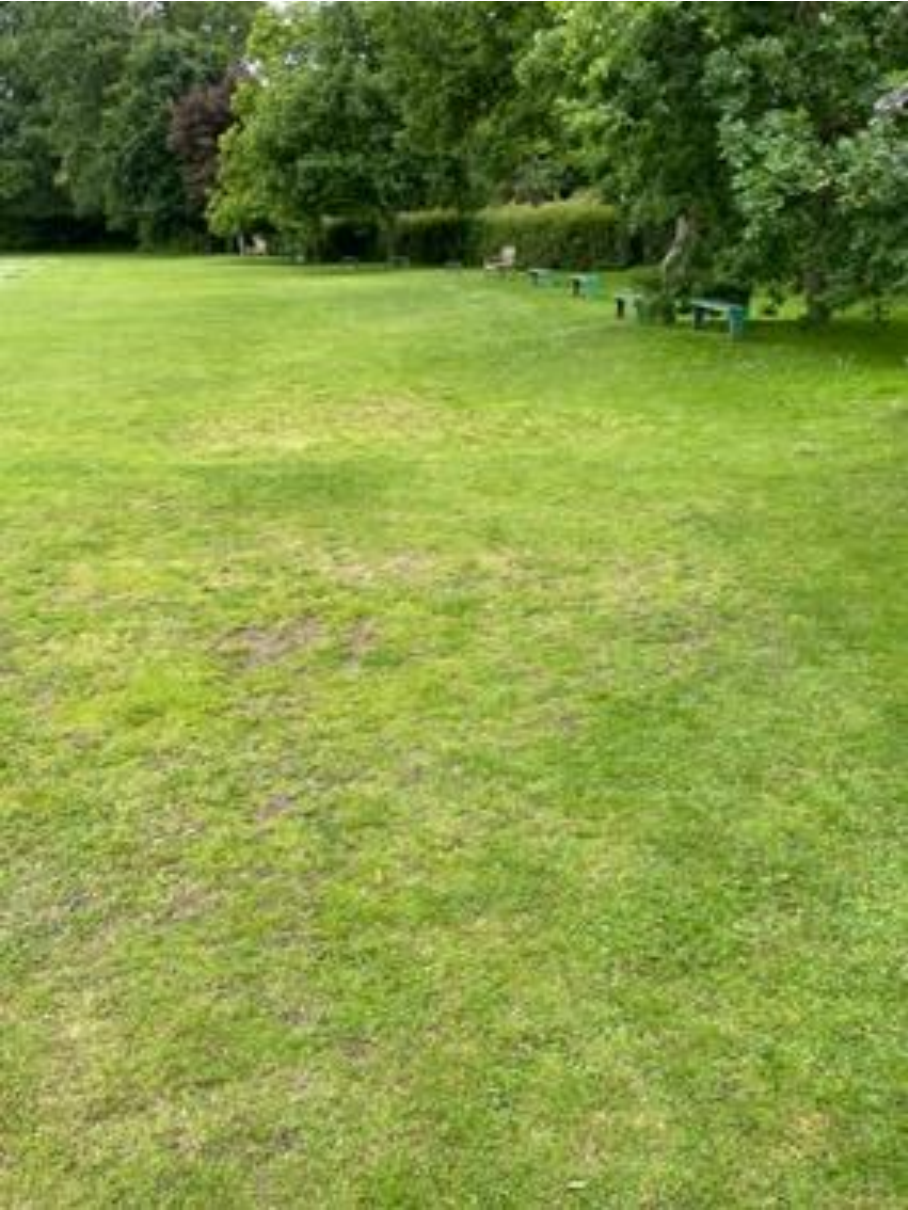
Rough/uneven surface

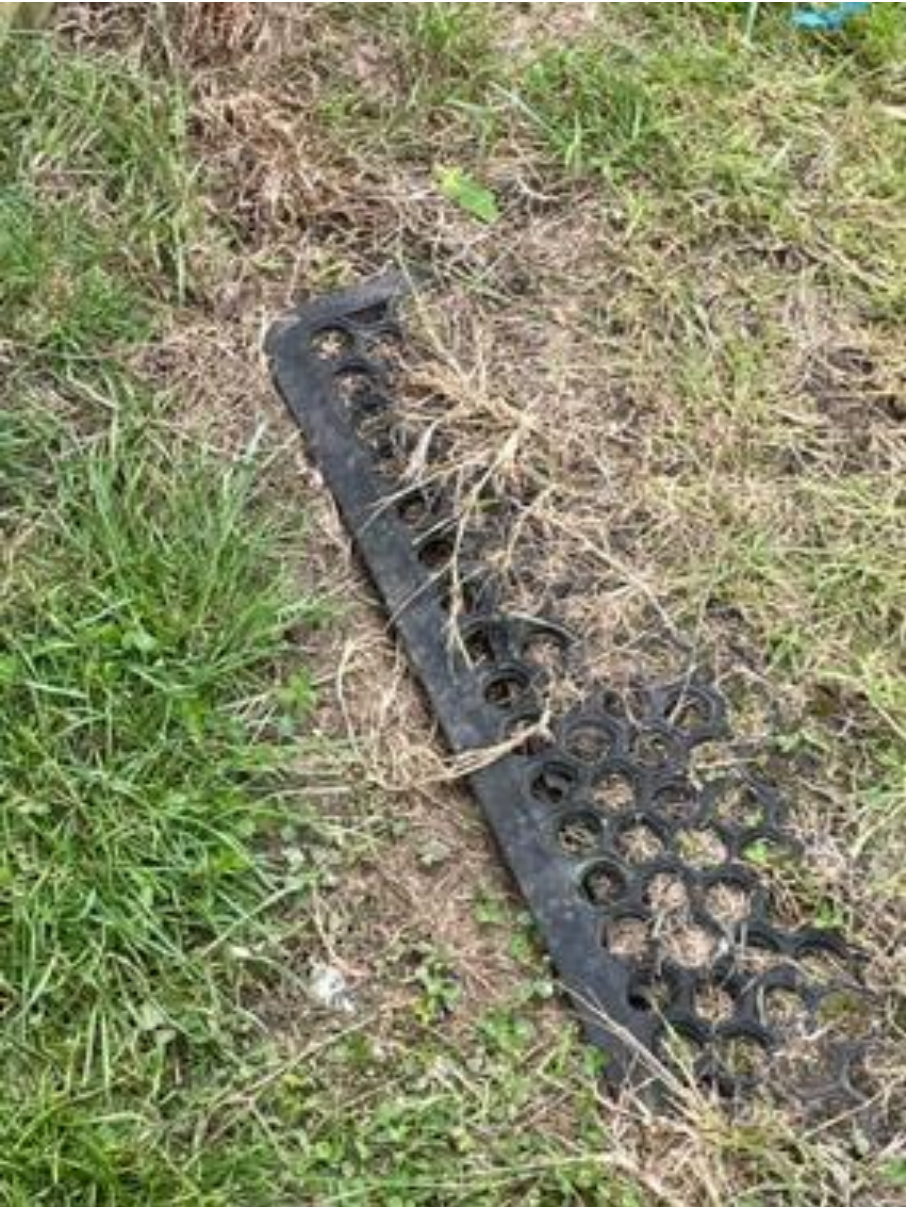
Matting at entrance overgrown and exposed edge.

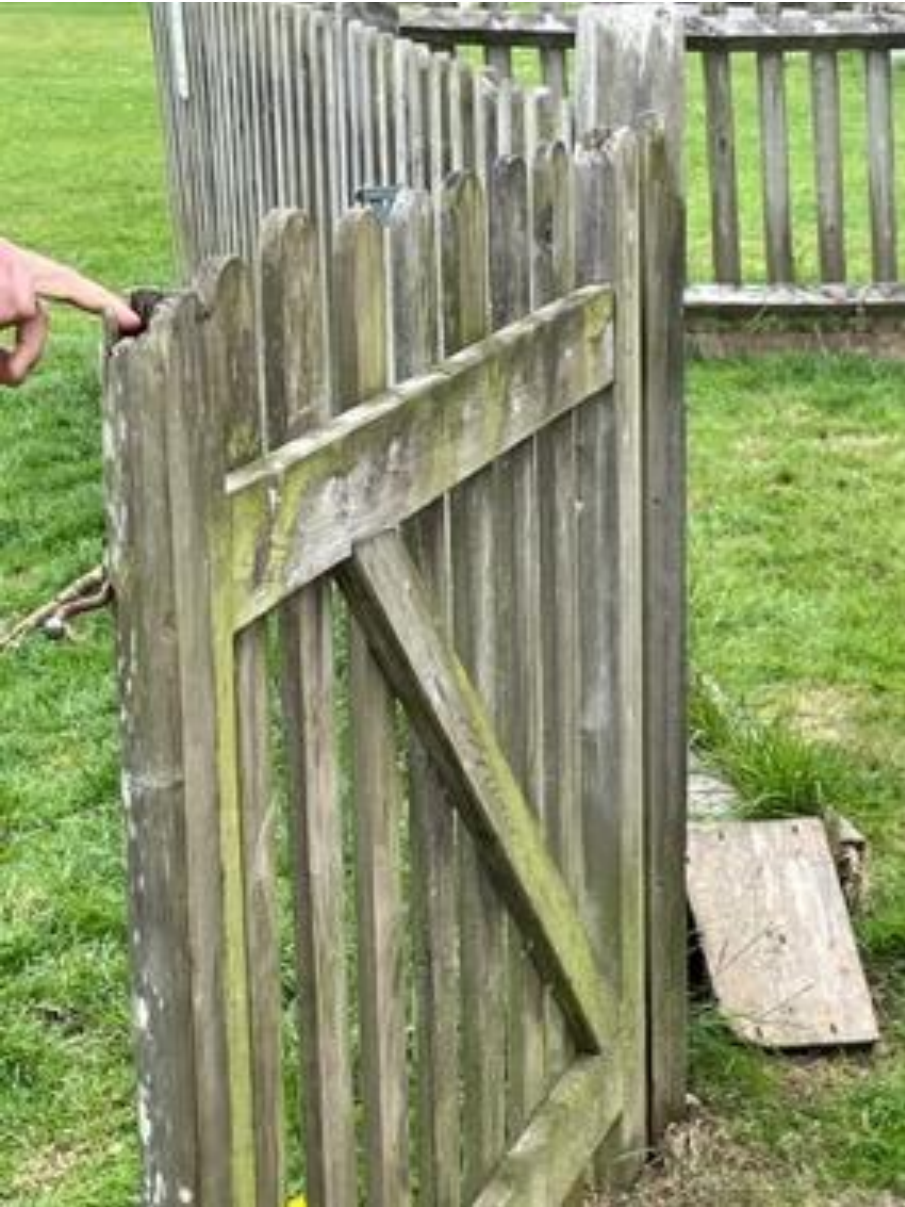
Loose /broken gate

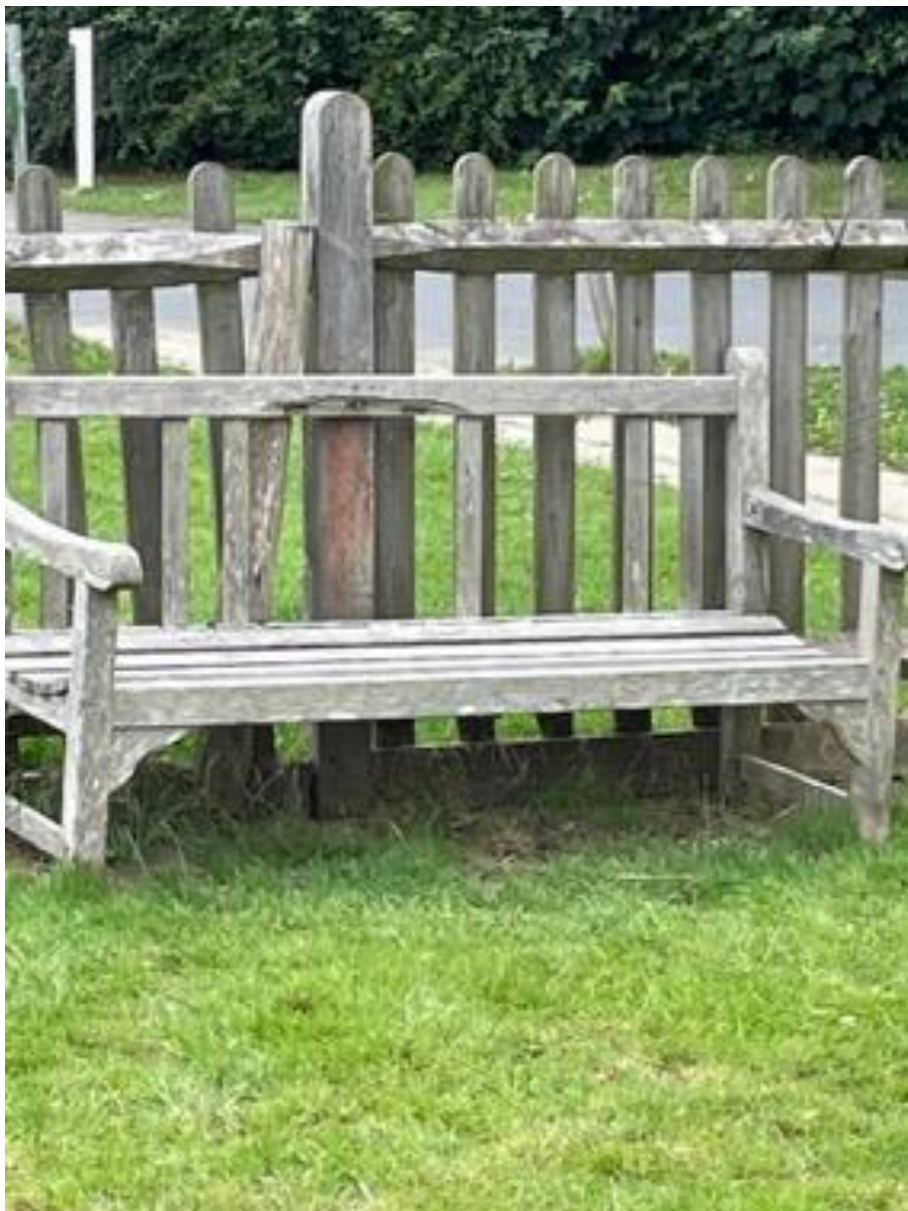
Dilapidated broken bench

11. That a project be established to replace the fencing, to restore, replace and add to the benches and flower boxes and the grassed area be made presentable and smooth.

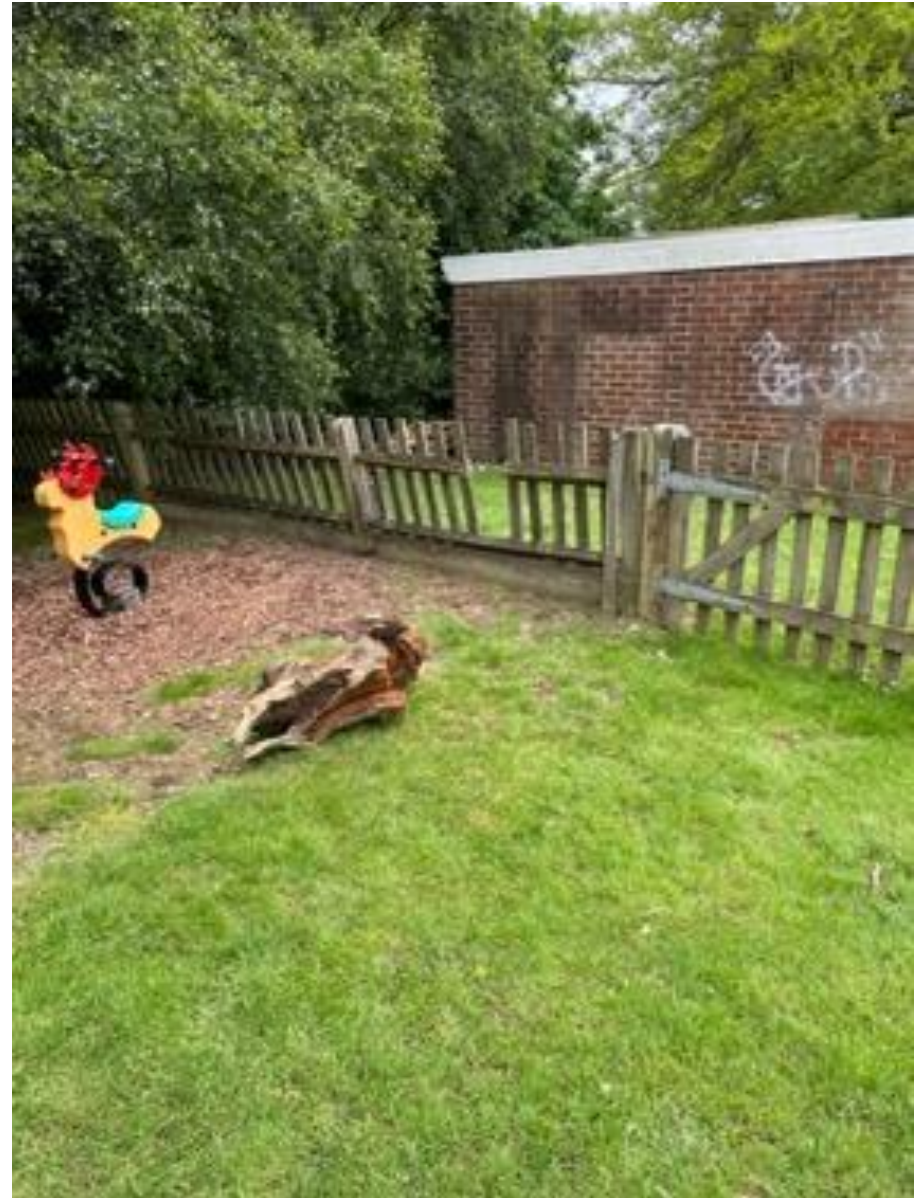
Tree root and uneven surface

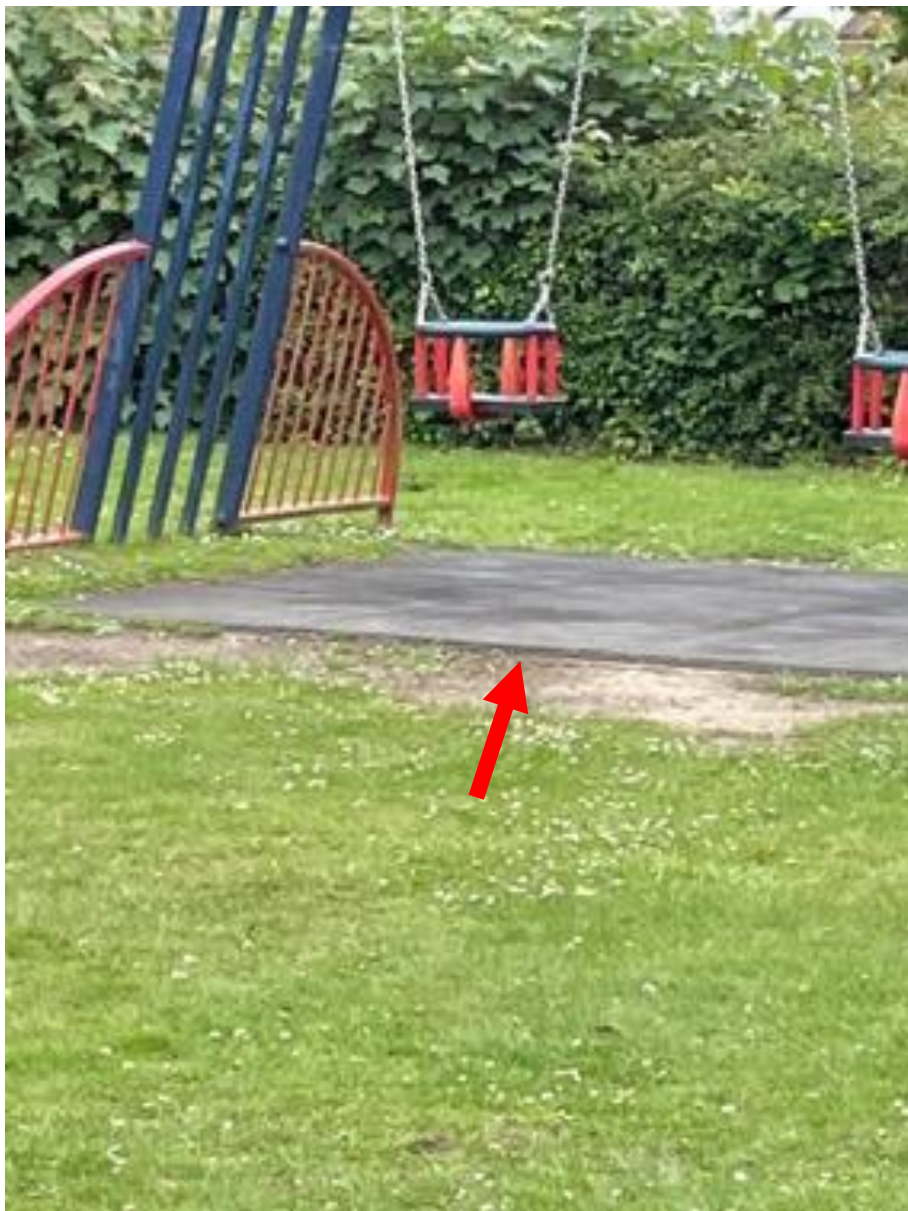
Southern most swings – Lip to play surface.

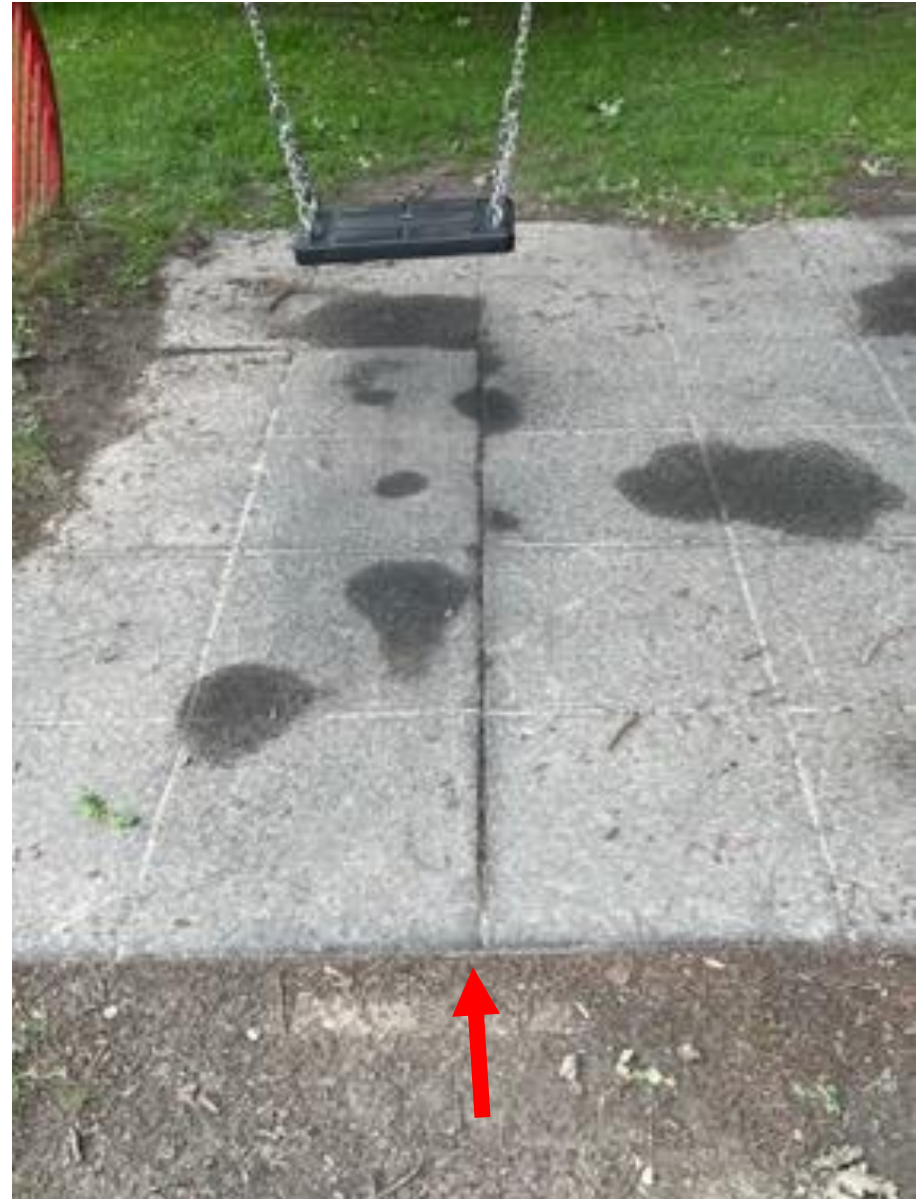
Northern most swings – Lip to play surface
