# Hawkhurst Parish Council Health and Safety Report

June 2022

Observations from audit of HPC facilities using HSE Slips and trips hazard spotting checklist and HSE Checklist for village and community halls.

Conducted by Cllr Paul Green and Cllr Simon Paish on Thursday 9<sup>th</sup> June 2022, conditions clear and dry, And 16<sup>th</sup> June 2022 conditions hot clear and dry.

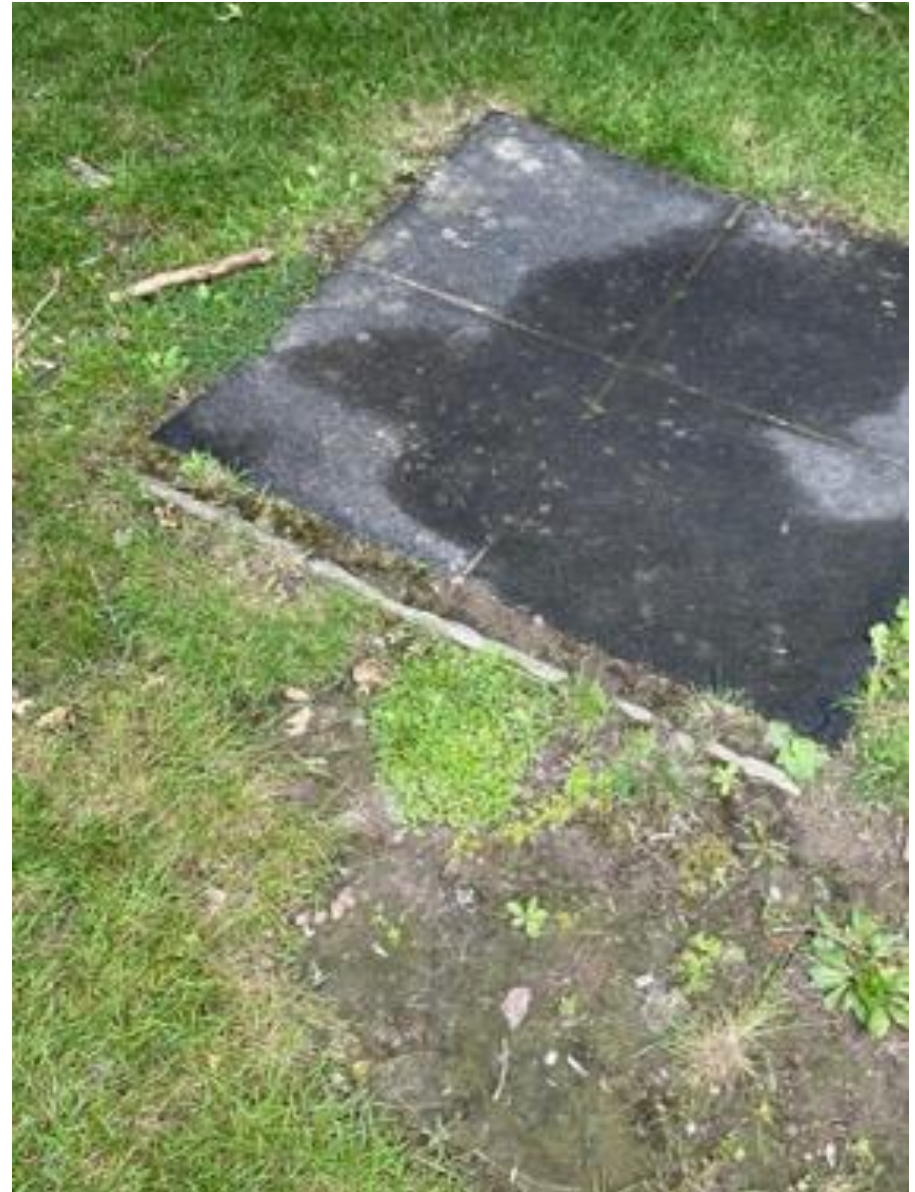
Rubberised surface remains in grass from removed piece of play equipment (old seesaw?)

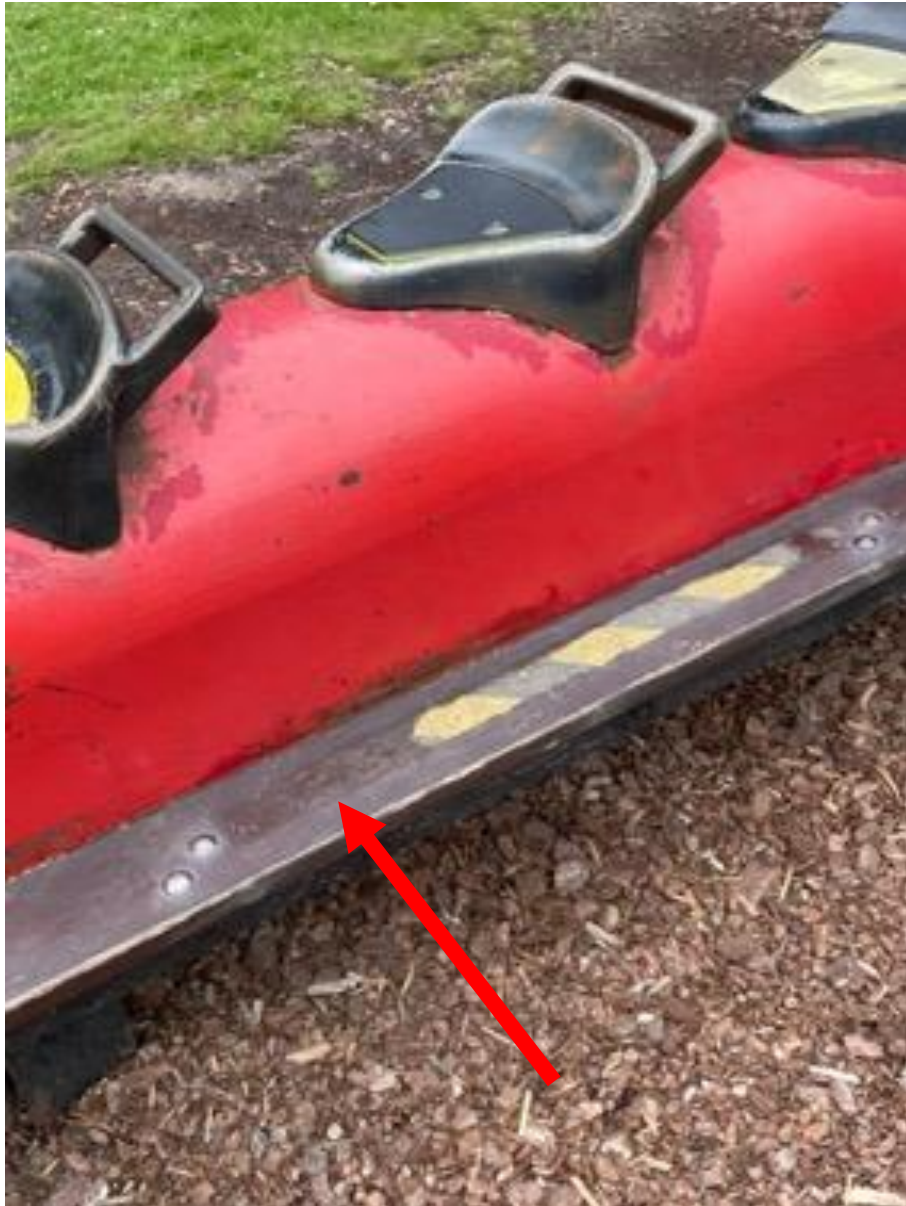
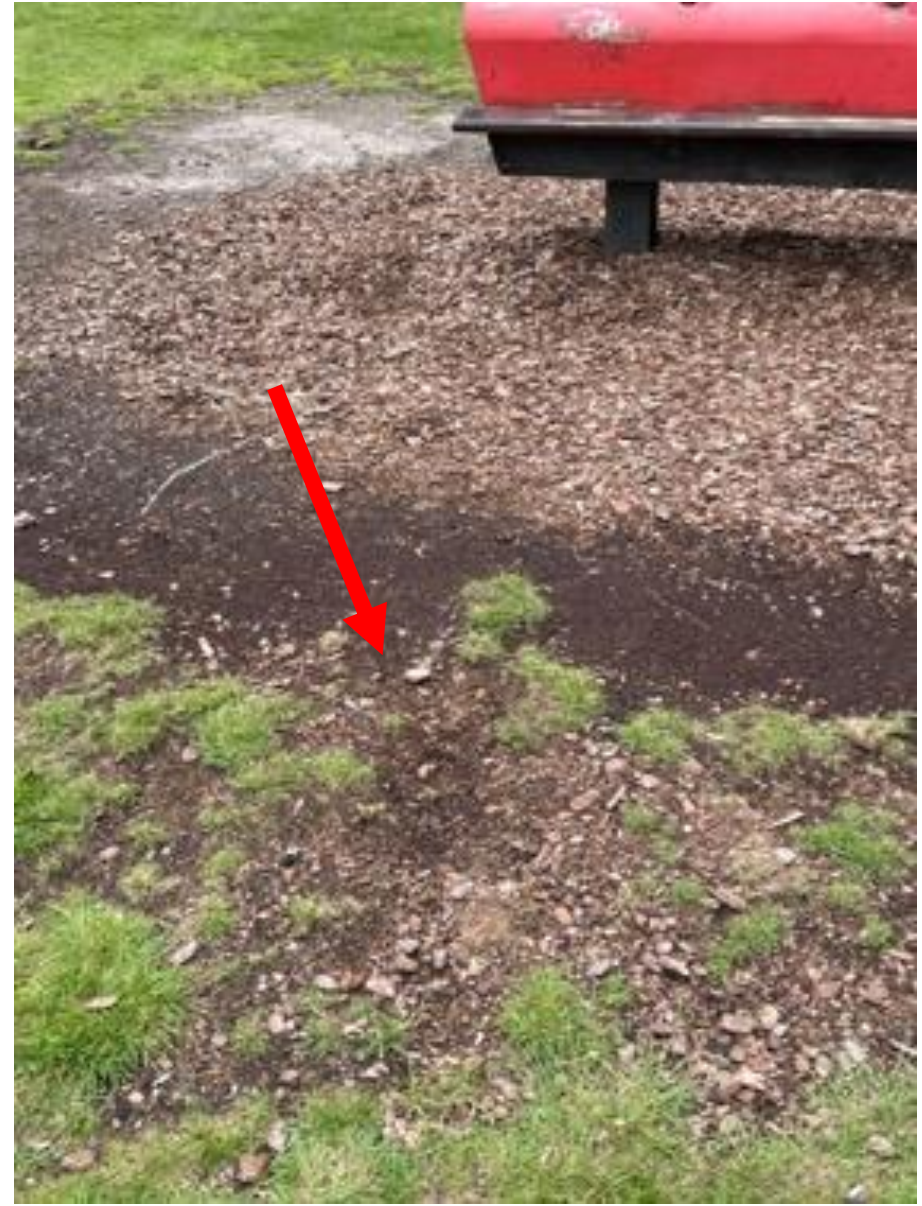
Uneven surface by rocking horse and worn grip

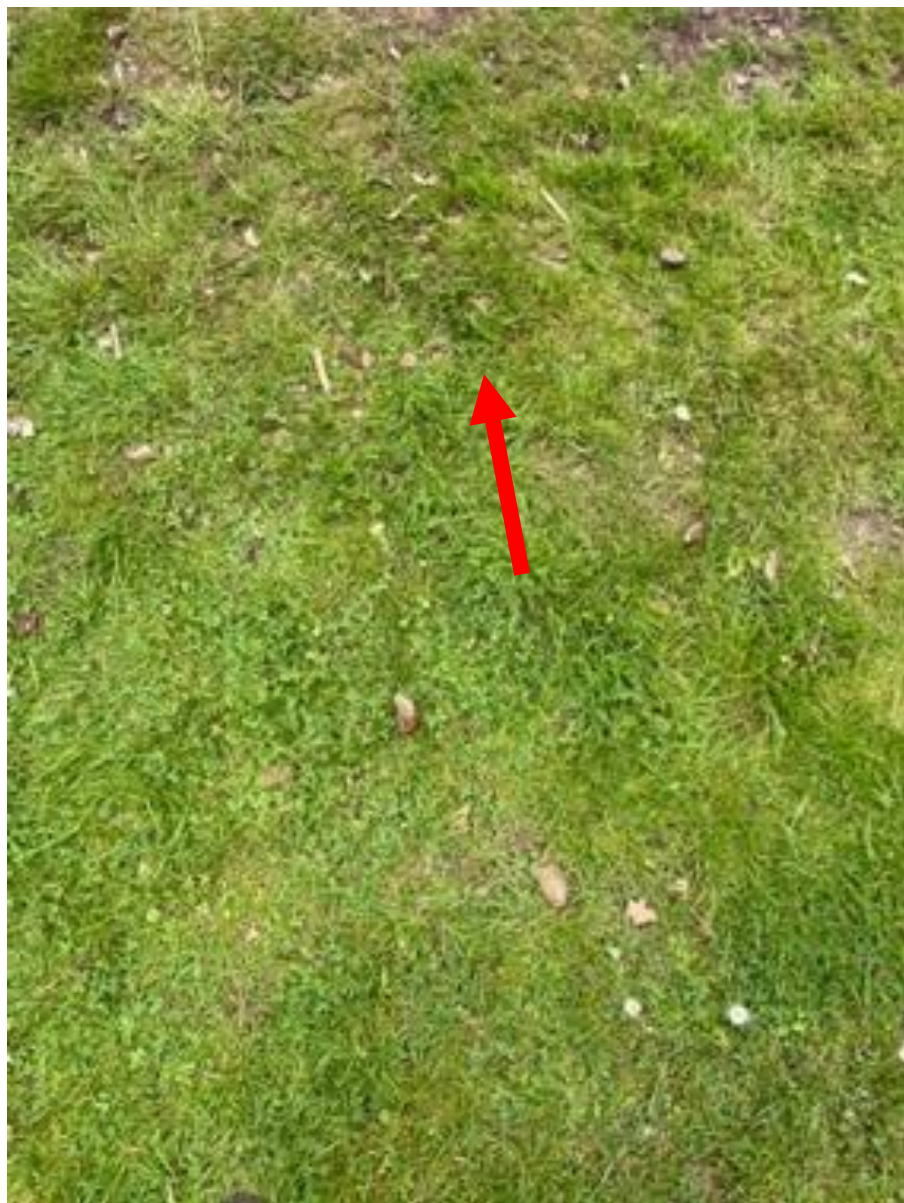
Uneven surface – ankle traps

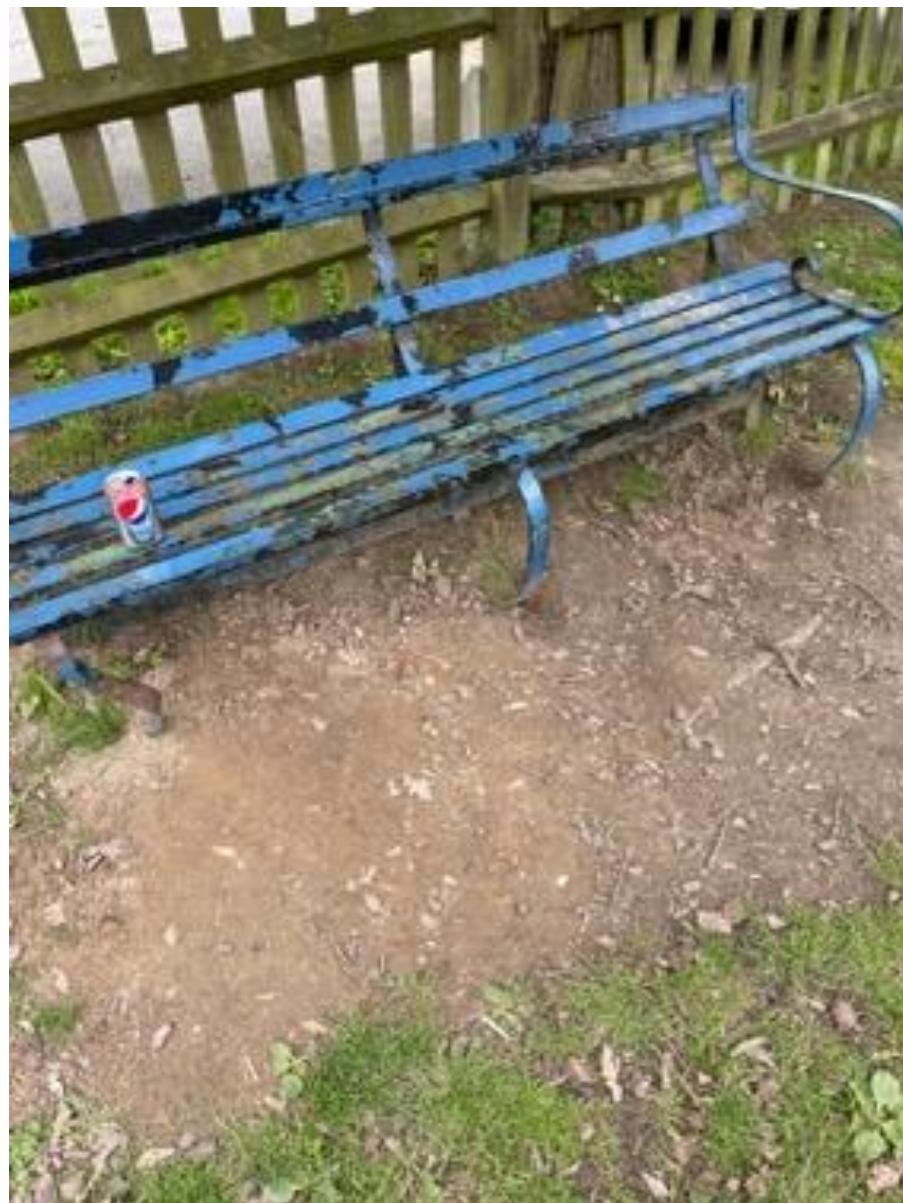
Damaged/exposed metal and uneven surface in front of bench.

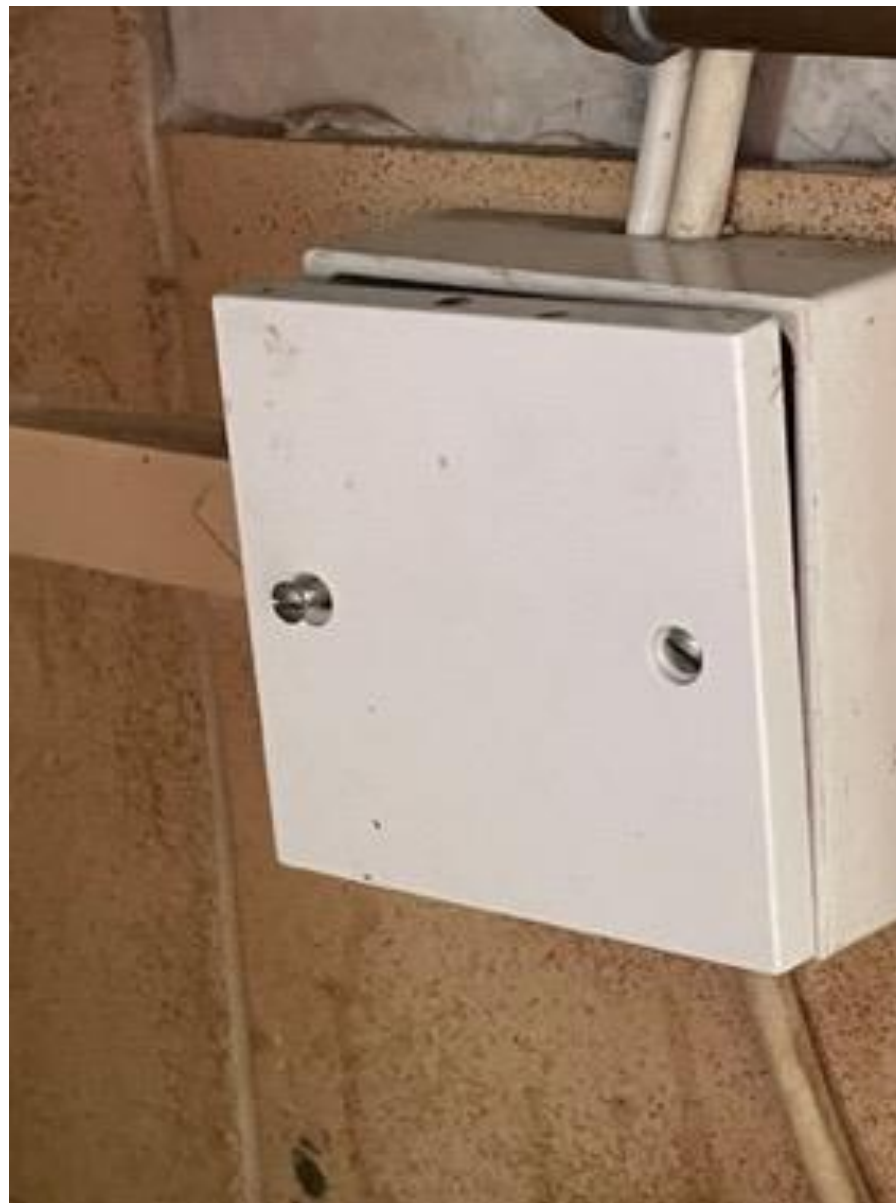
Loose electrical cover under boiler

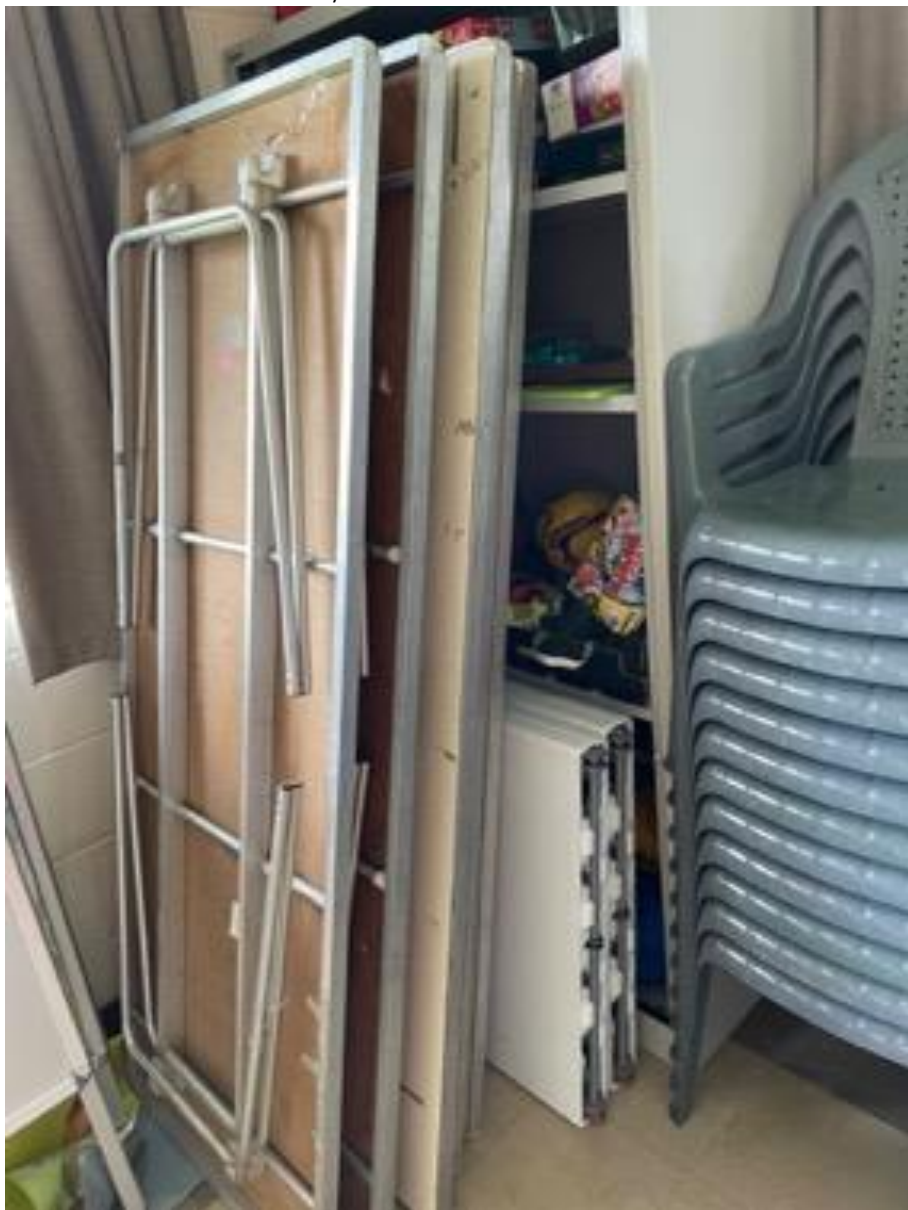
Chairs stacked too high  
Tables not stored securely

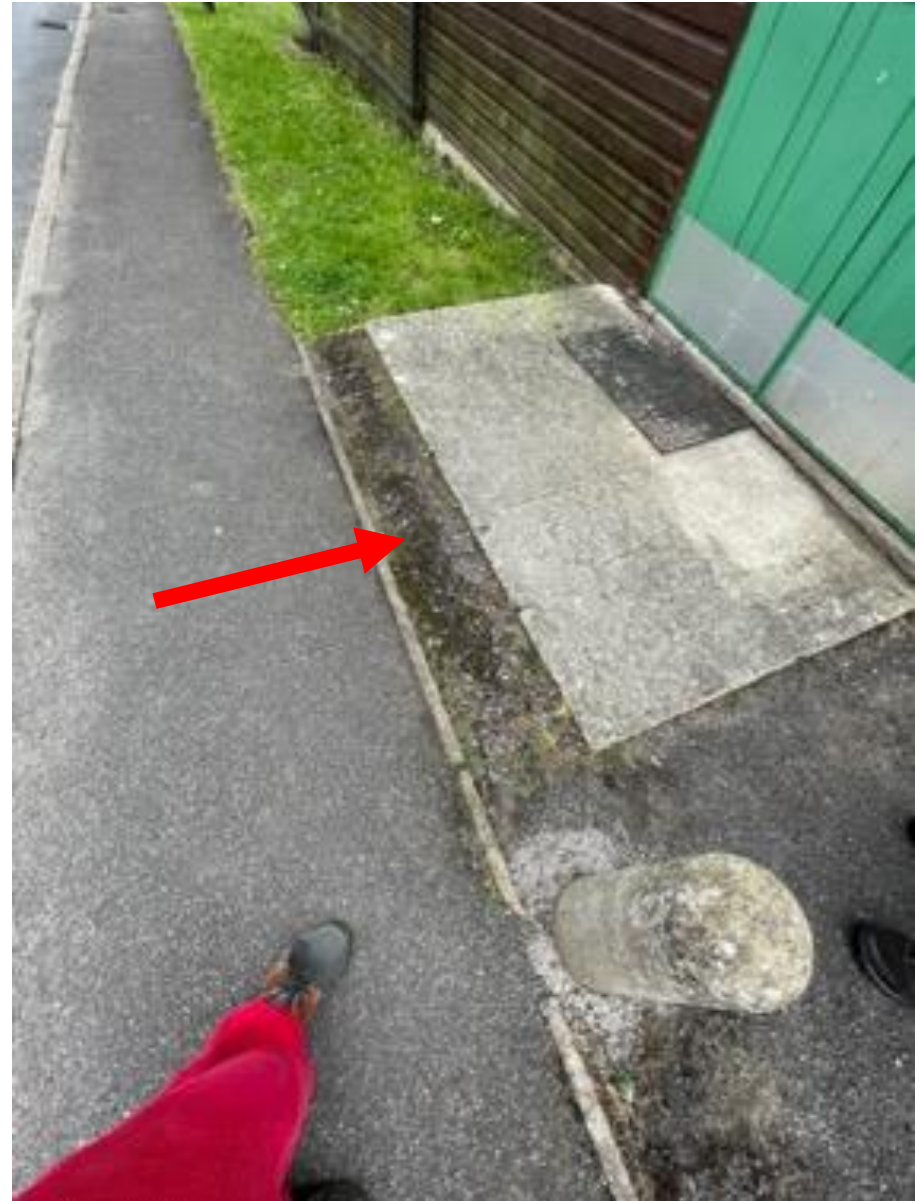
Main entrance to building  
Transition between public footpath and concrete?

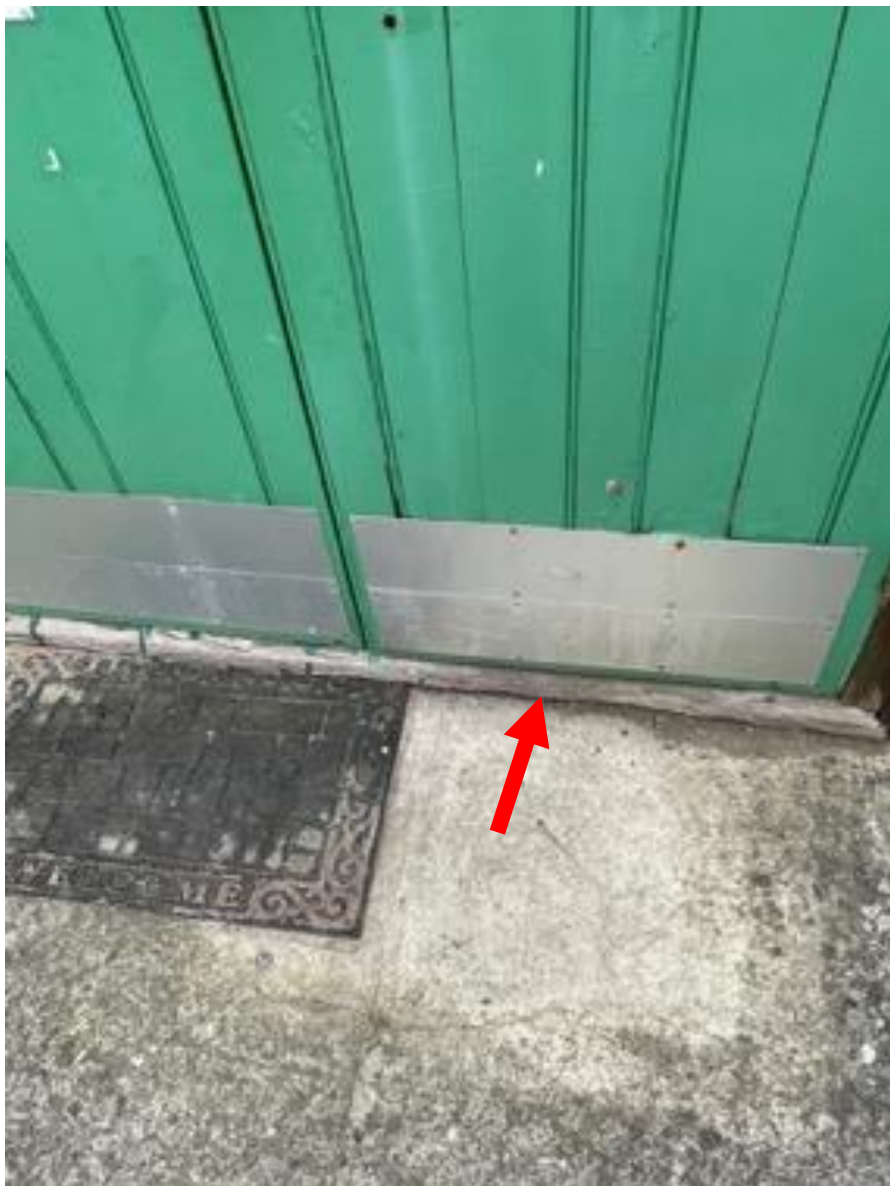
Threshold worn and uneven

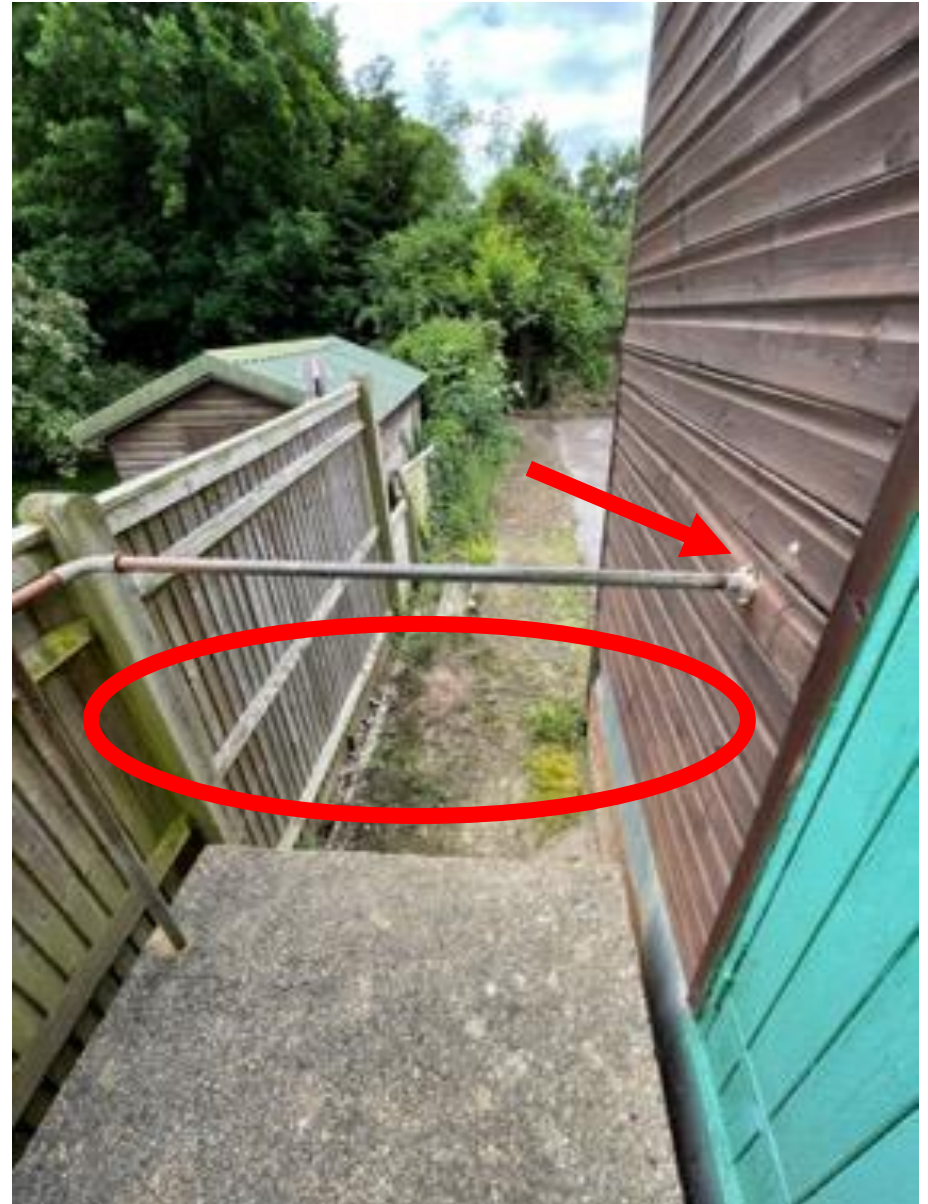
End of existing handrail not securely fastened to building

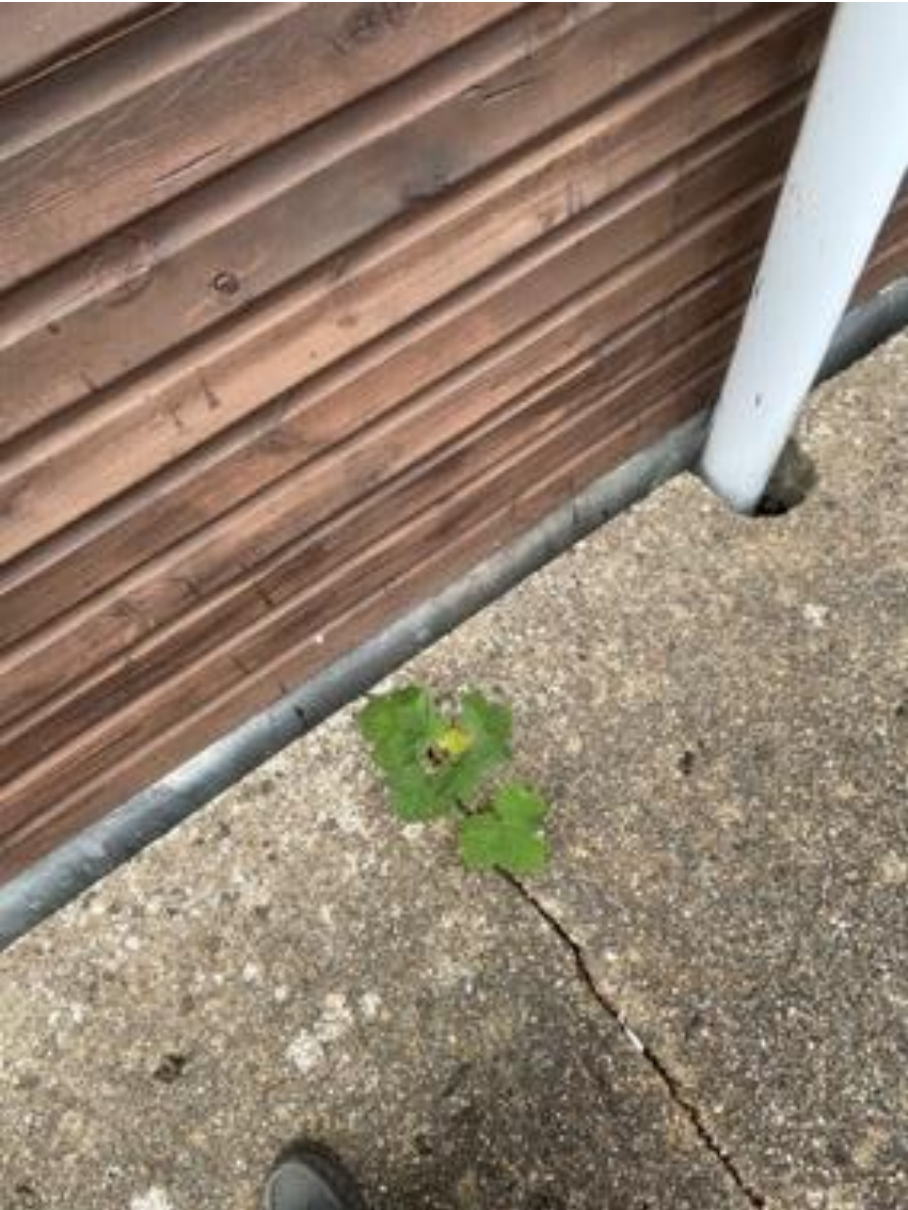
Moss and weeds on surface

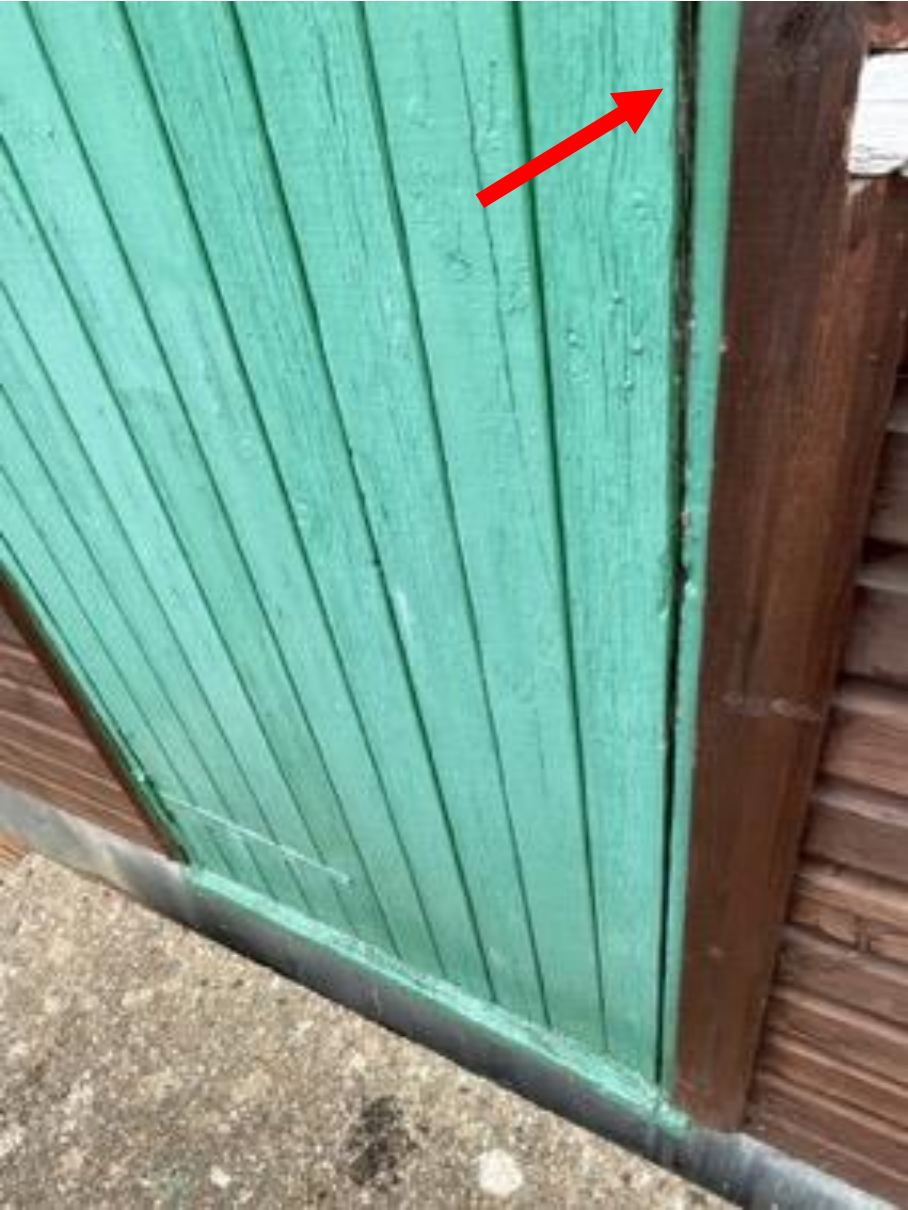
Emergency exit door needs adjusting and redundant pipe removing

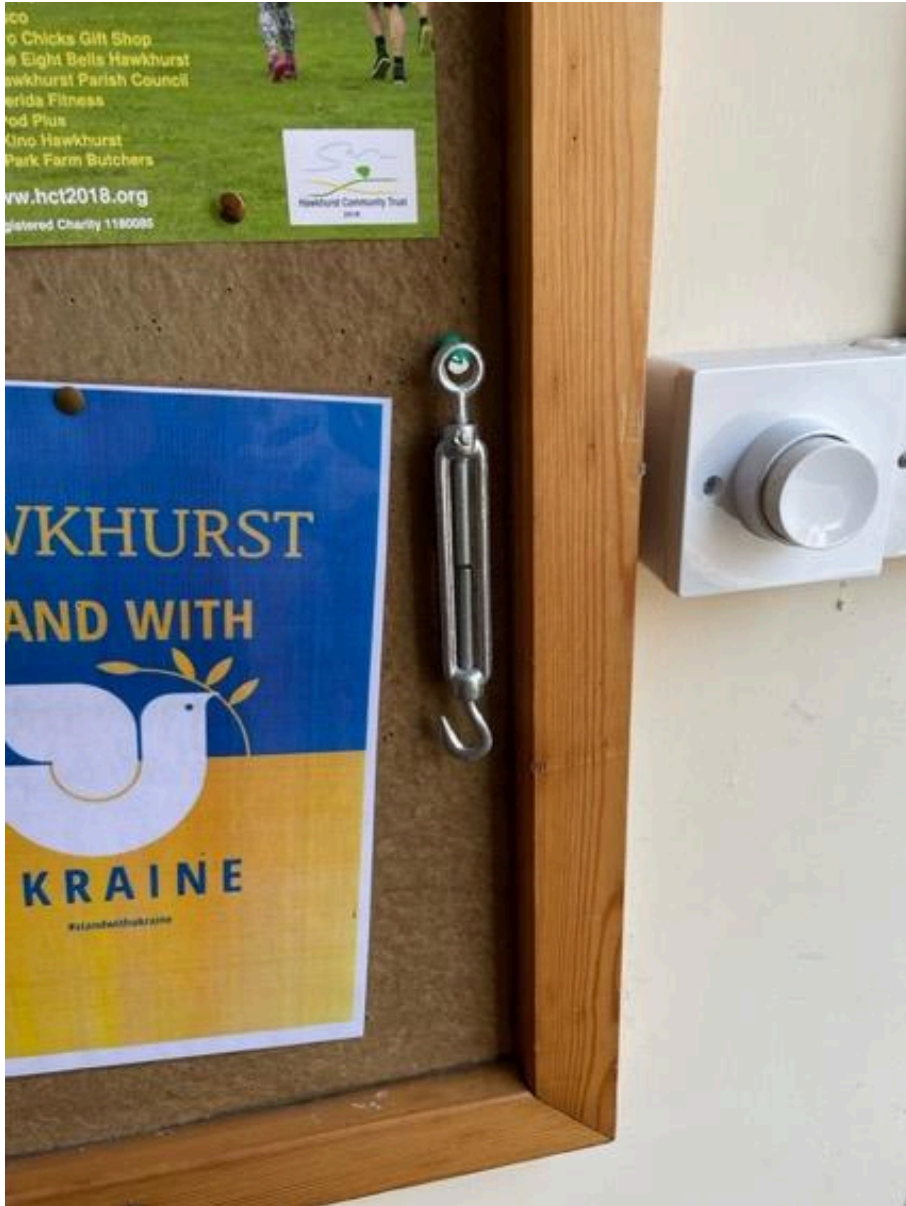
Main door restraint hook missing

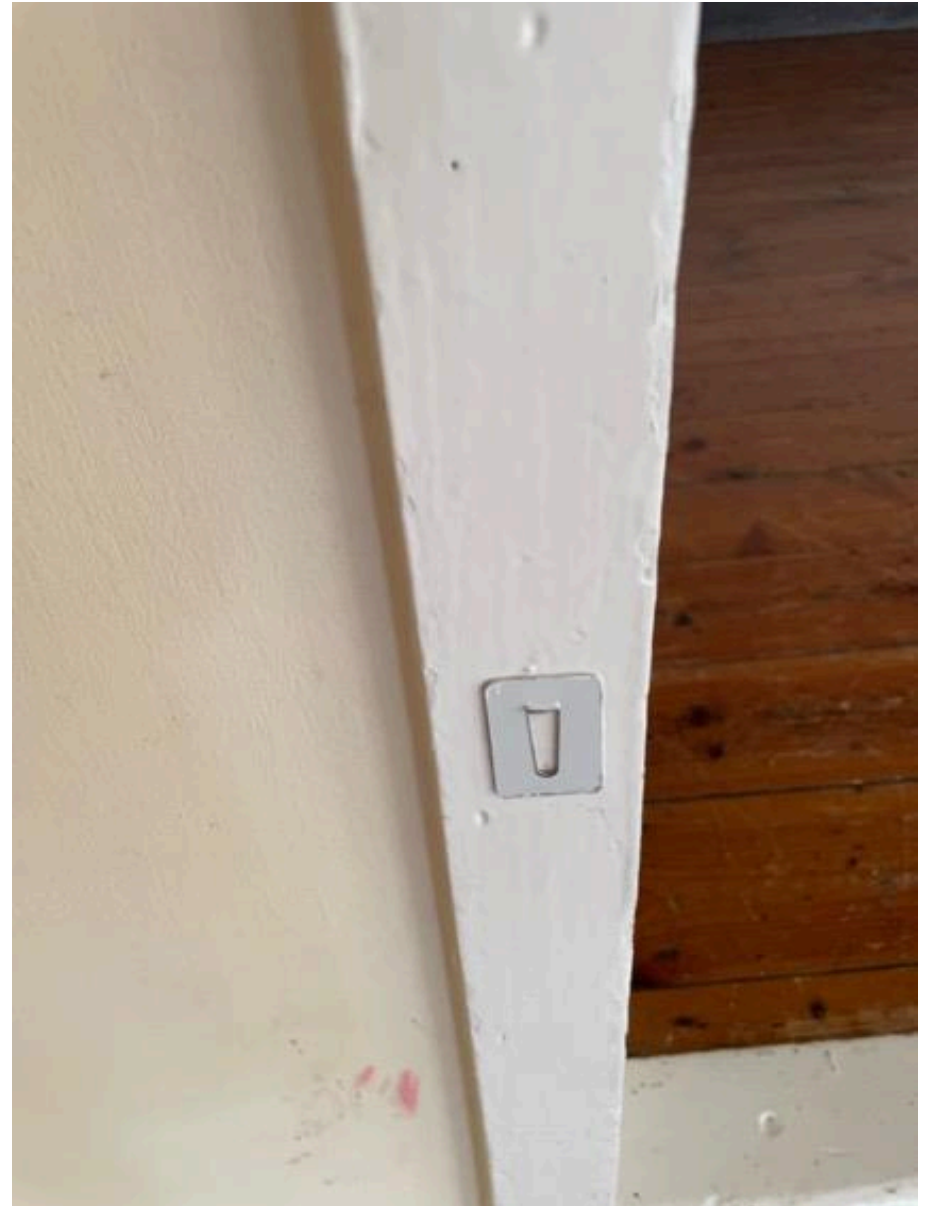
Broken metal clip with sharp edges to LHS of stage at front

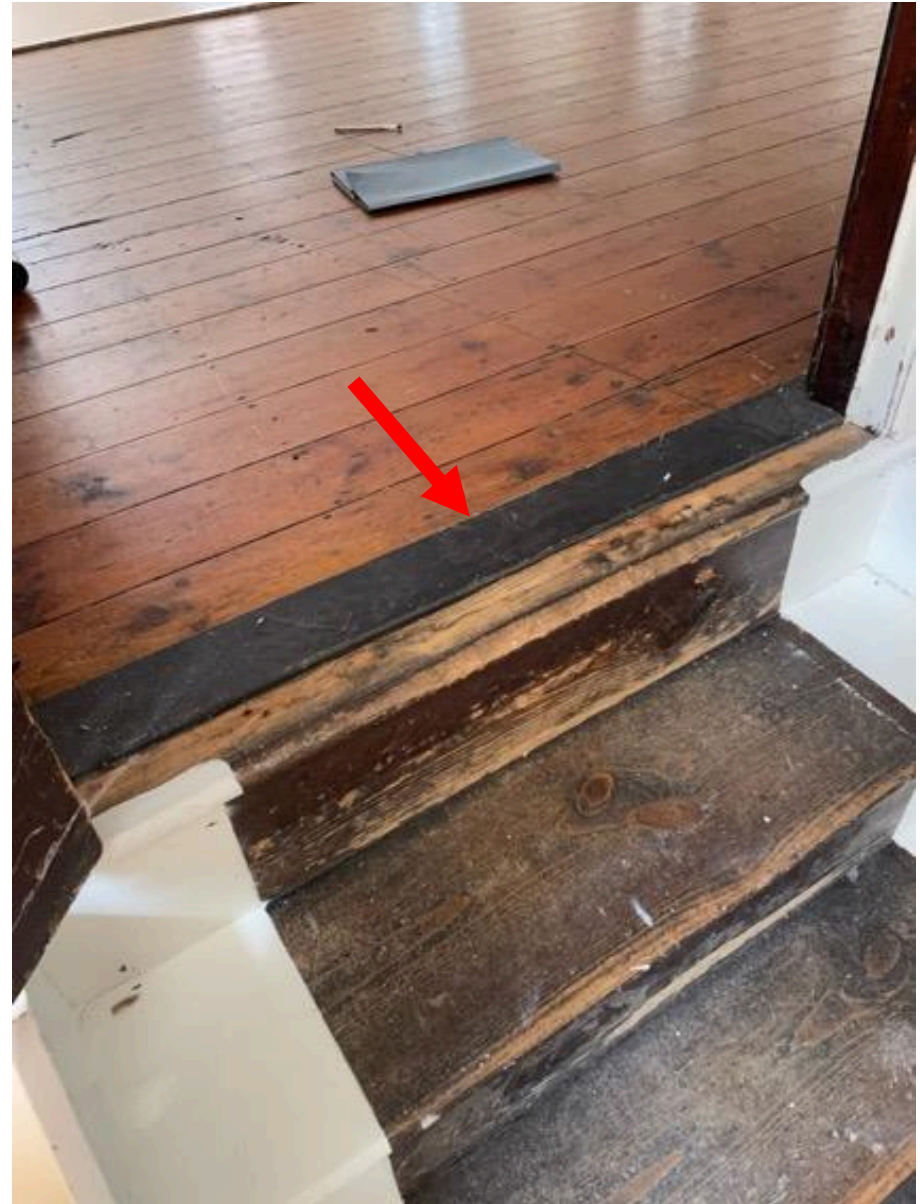
Raised threshold to stage door

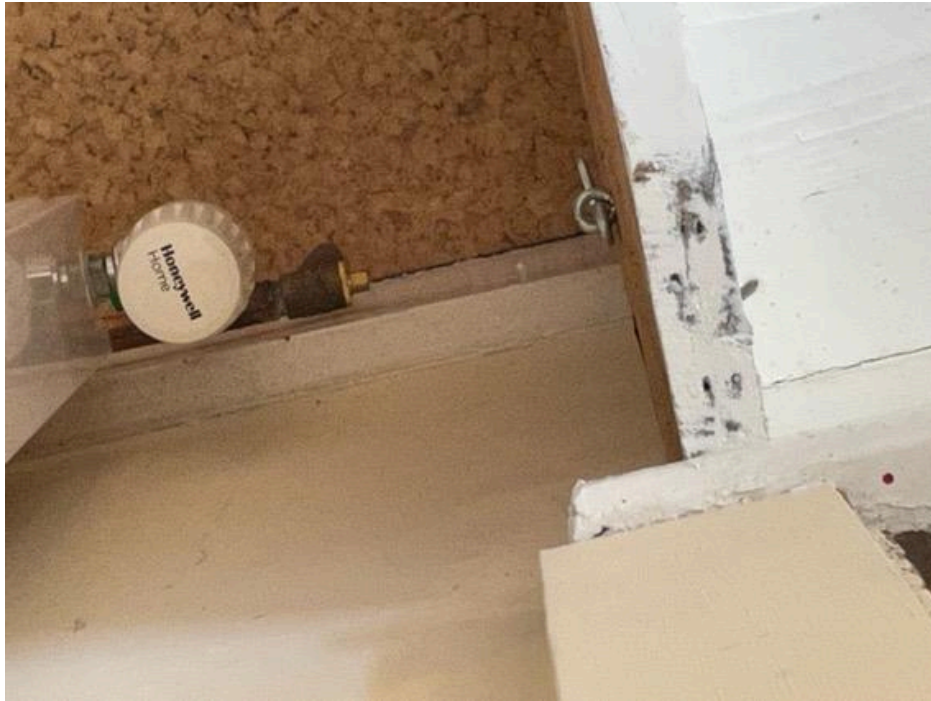
Stair securing eye missing

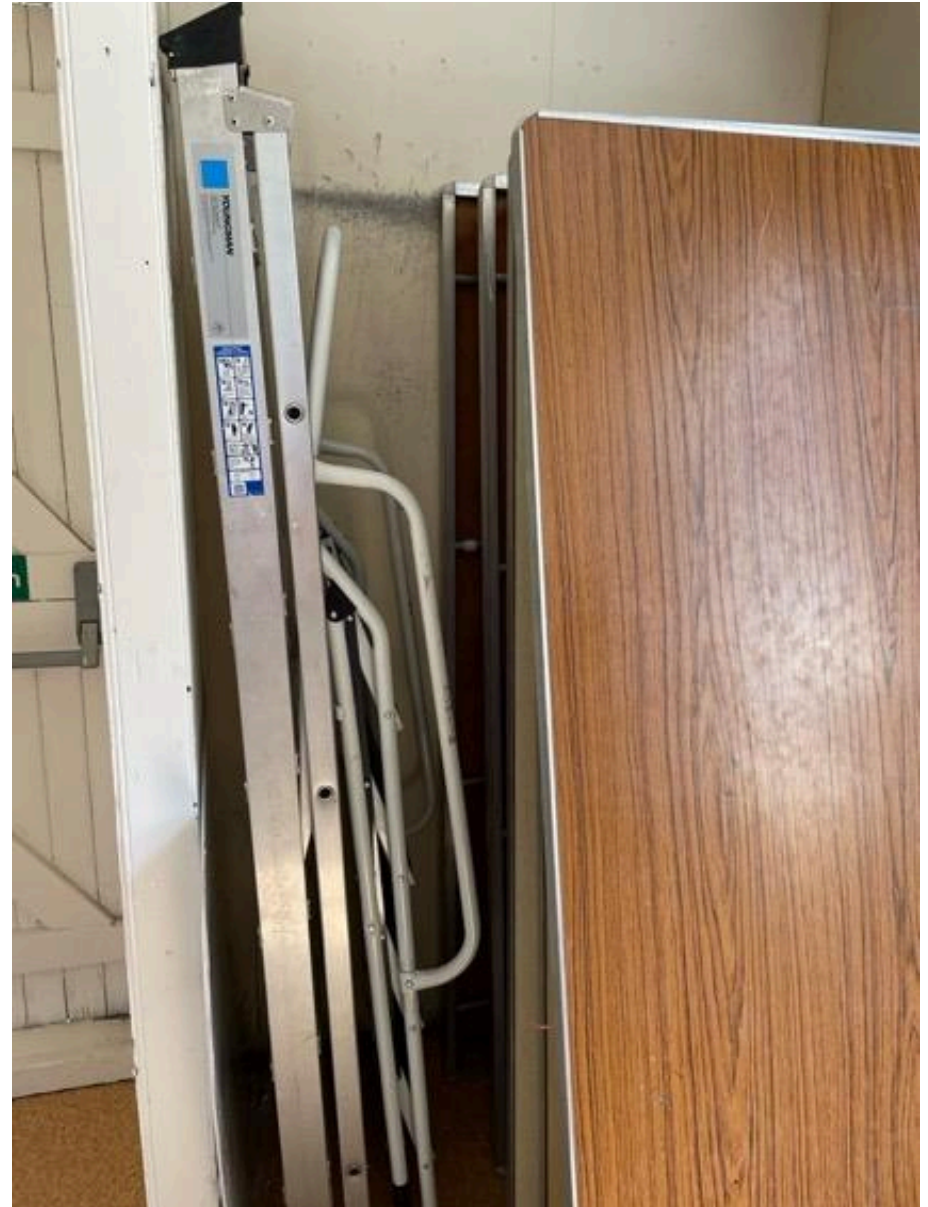
Ladders inappropriately stored and not secure

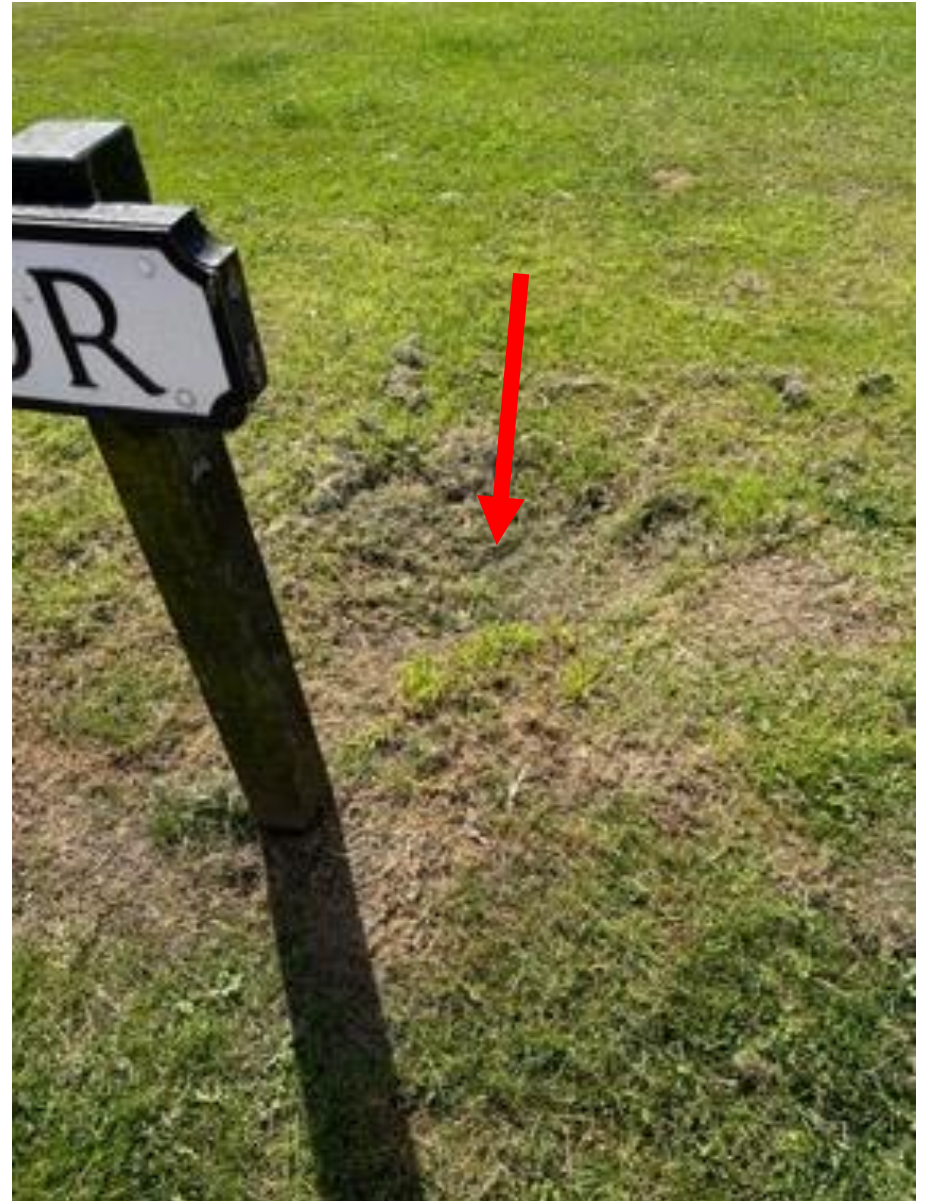
Large dip in grass

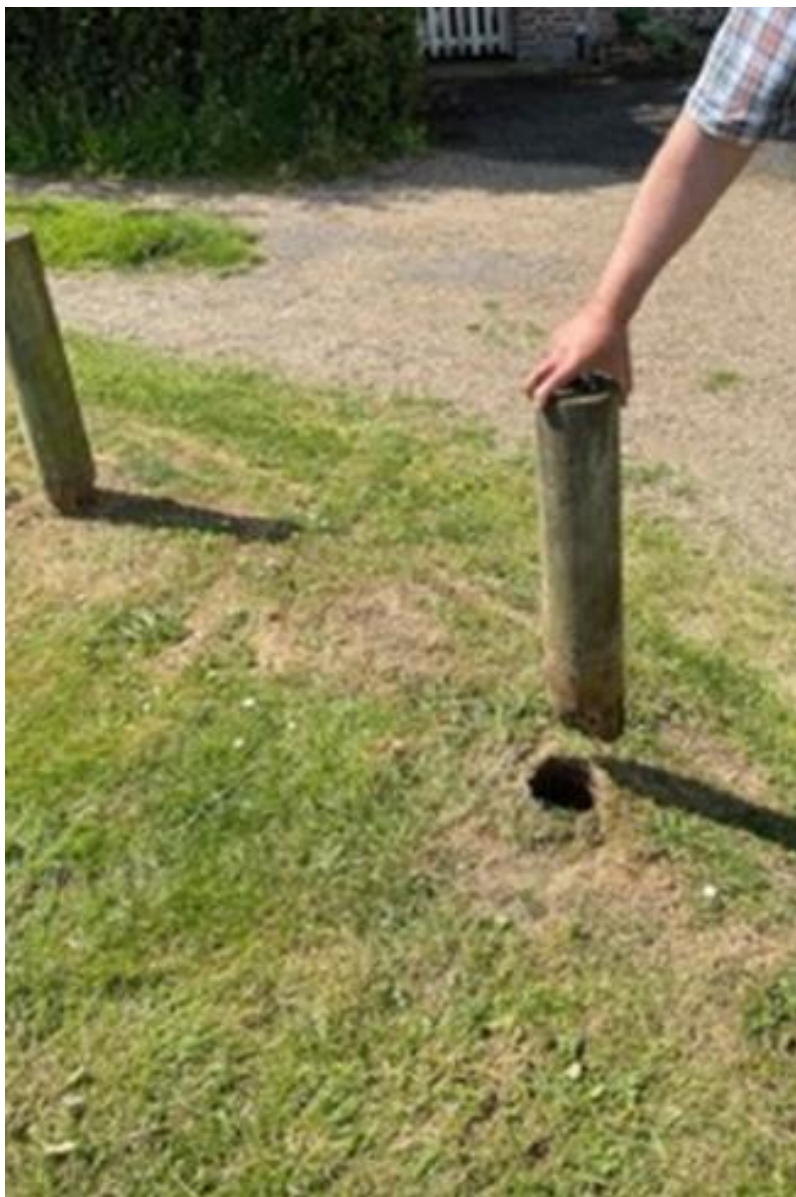
Broken and insecure posts on perimeter

6. That the Council instructs a contractor to make good the entrance lip to the Moor as soon as practicable using maintenance budget or General Reserves.
7. That the Council instructs a contractor (or the bonfire society) to examine and fix the beacon as soon as practicable using monies from the maintenance budget.
8. That FAS bring forward a maintenance plan for the Moor that includes the maintenance of the surface and replacement of broken and damaged posts (and note that the Council's preference is to use wooden posts on the Moor).

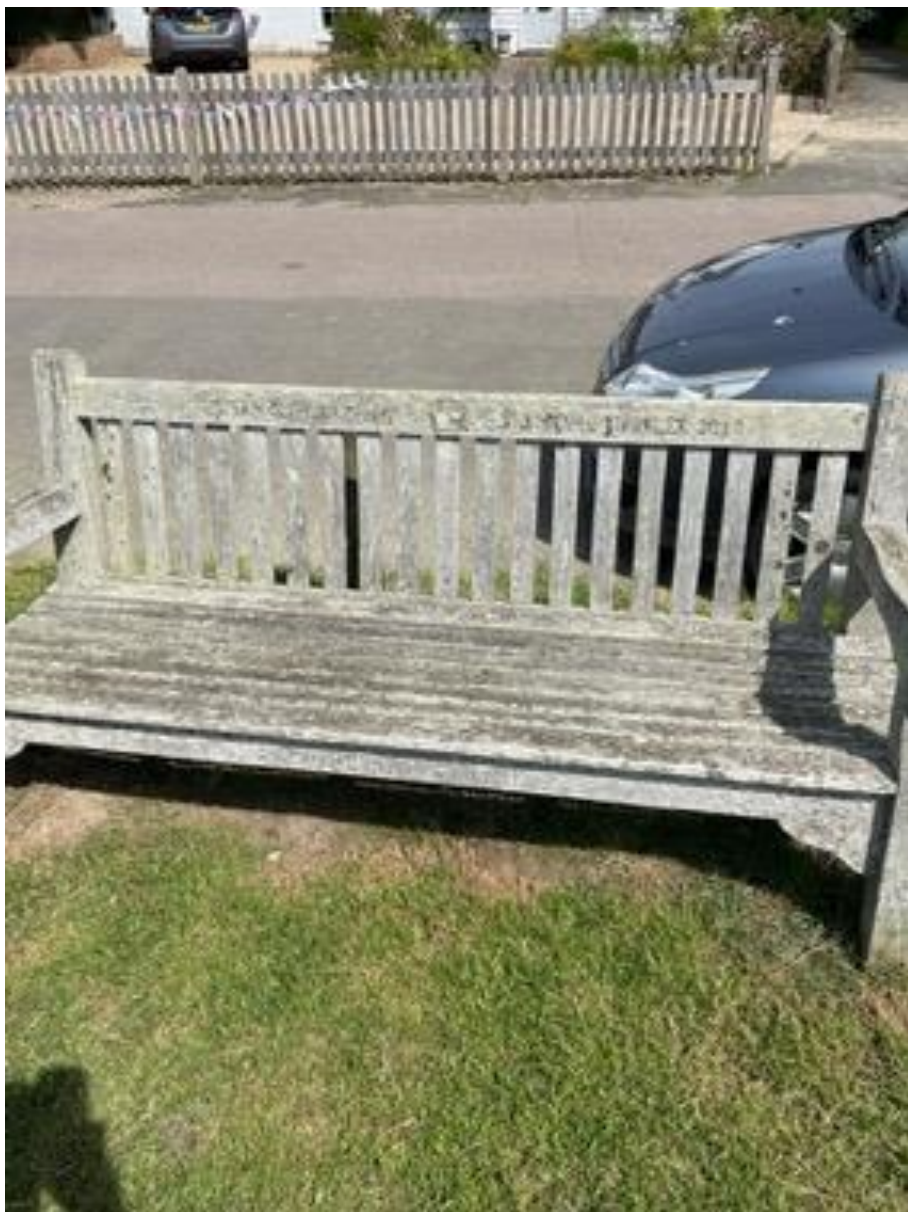
Bench not secure leaning backward

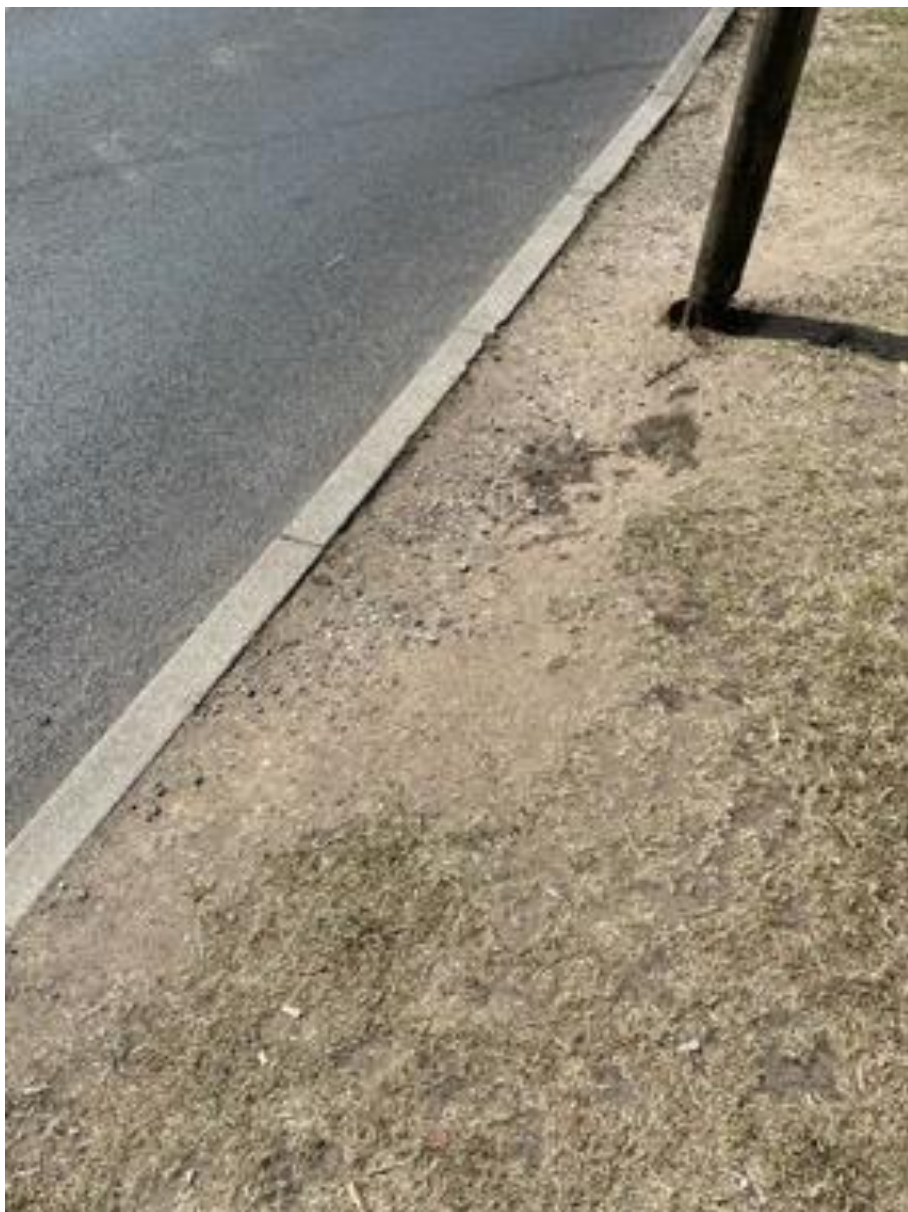
Hole where post is removed to allow access
