# Hawkhurst Parish Council Health and Safety Report

June 2022

Observations from audit of HPC facilities using HSE Slips and trips hazard spotting checklist and HSE Checklist for village and community halls.

Conducted by Cllr Paul Green and Cllr Simon Paish on Thursday 9<sup>th</sup> June 2022, conditions clear and dry, And 16<sup>th</sup> June 2022 conditions hot clear and dry.

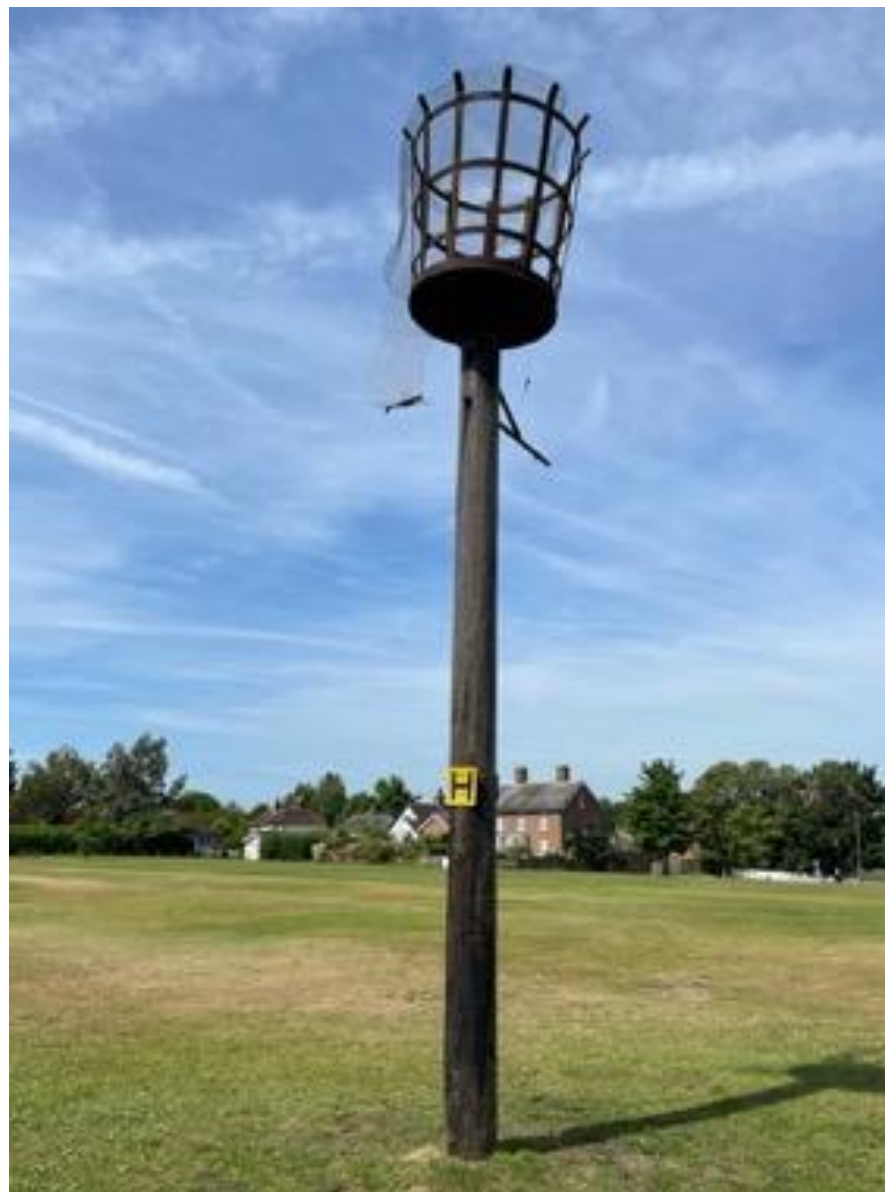
Top of beacon not secure and post leaning

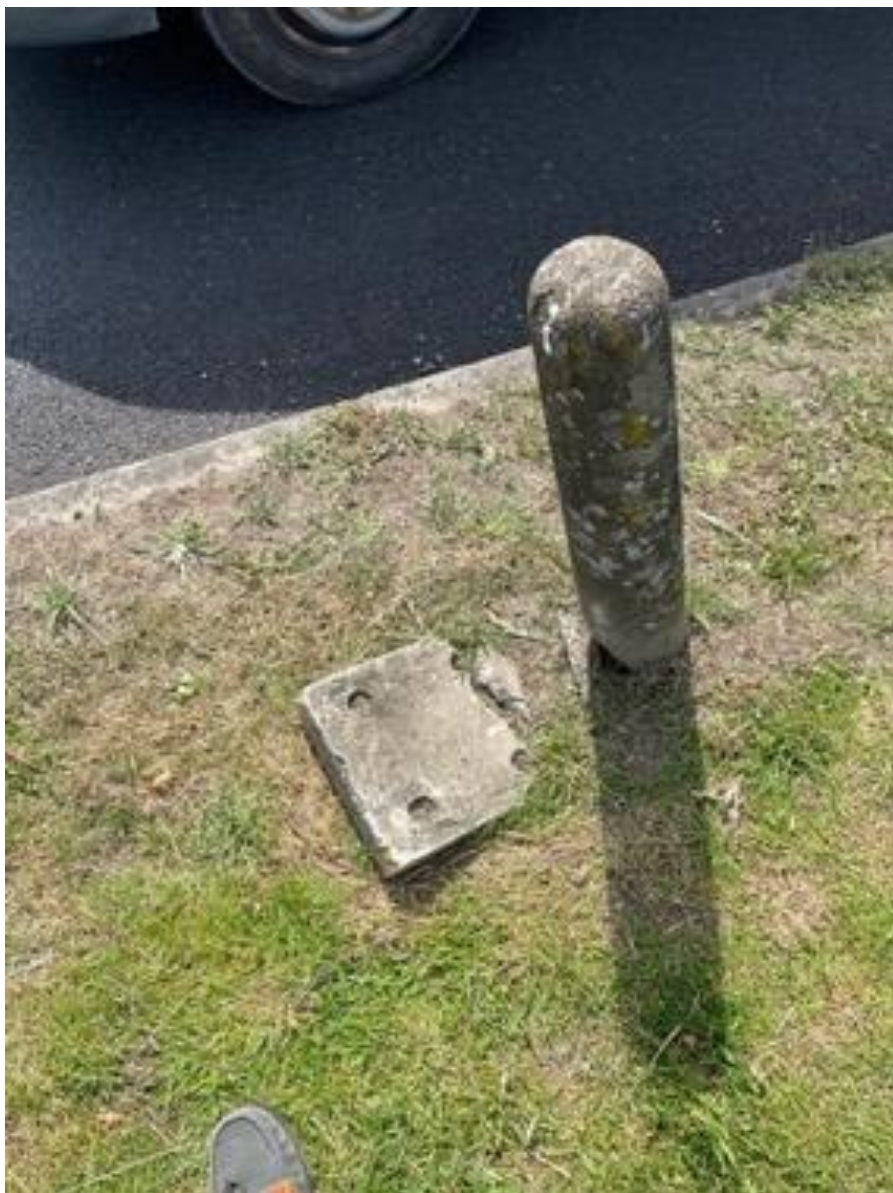
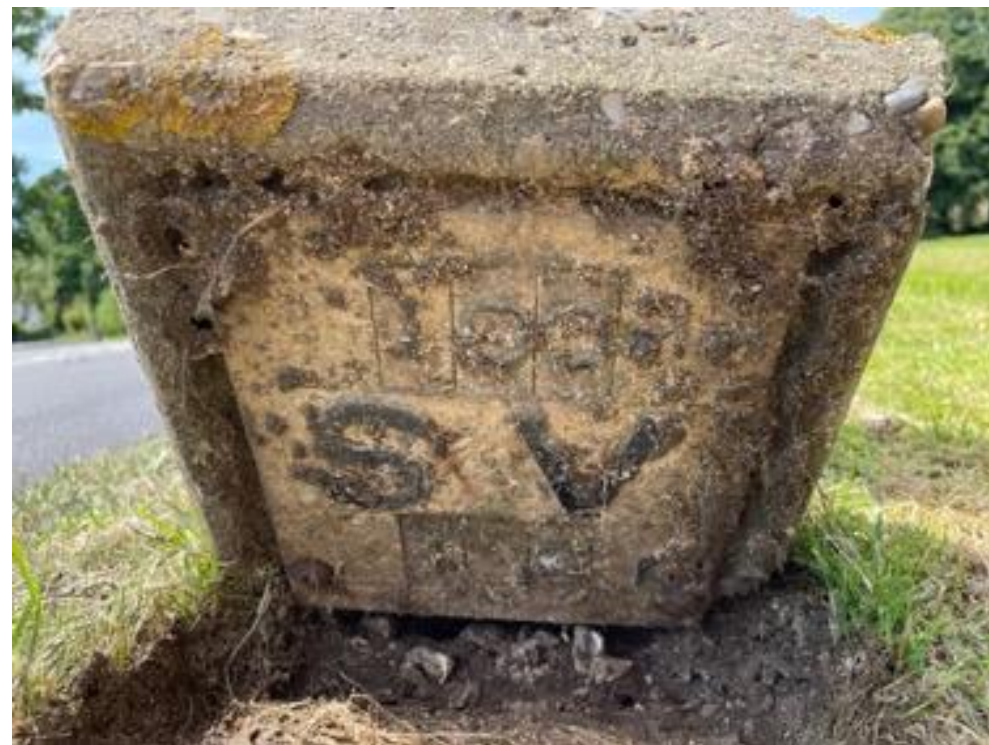
Sluice Valve marker post and concrete post cracked and broken

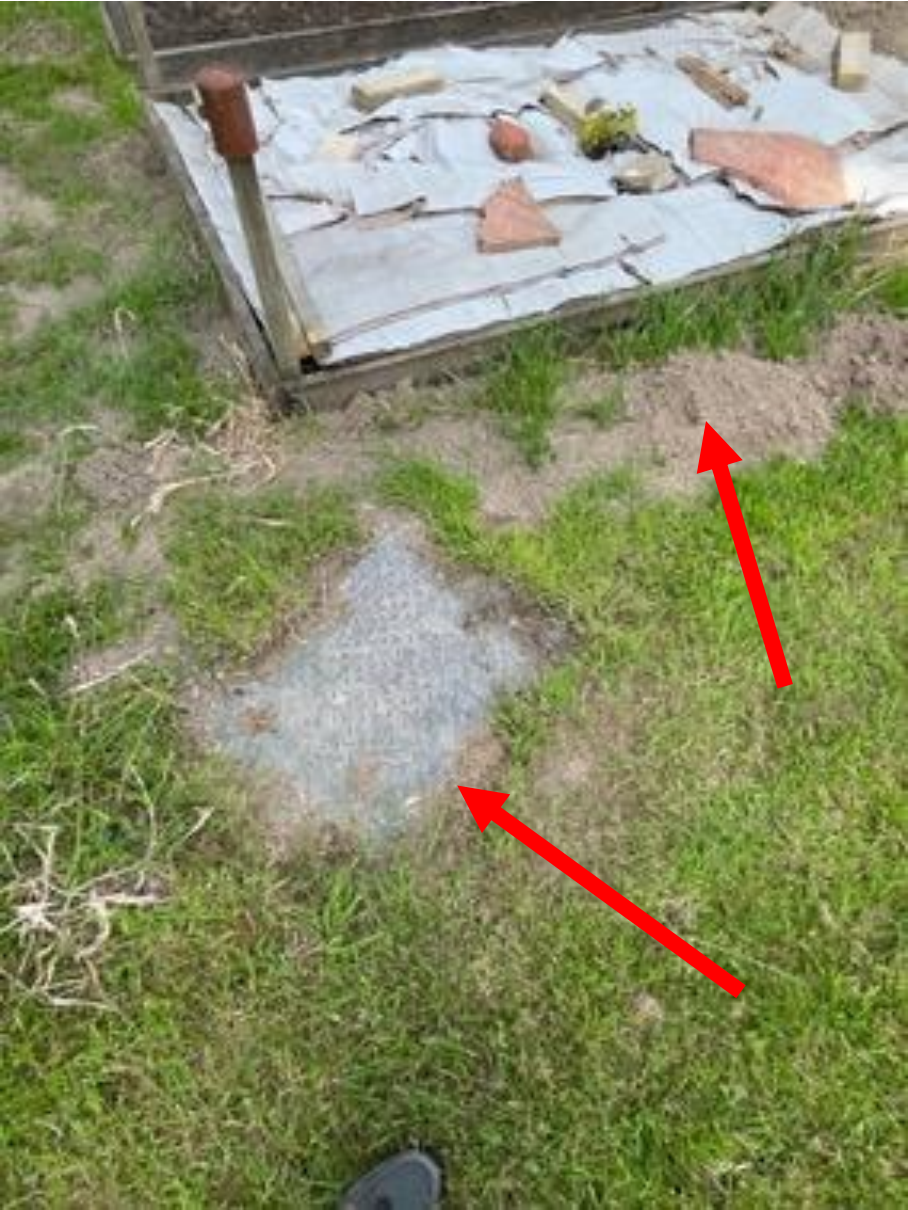
Mole hills and manhole cover

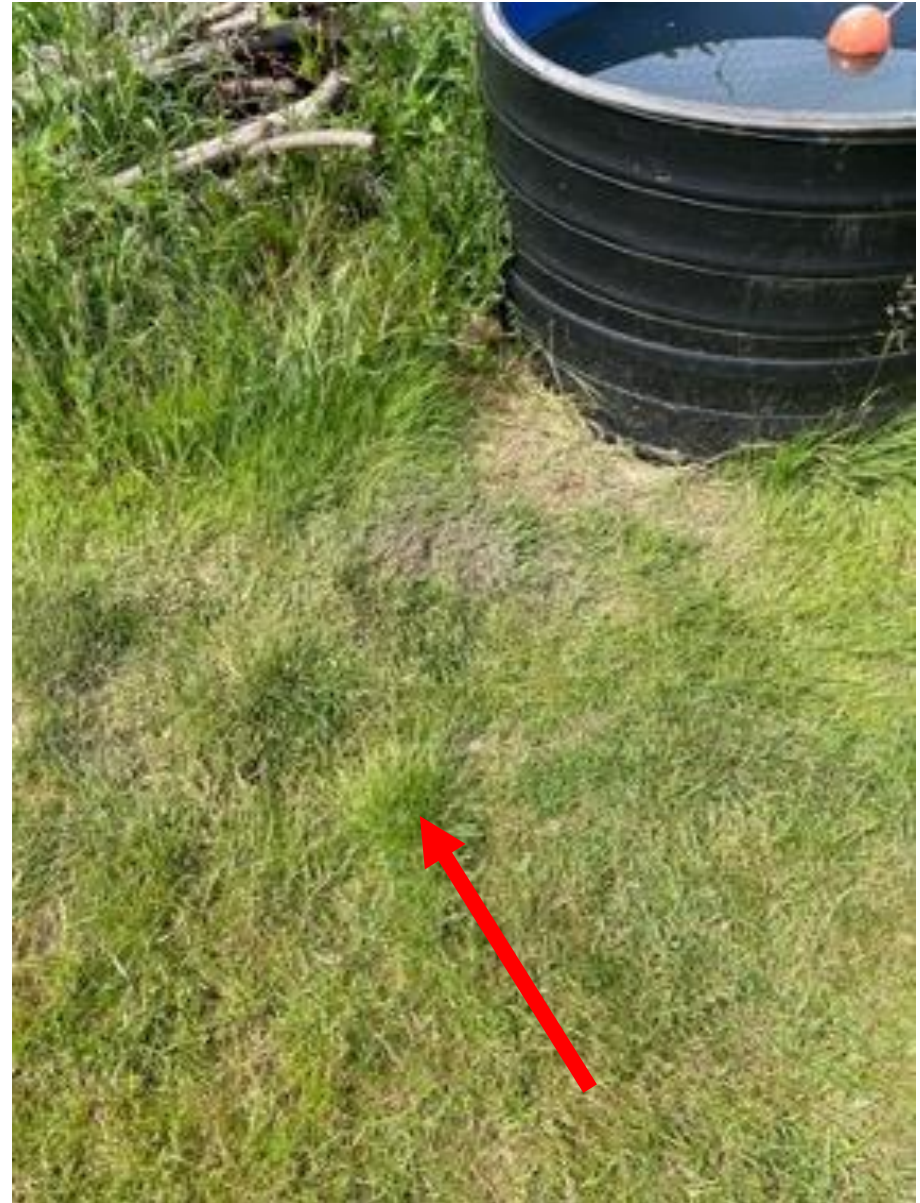
Concealed pothole by water drum

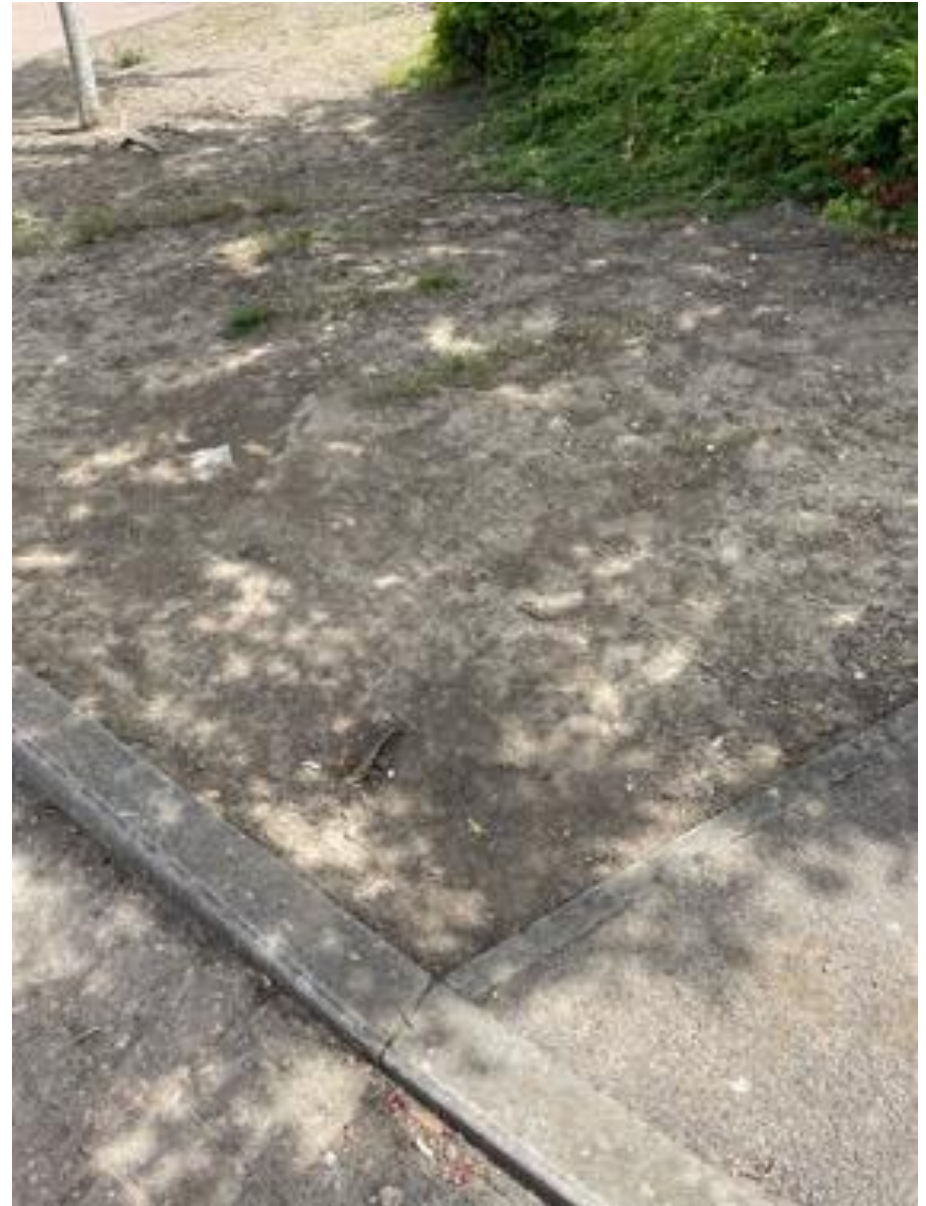
Rough surface and raised rear edge of curb in flowerbed by West entrance

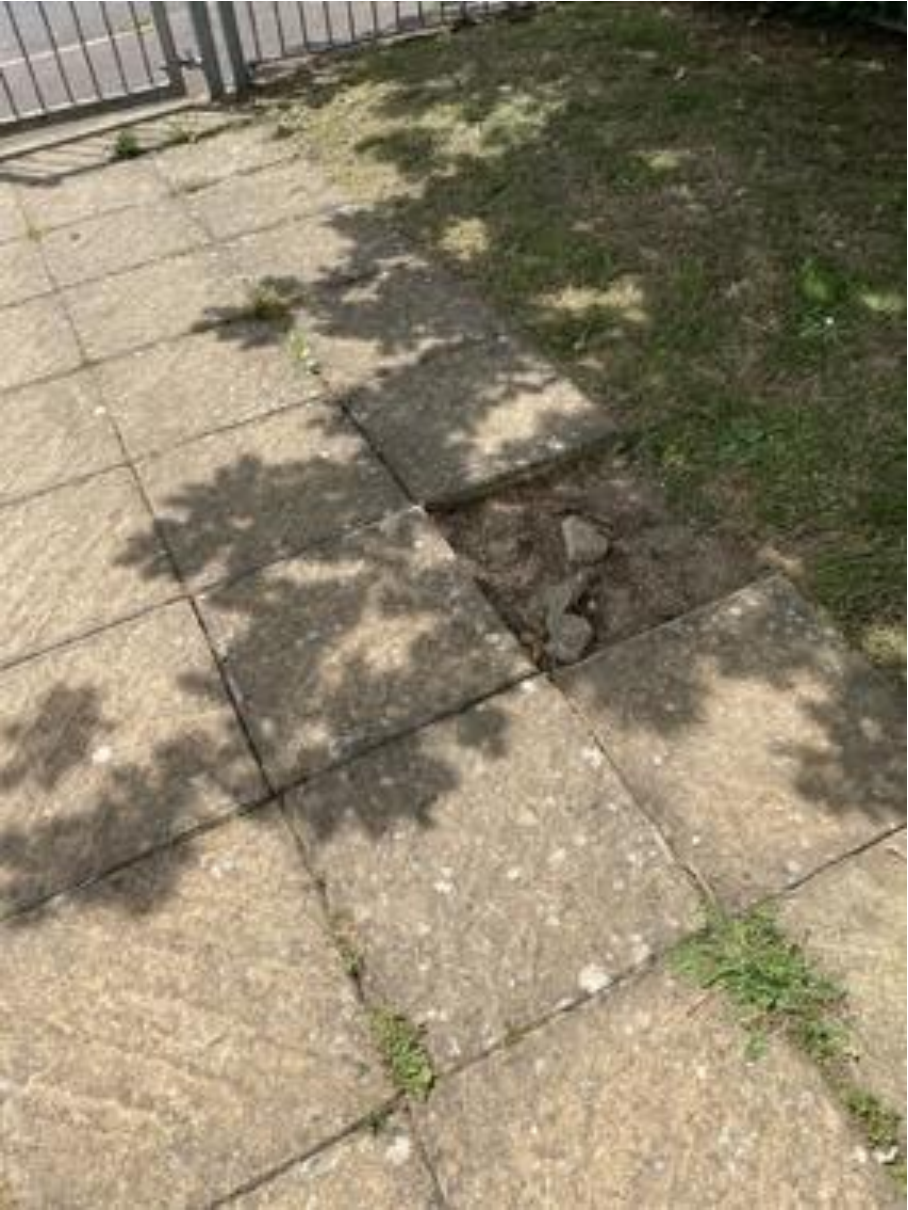
Side path missing slab

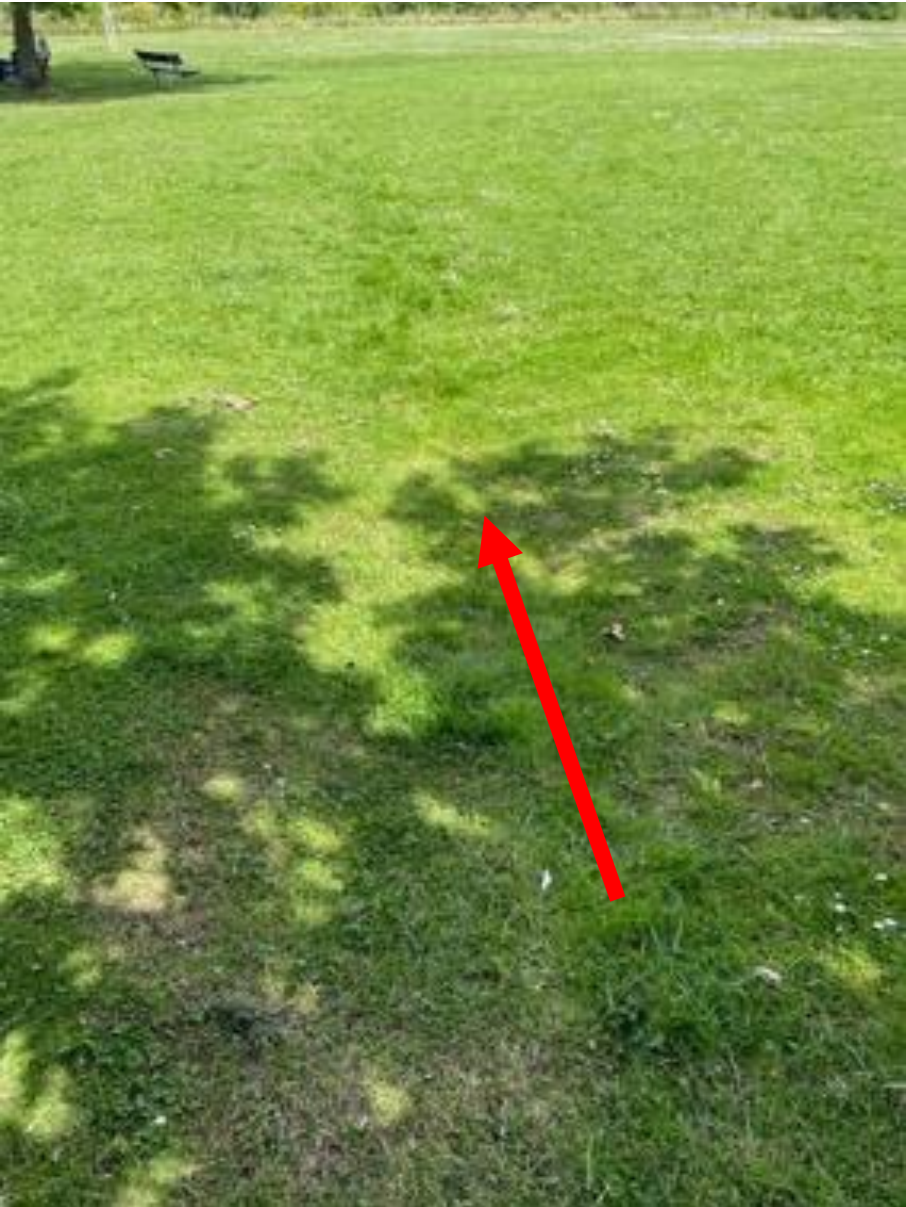
Long dip in surface from sunken services trench

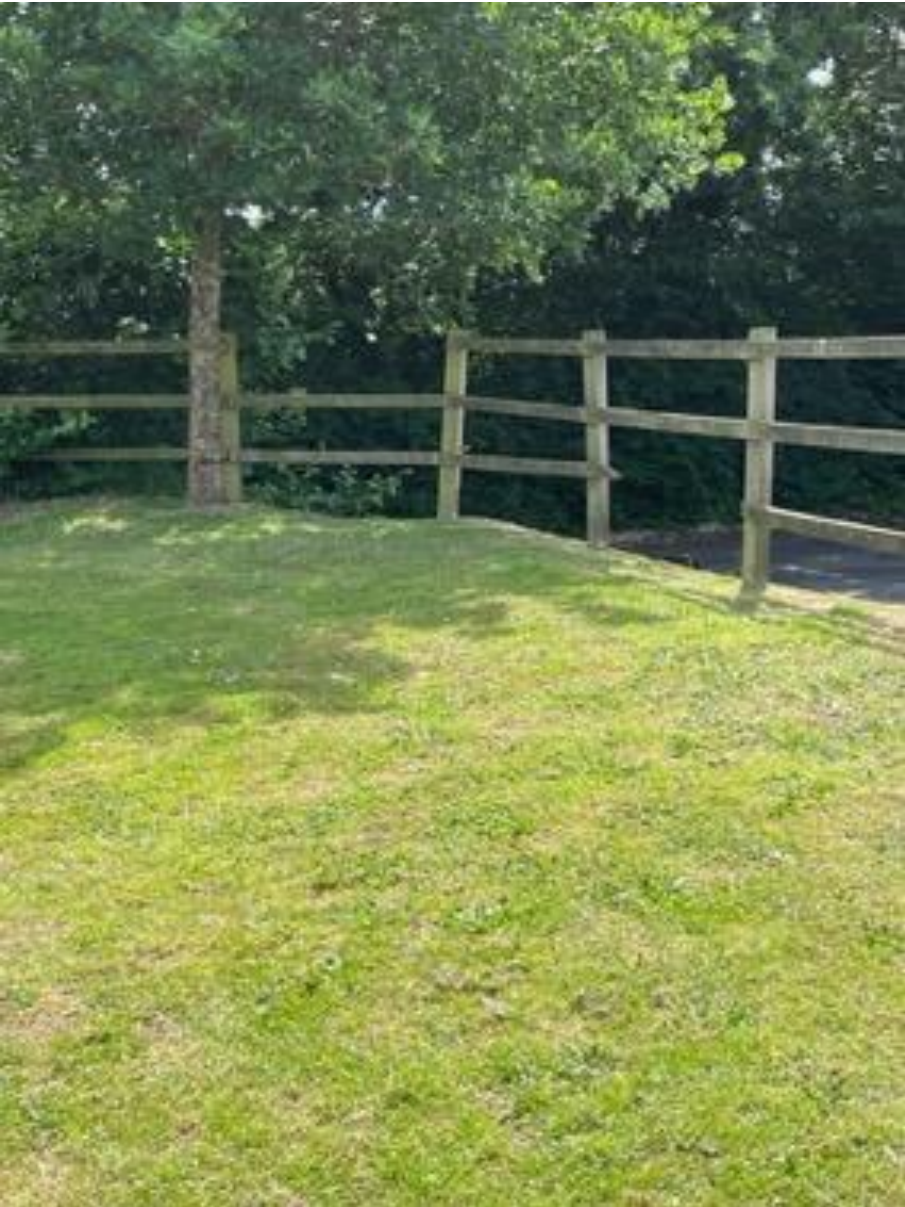
SE corner fence rails broken

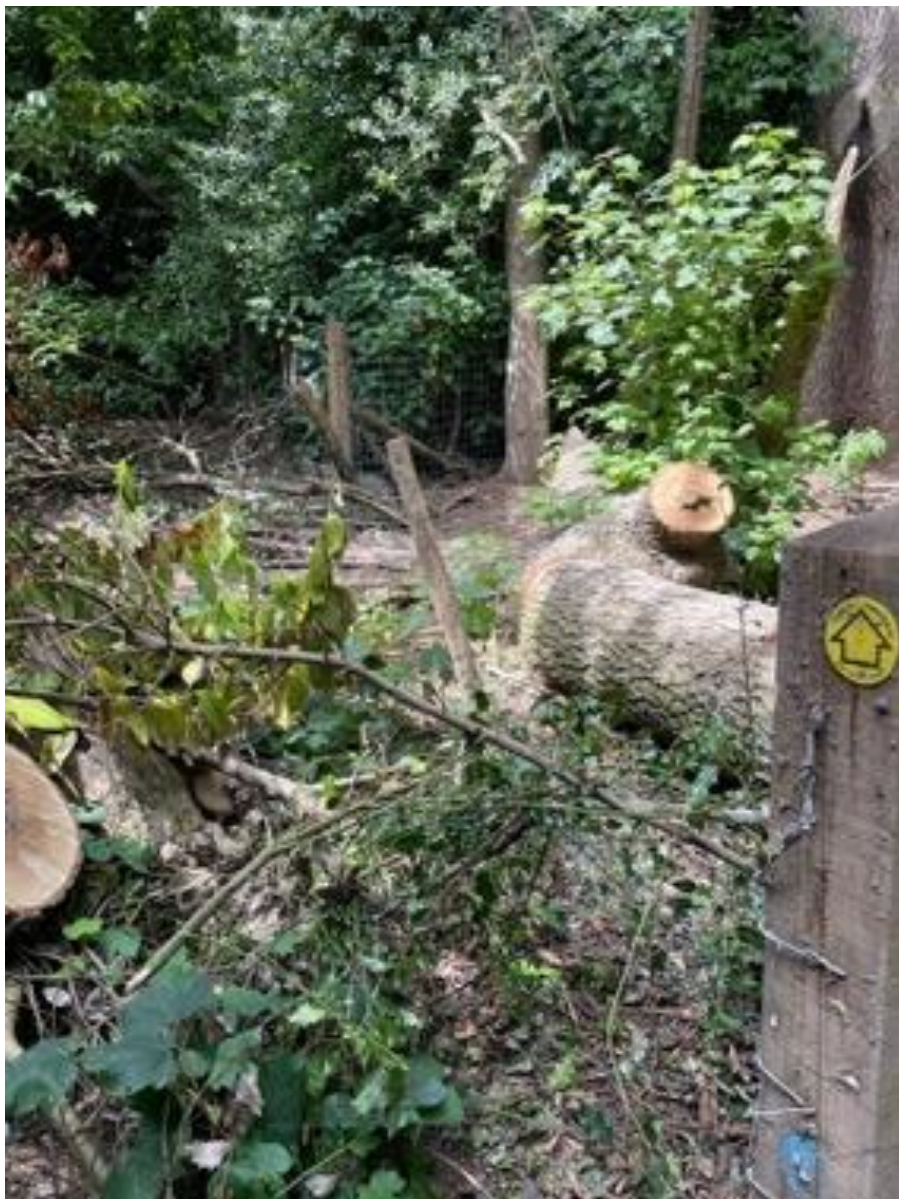
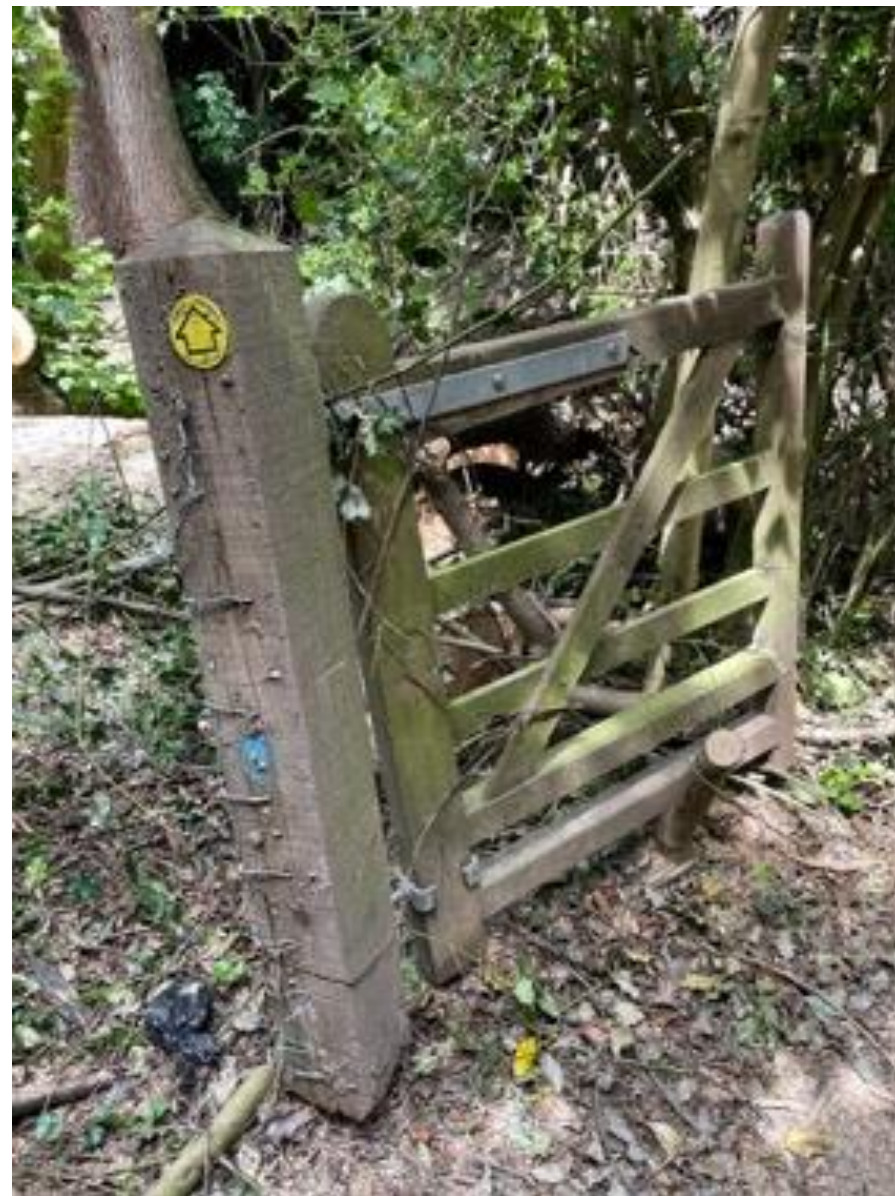
Fence broken and fallen tree

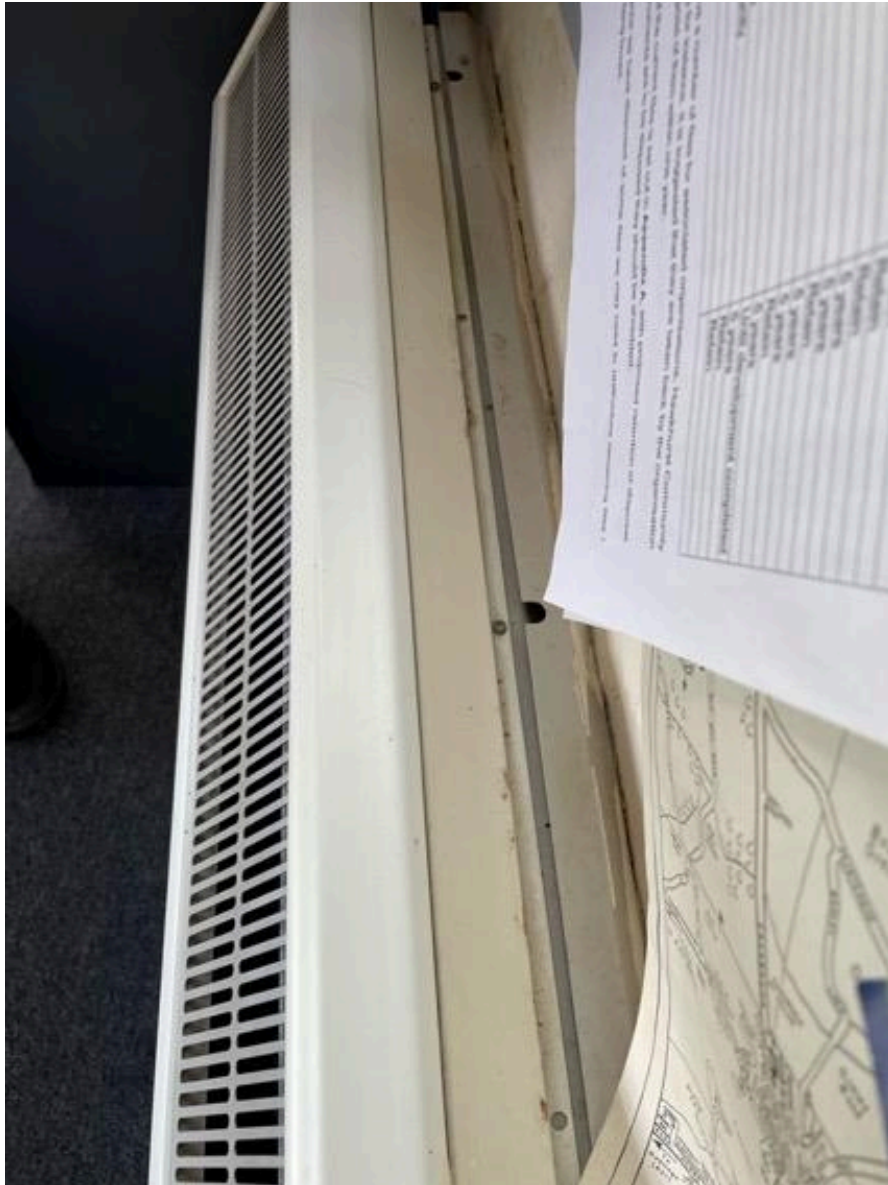
Heater cover not fitted correctly exposing sharp edge.

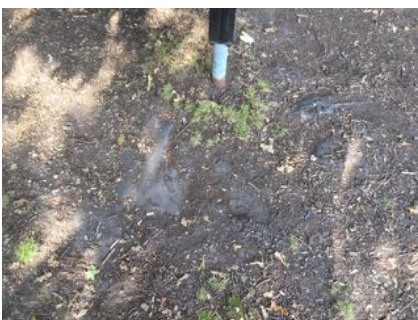
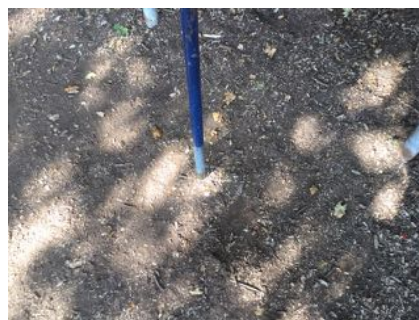
Foundation exposed.
