# Hawkhurst Parish Council Health and Safety Report

June 2022

Observations from audit of HPC facilities using HSE Slips and trips hazard spotting checklist and HSE Checklist for village and community halls.

Conducted by Cllr Paul Green and Cllr Simon Paish on Thursday 9<sup>th</sup> June 2022, conditions clear and dry, And 16<sup>th</sup> June 2022 conditions hot clear and dry.

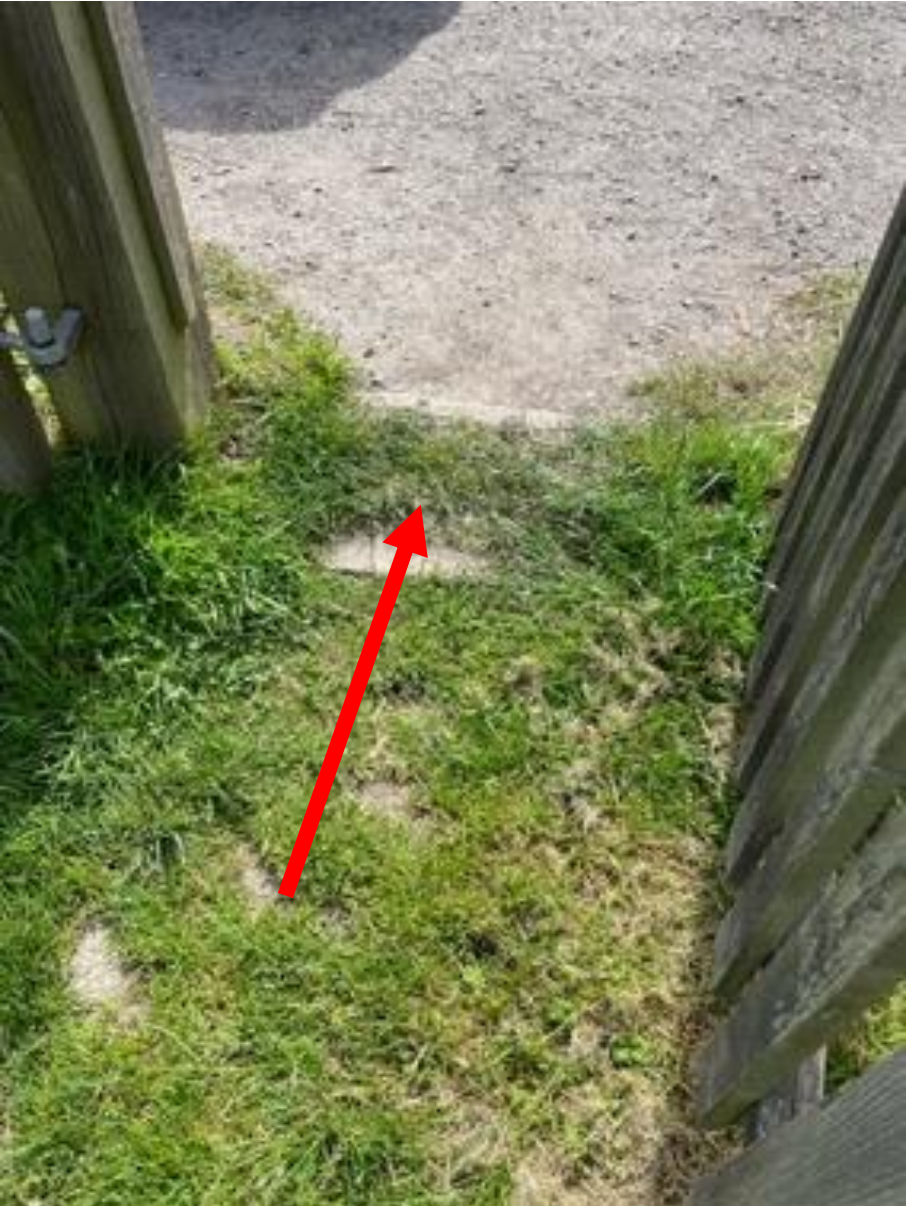
Entrance gate raised edge

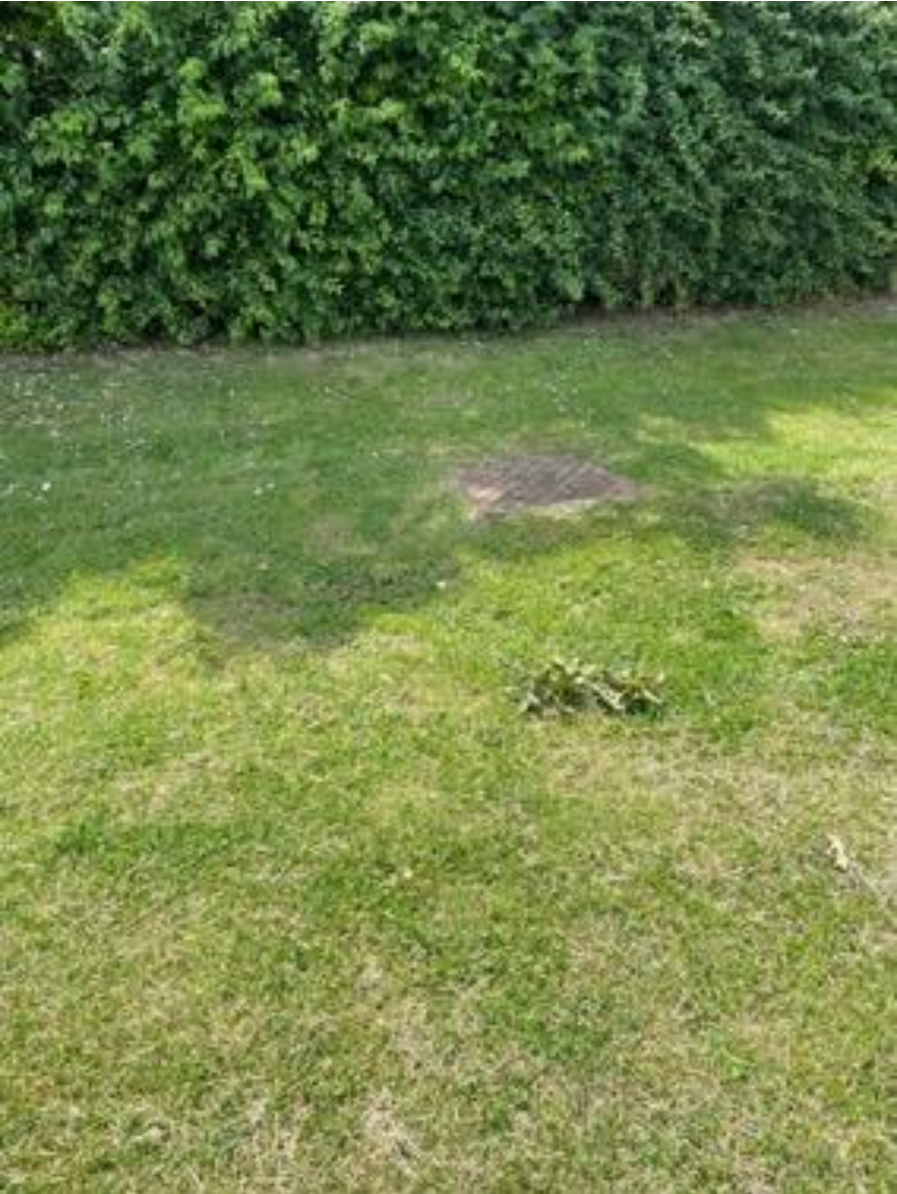
Raised manhole cover

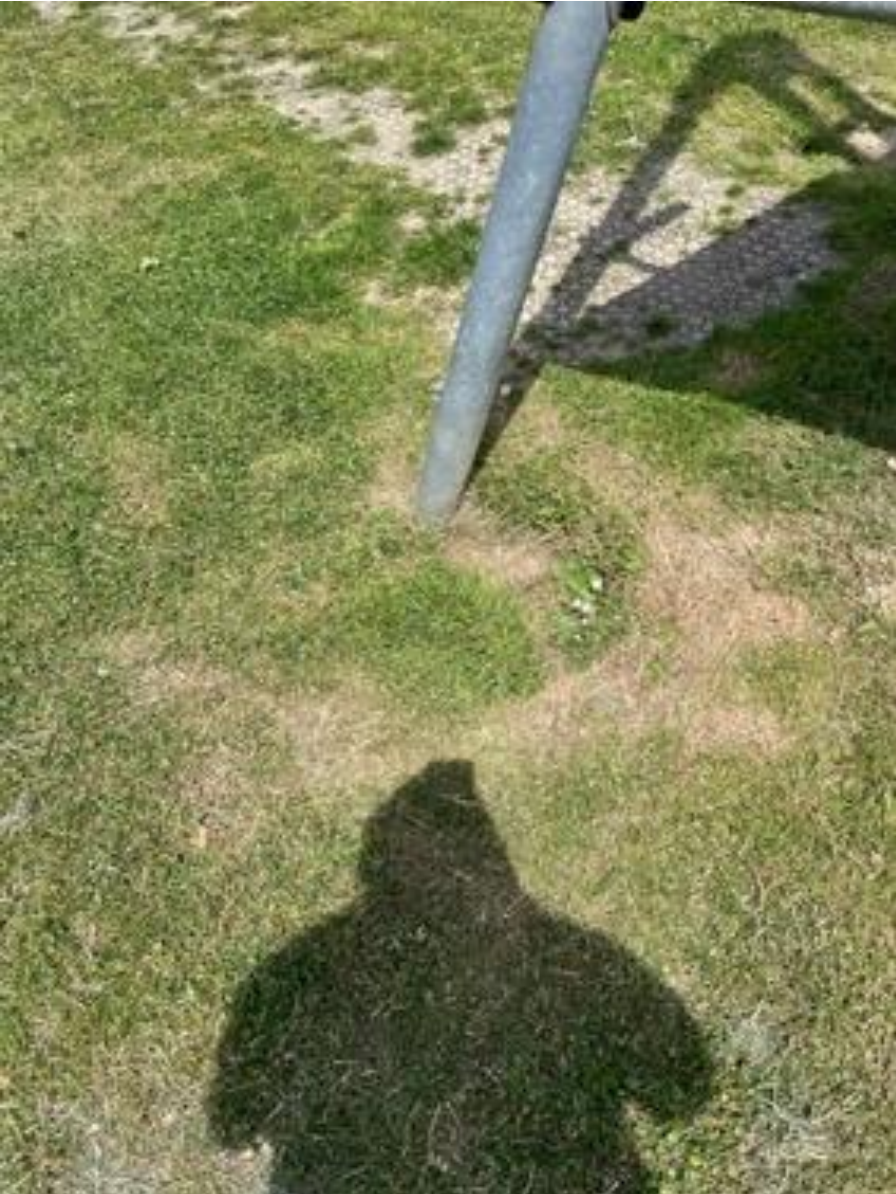
Potholes around zipwire base
