# Hawkhurst Parish Council Health and Safety Report

June 2022

Observations from audit of HPC facilities using HSE Slips and trips hazard spotting checklist and HSE Checklist for village and community halls.

Conducted by Cllr Paul Green and Cllr Simon Paish on Thursday 9<sup>th</sup> June 2022, conditions clear and dry, And 16<sup>th</sup> June 2022 conditions hot clear and dry.

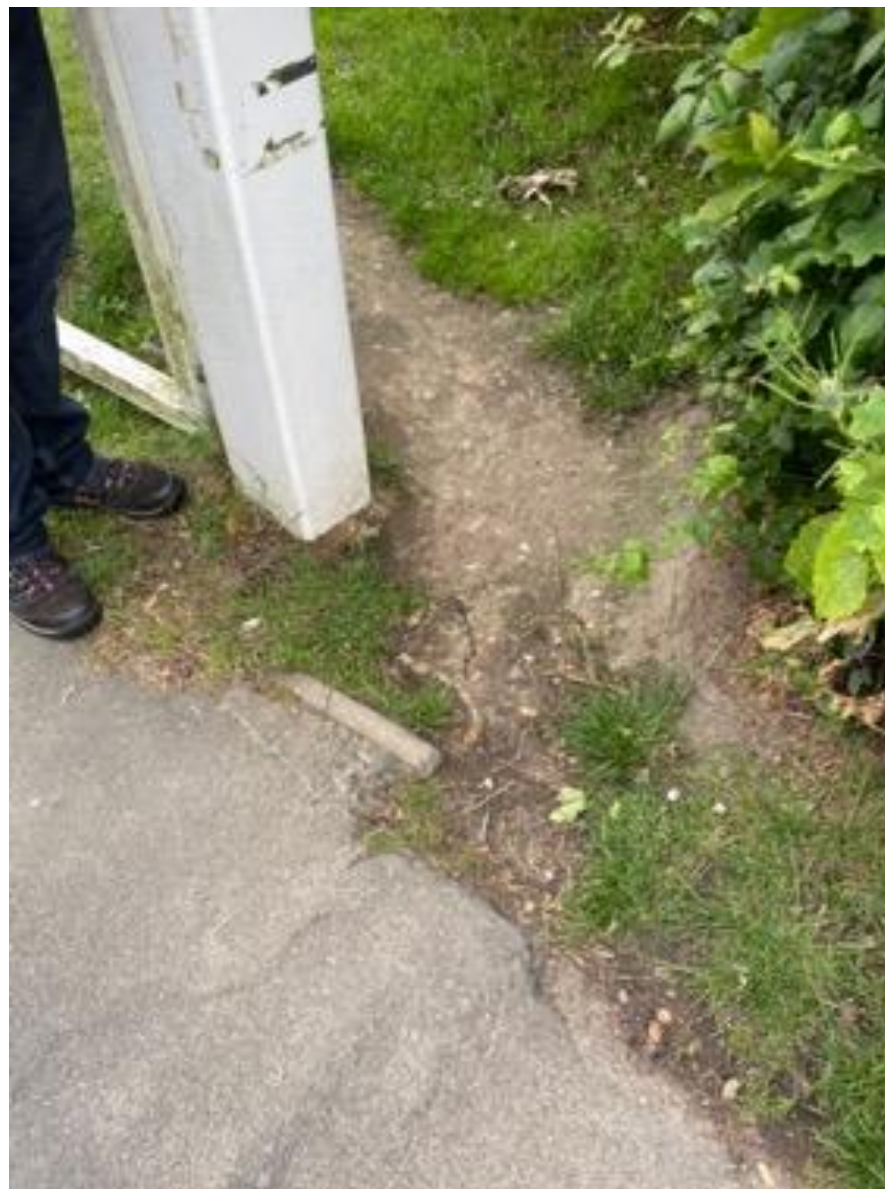
By the entrance gate uneven surface

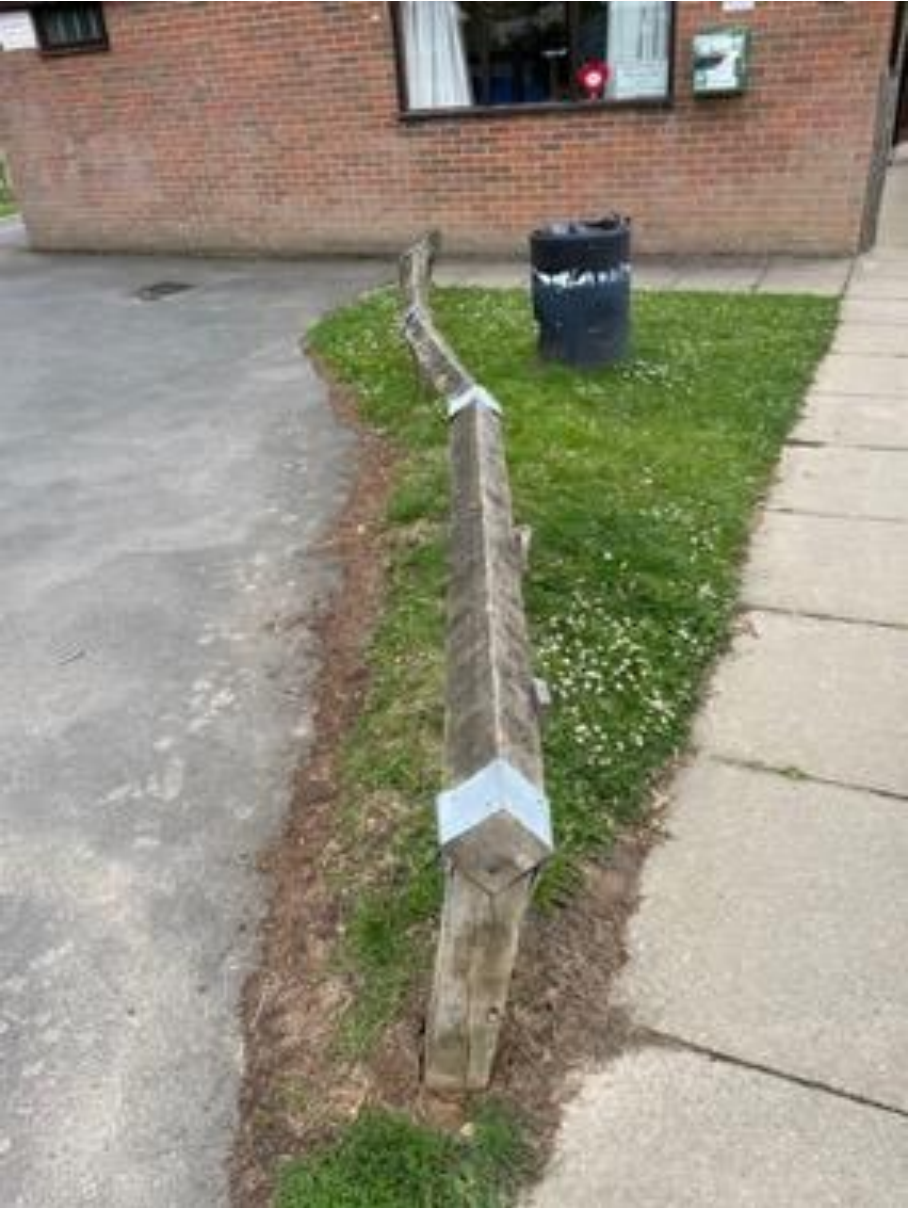
Low and broken/unstable fence rail

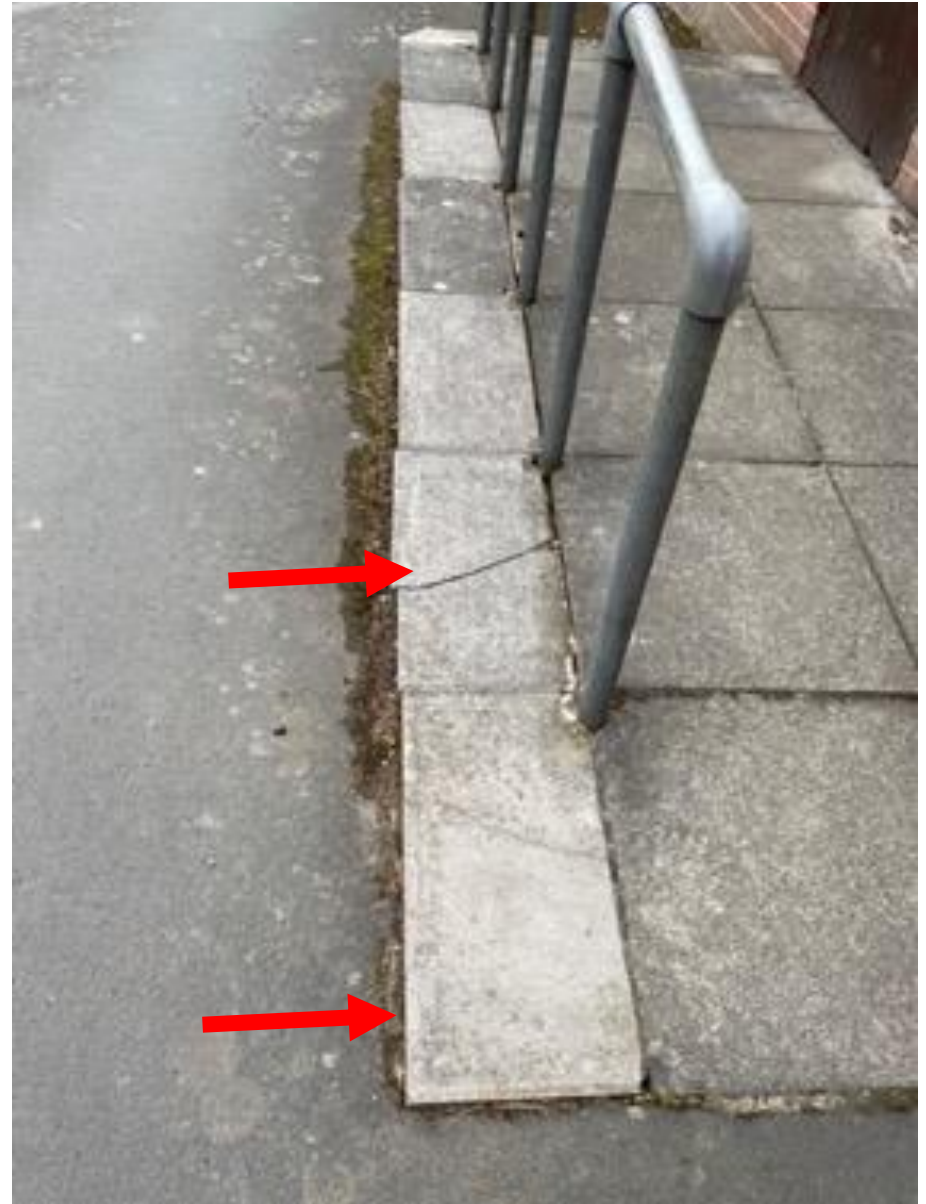
Loose slabs on edge of Ramp to public toilet raised edge to side at start of ramp

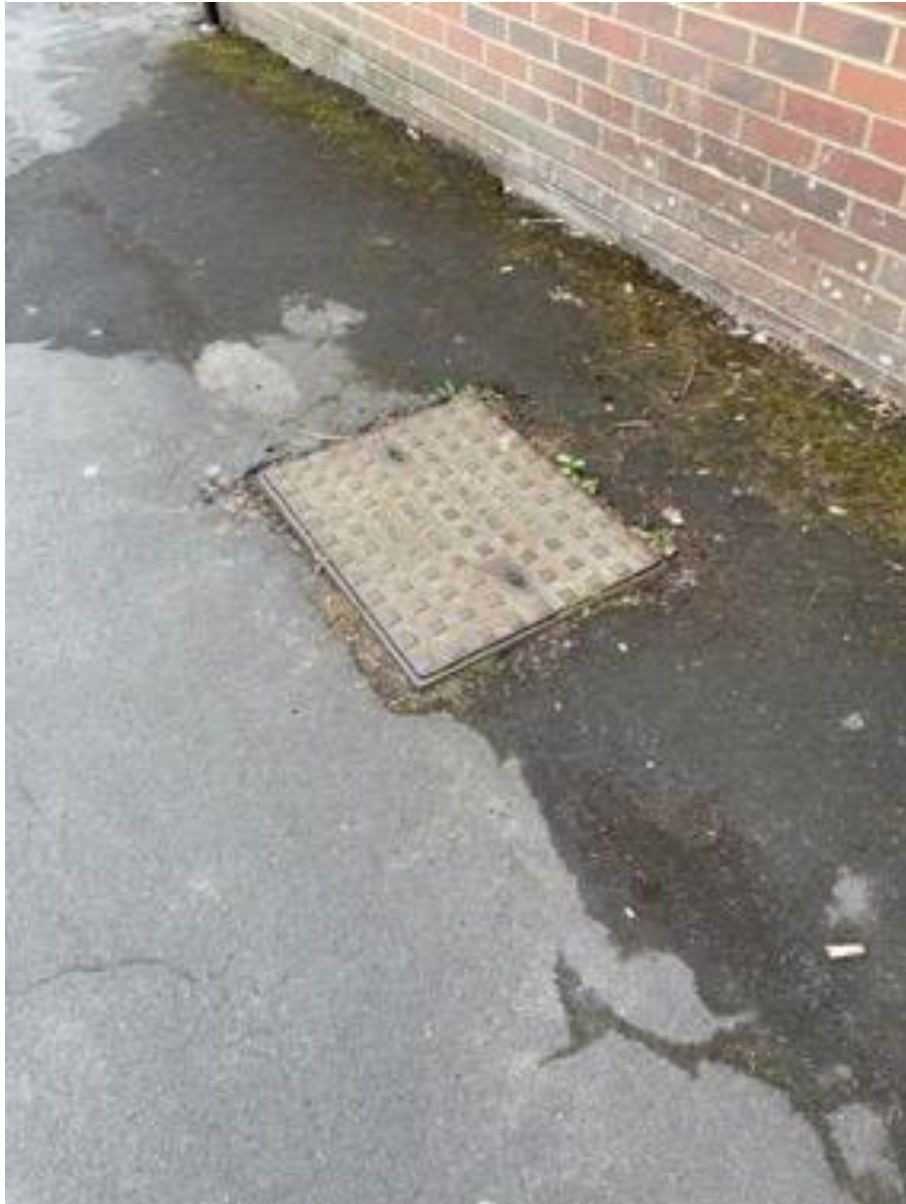
Raised manhole cover in Tarmac to the rear of changing rooms

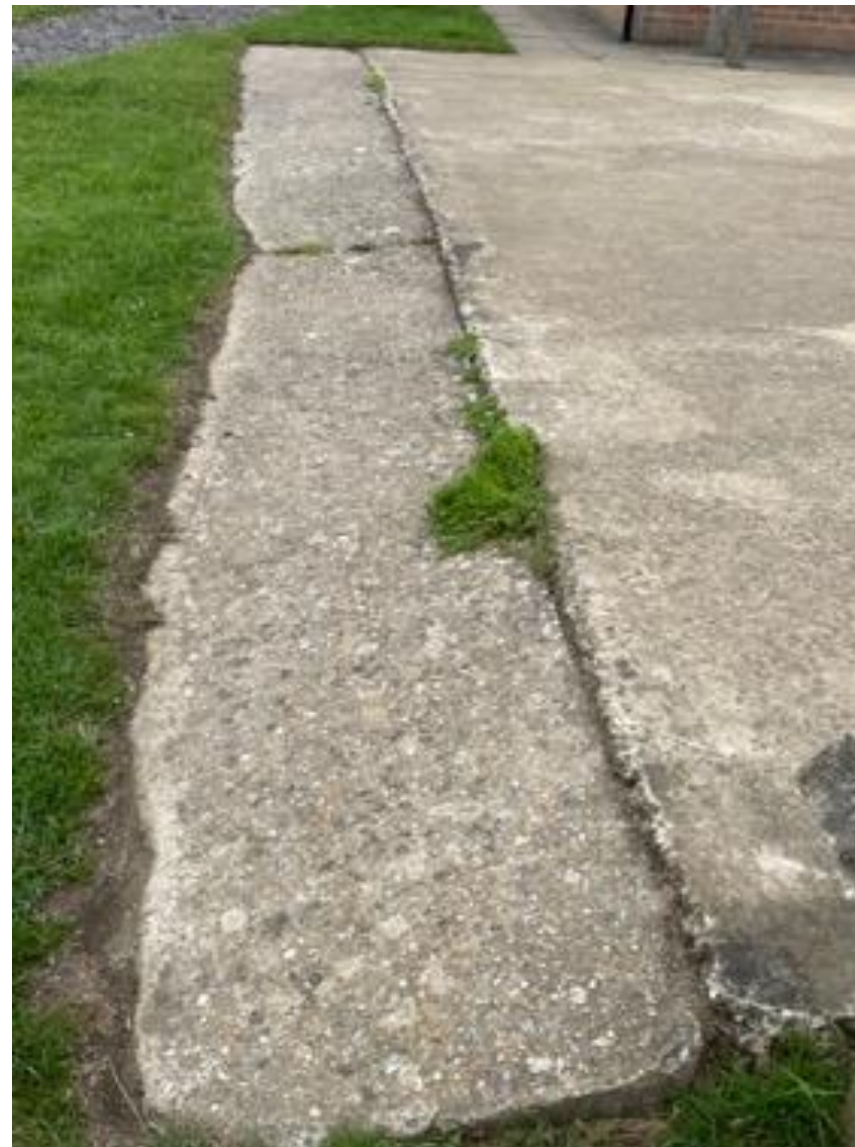
Concrete slab – Previously garage base. There is a ridge in the grass adjacent to the concrete and some weed on the surface of the infill. The Concrete slab is proud of the infill in places. The gradient of the infill slope changes throughout its length.

The immediate action was that from 8th June all special events on KGV (as opposed to its normal use) must have the area around the concrete base of the demolished garage roped-off. The clerk was asked to ensure that the barrier was similar to that used for the beacon not just a piece of tape.

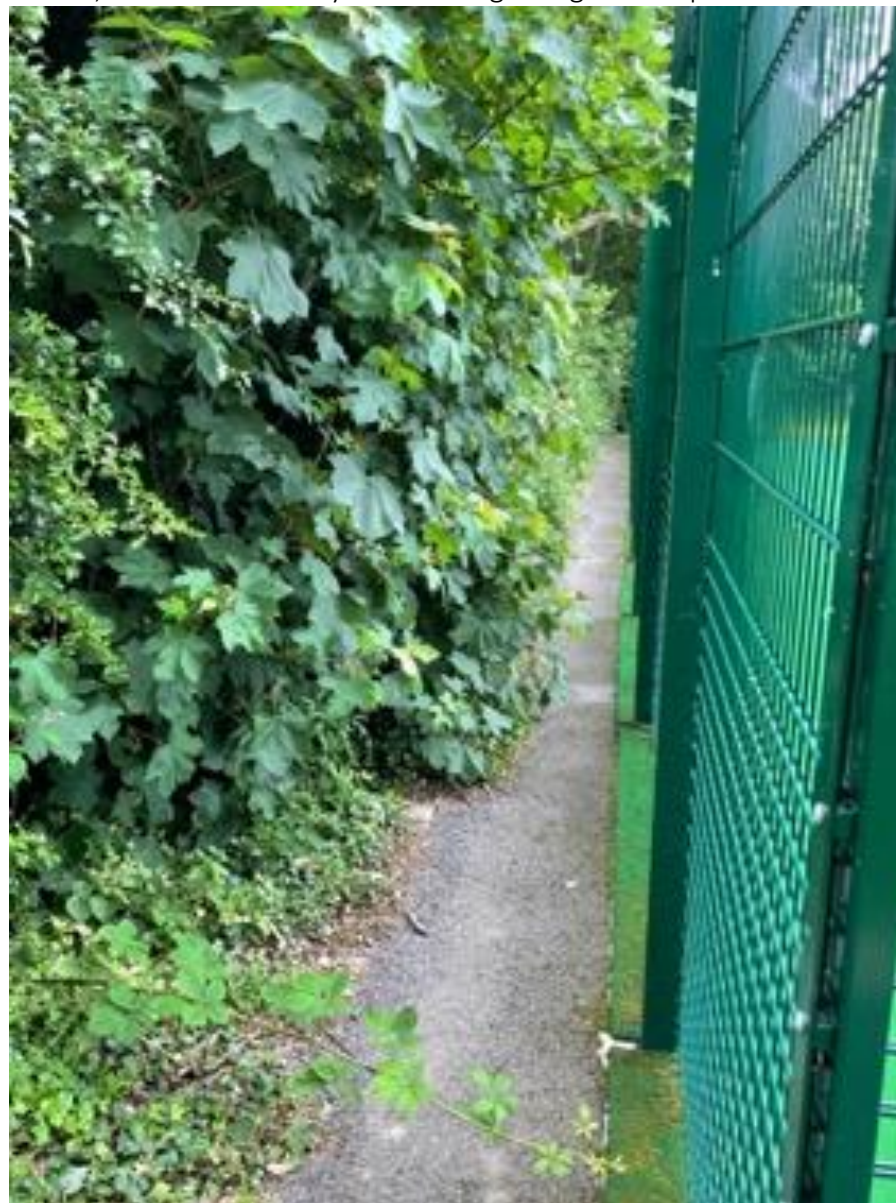
Moss is forming in the surface of the external footway around the MUGA, fence the footway is becoming overgrown in places.

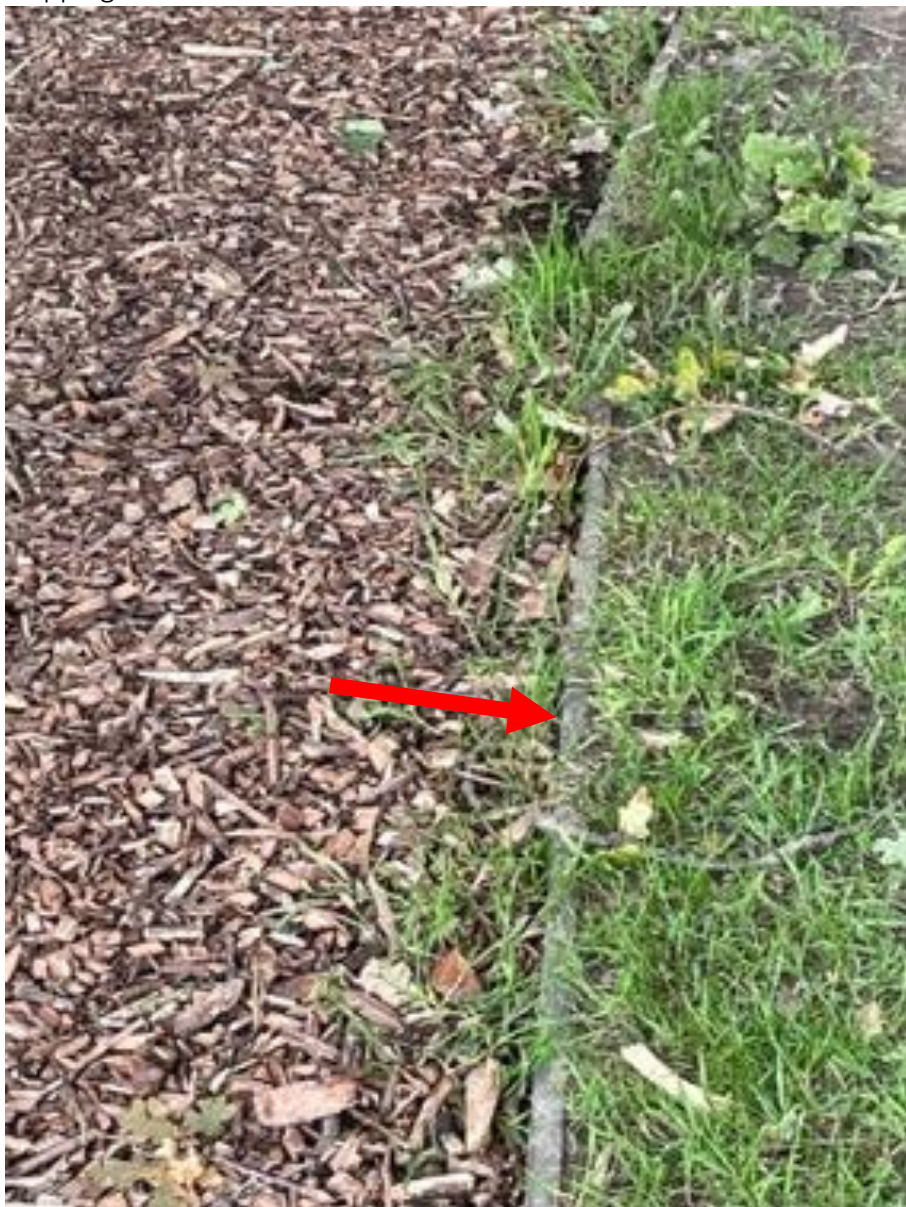
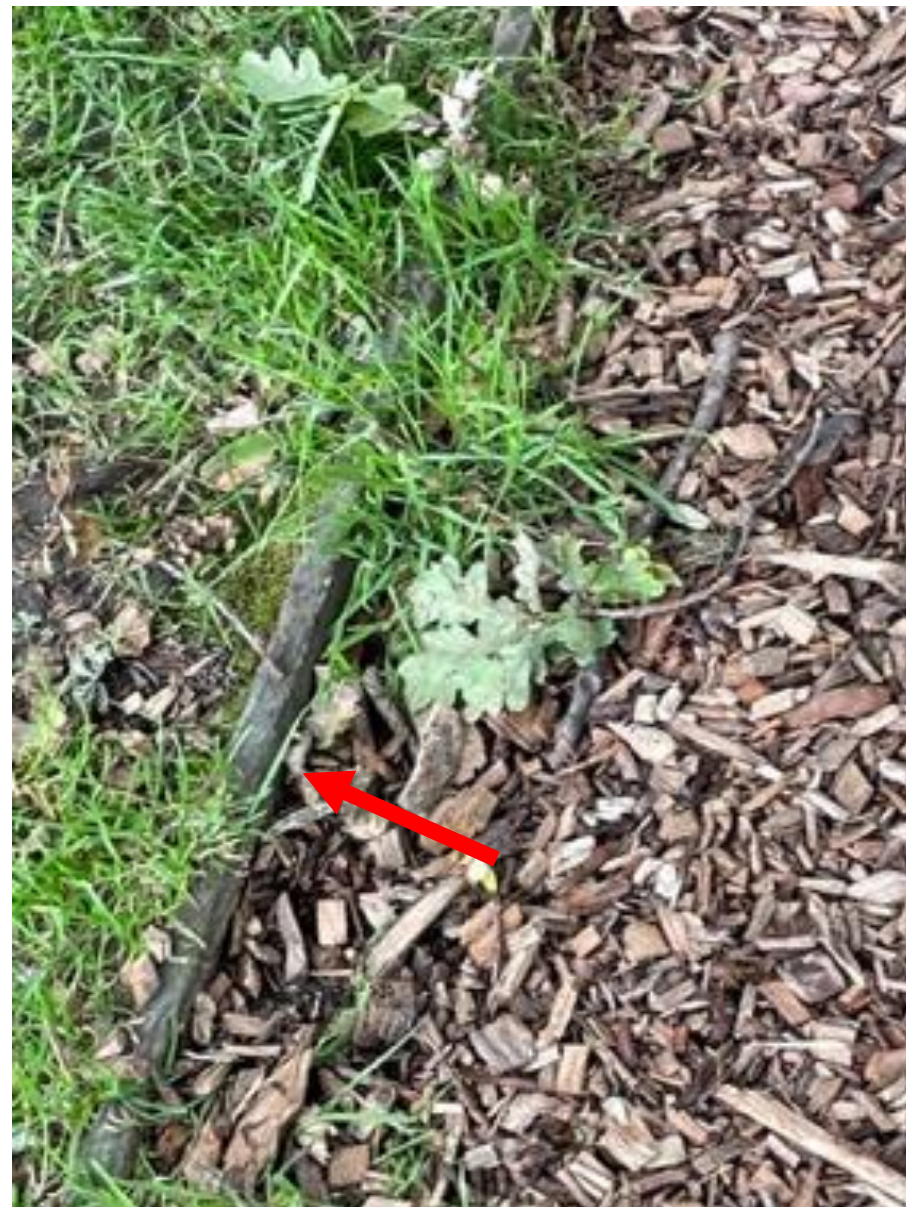
Exposed wooden boards to edge of footway due to low level of wood chippings

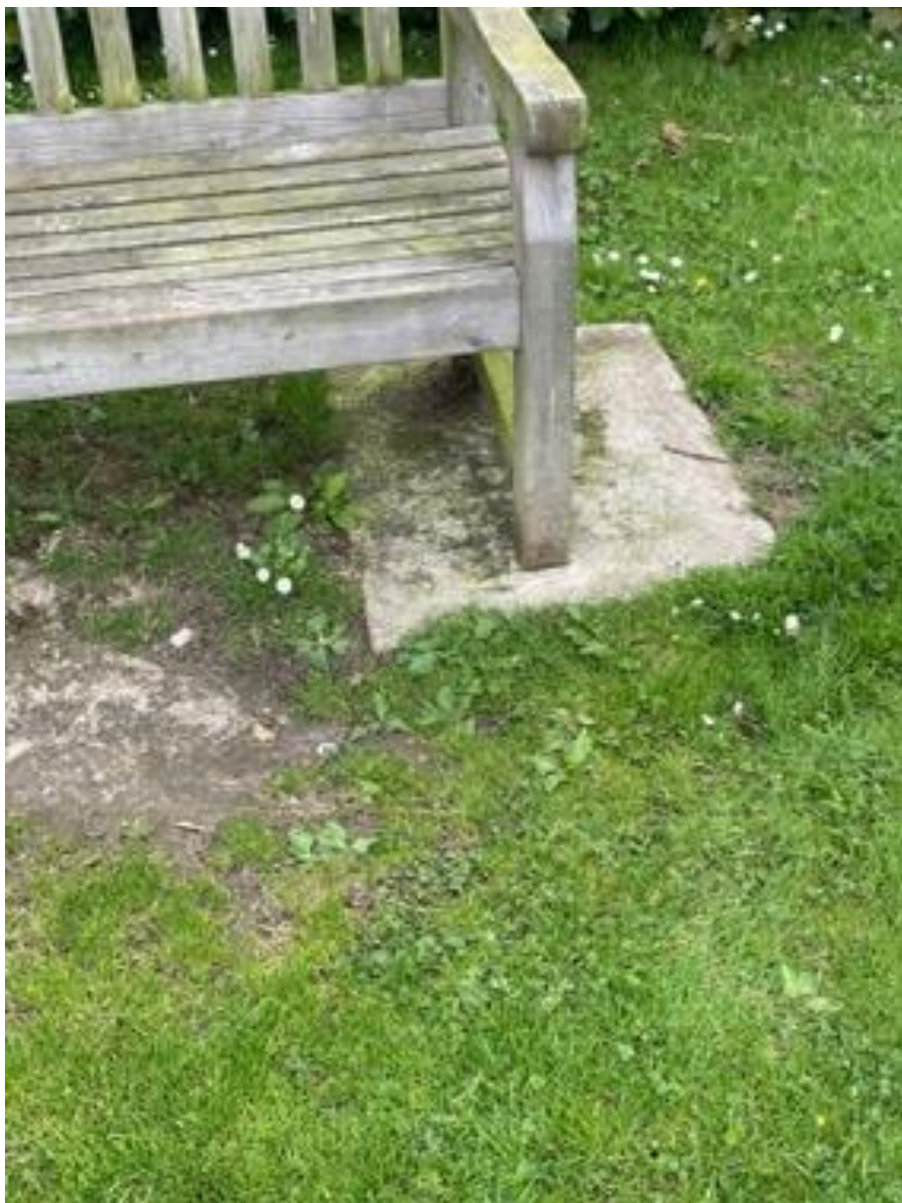
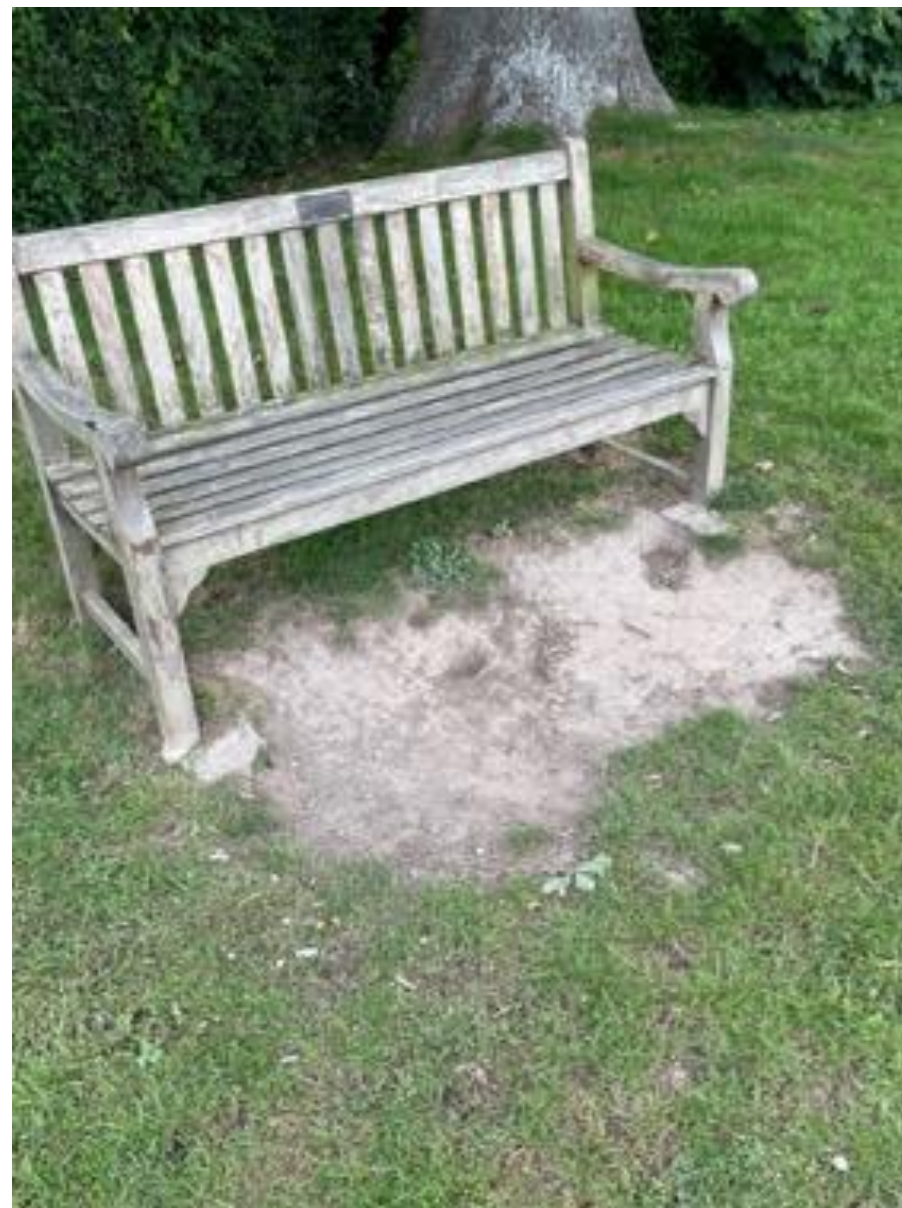
Benches along western boundary – Uneven surfaces

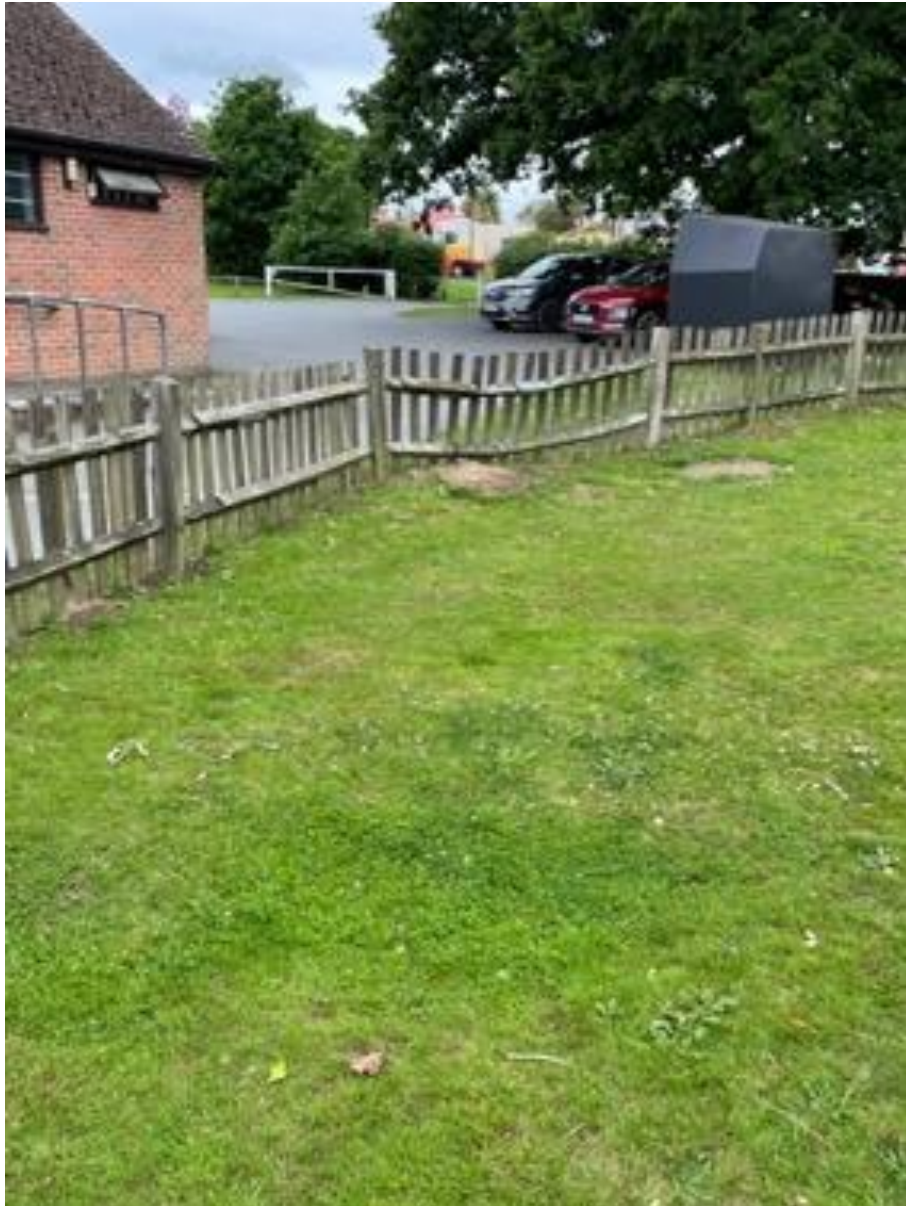
Refer also to RoSPA report Appendix B for full detail of playground.  
Uneven surface

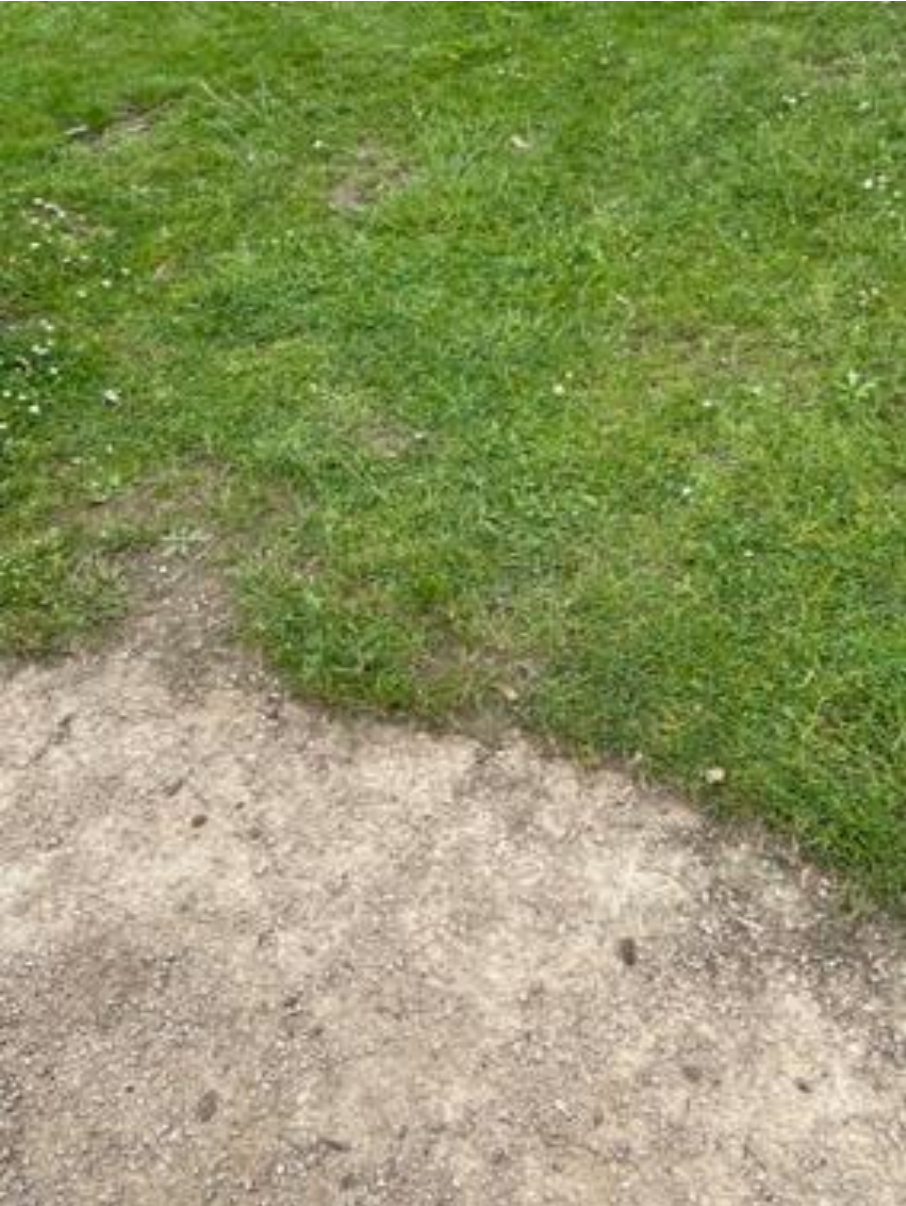
Surface inside entrance gate uneven and steep transition to grass.

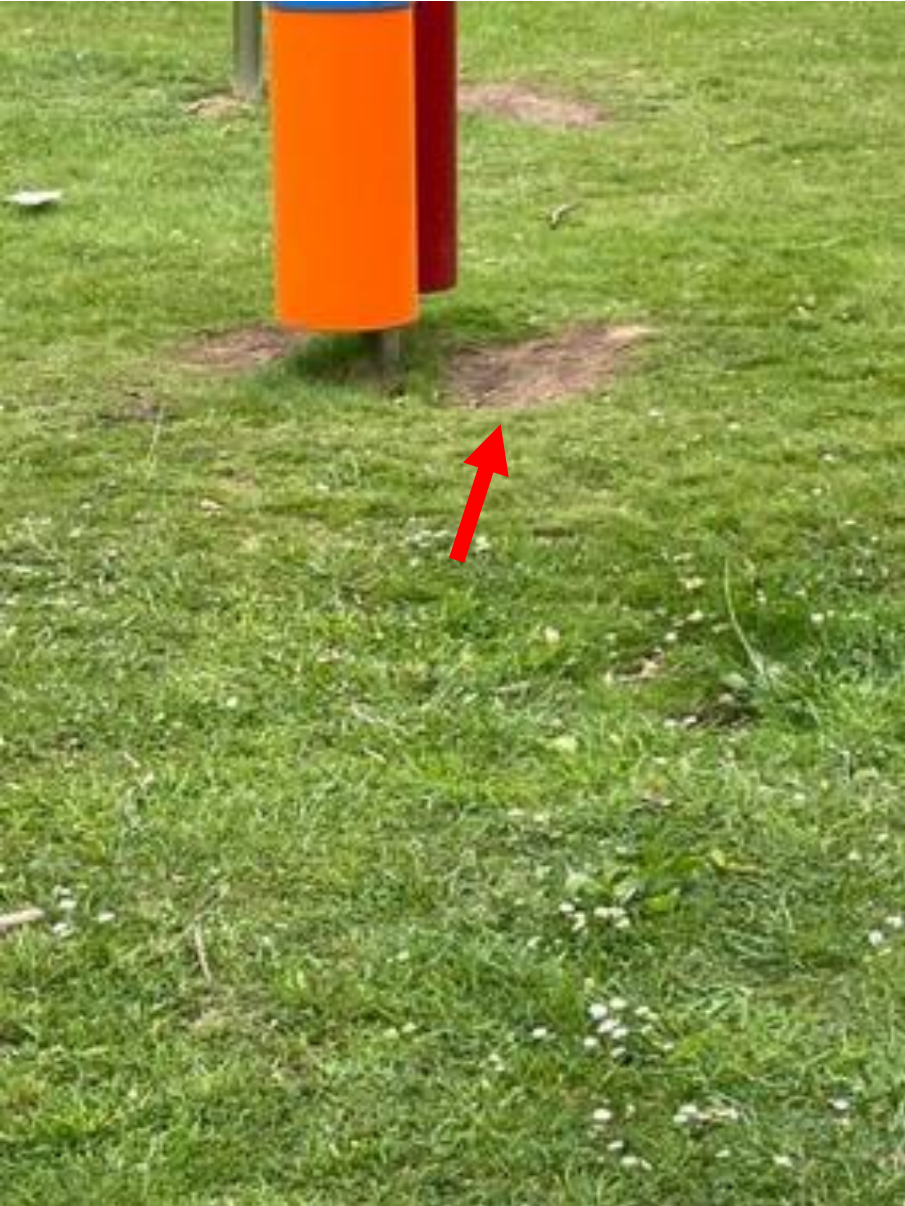
Divot in front of bongos

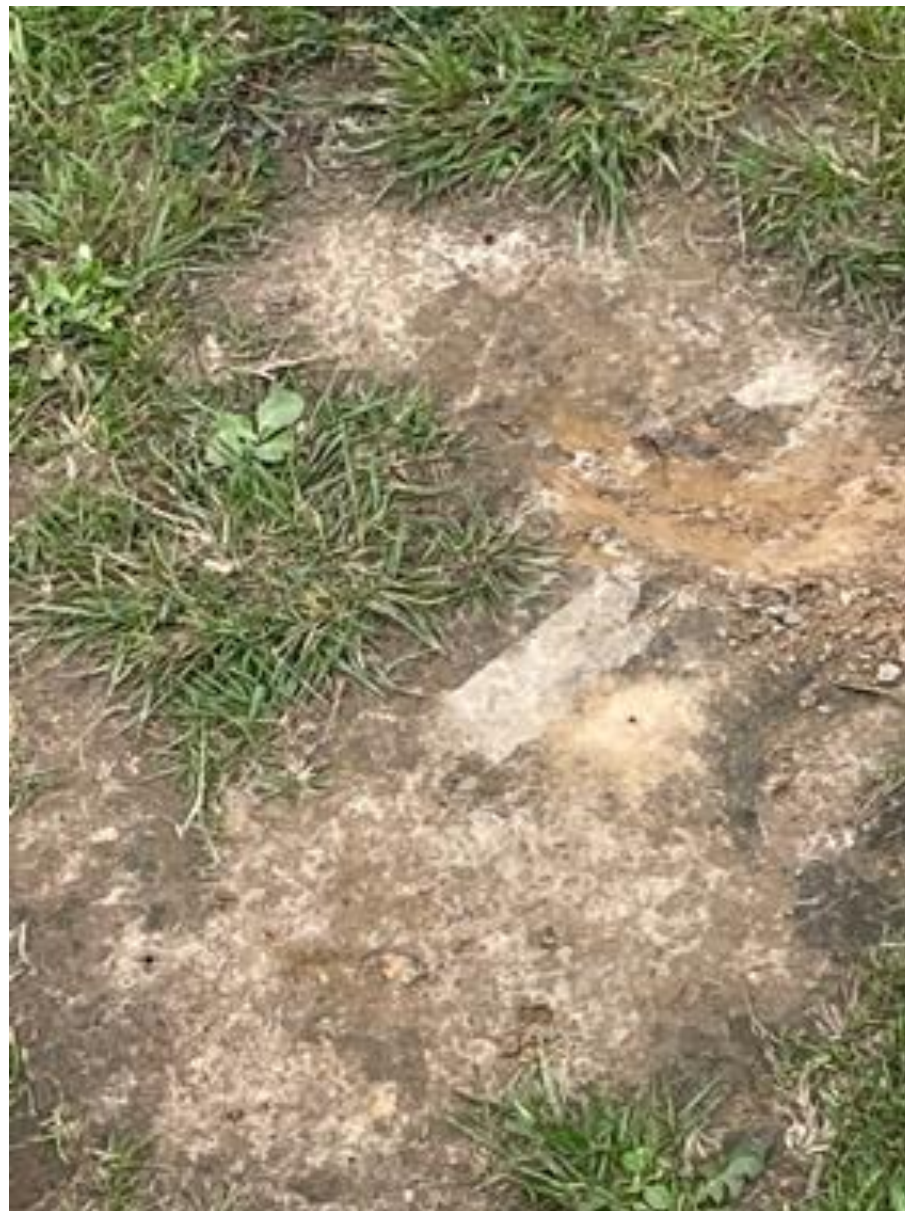
Mole hills and uneven surface to right of swings.

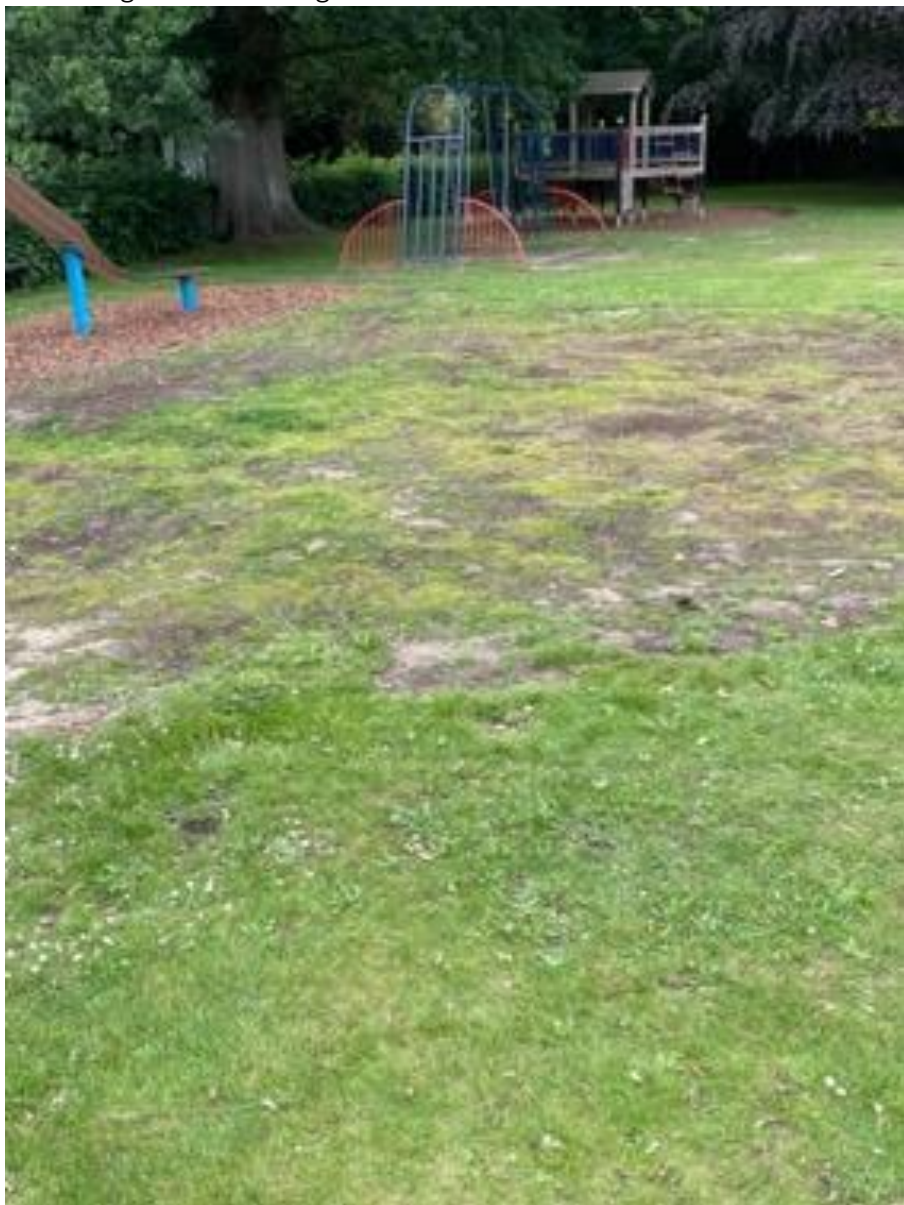
Area beside slide. A piece of equipment has been removed and the remaining surface is rough and uneven

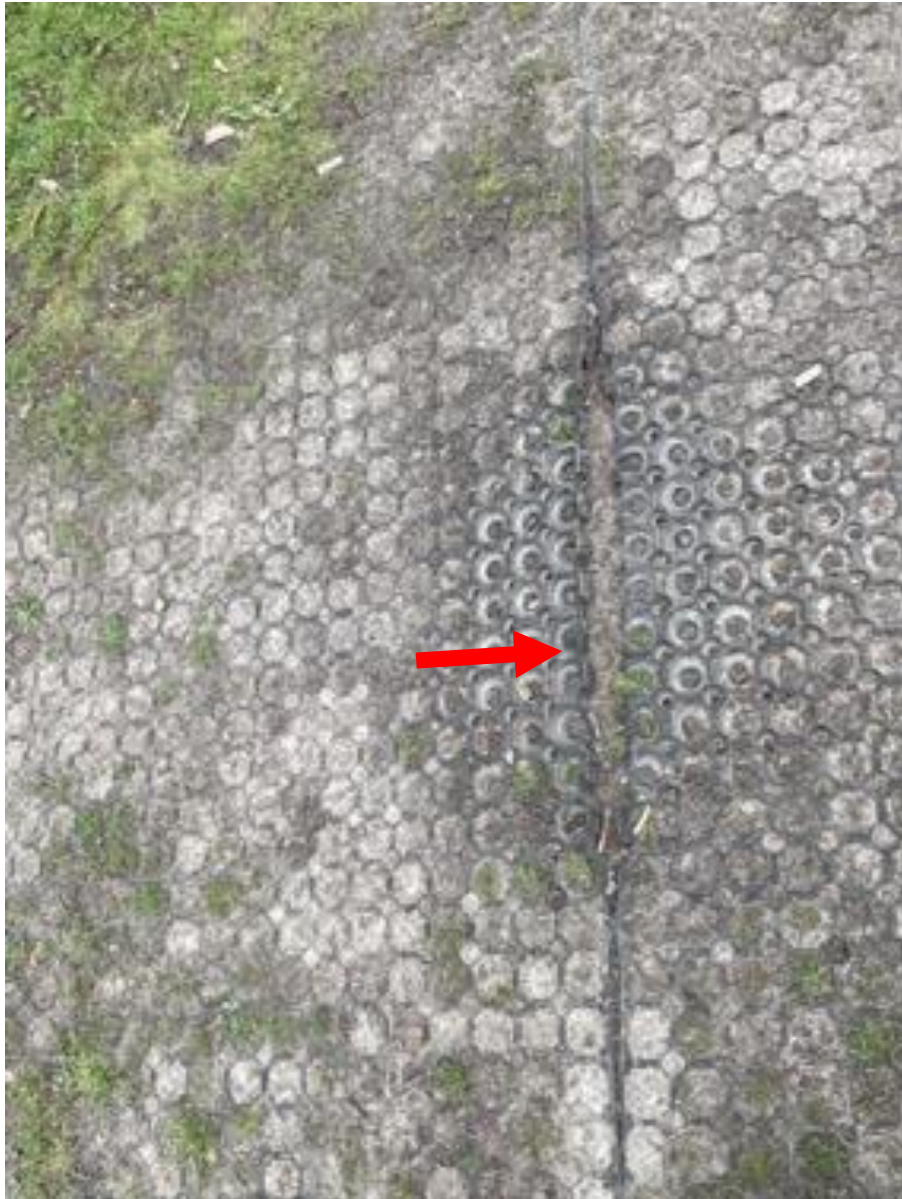
Metal climbing frame - Play surface has exposed and raised edges.

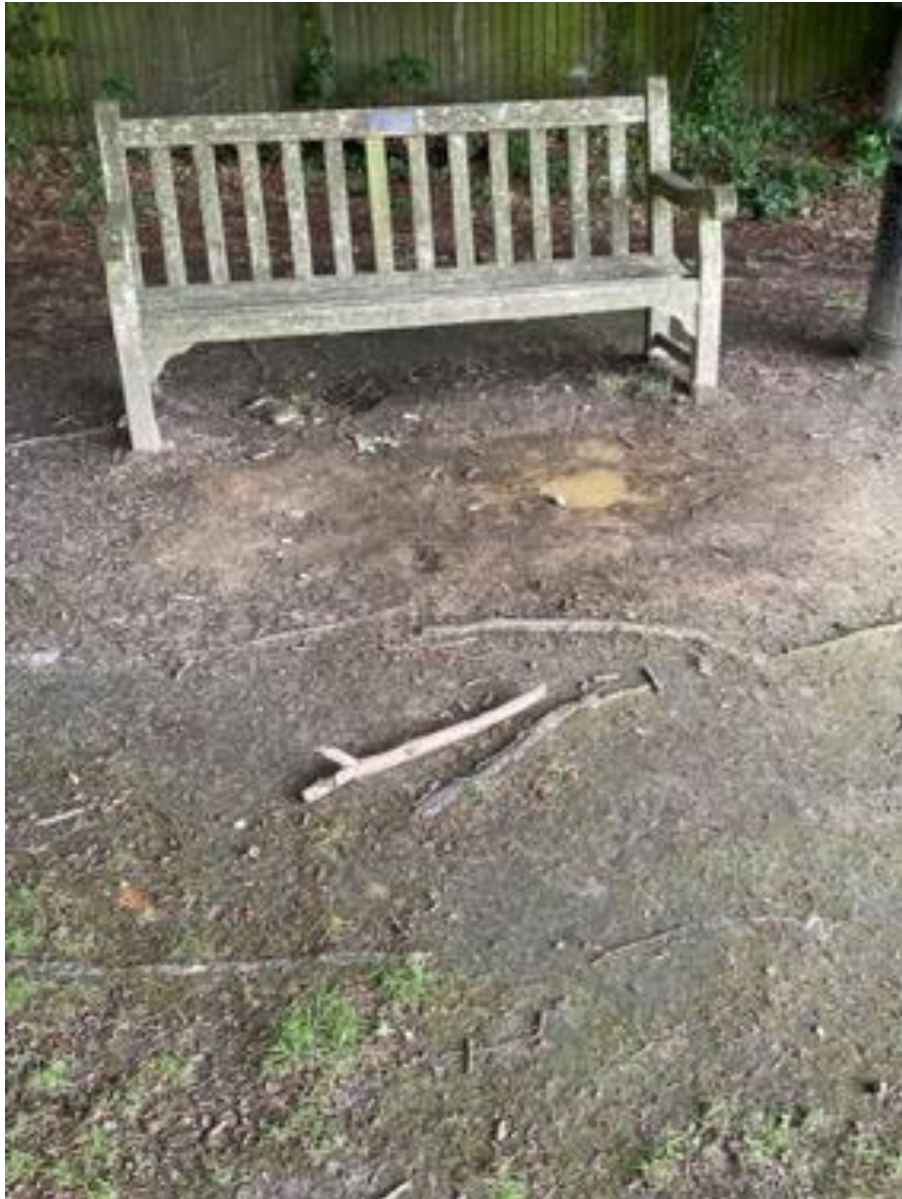
Wooden bench – area in front has a dip and puddle making the surrounding area muddy and slippery and some tree roots on surface

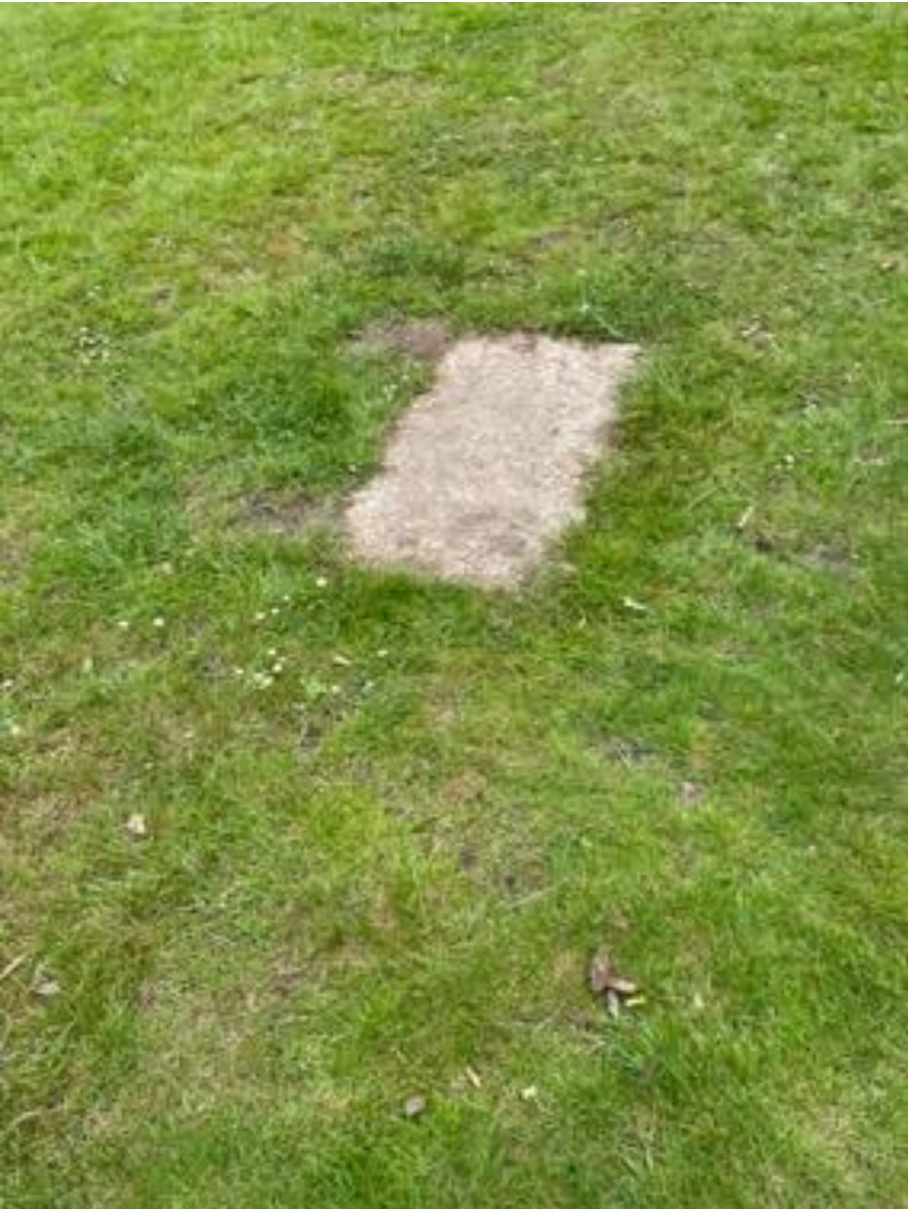
Concrete block in grass surface

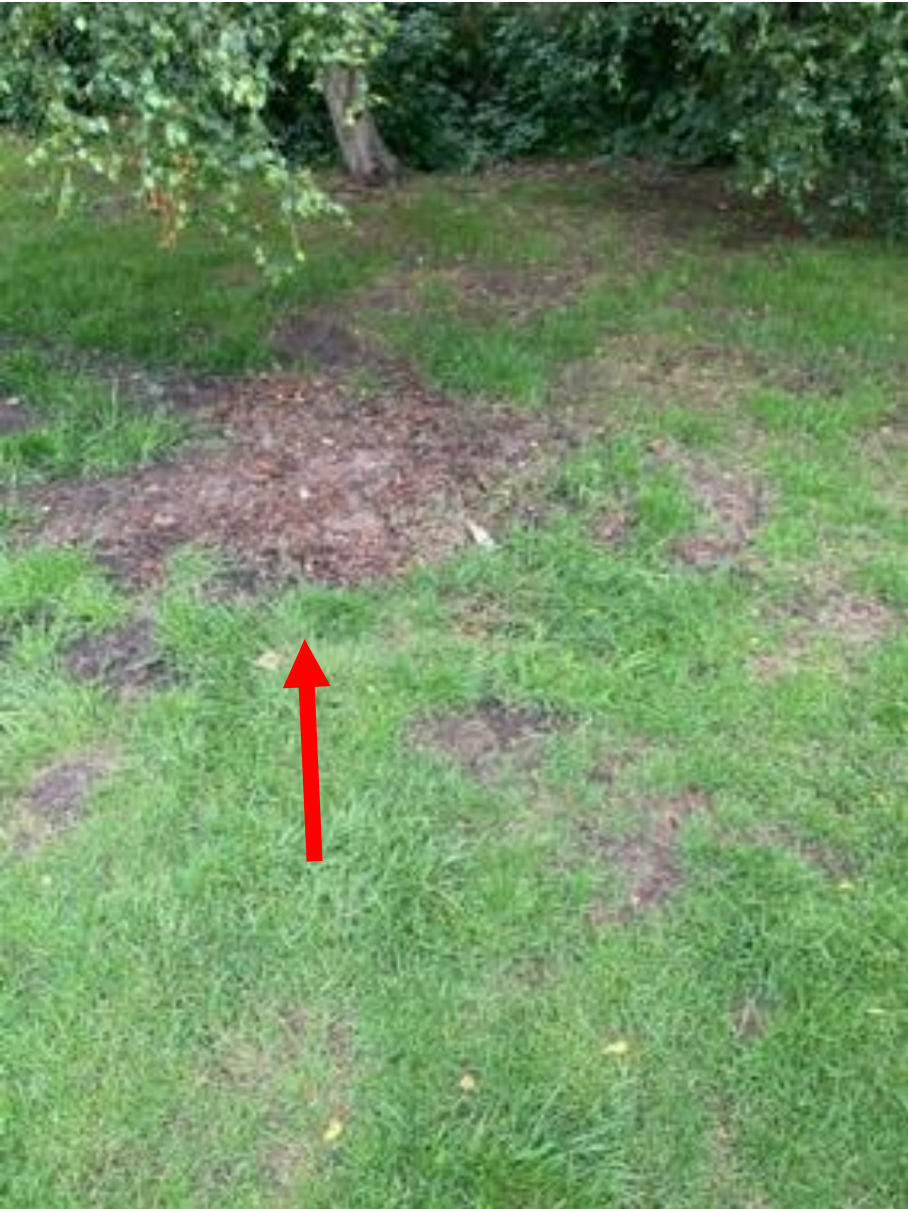
Rotten tree stump has left crater and uneven surface

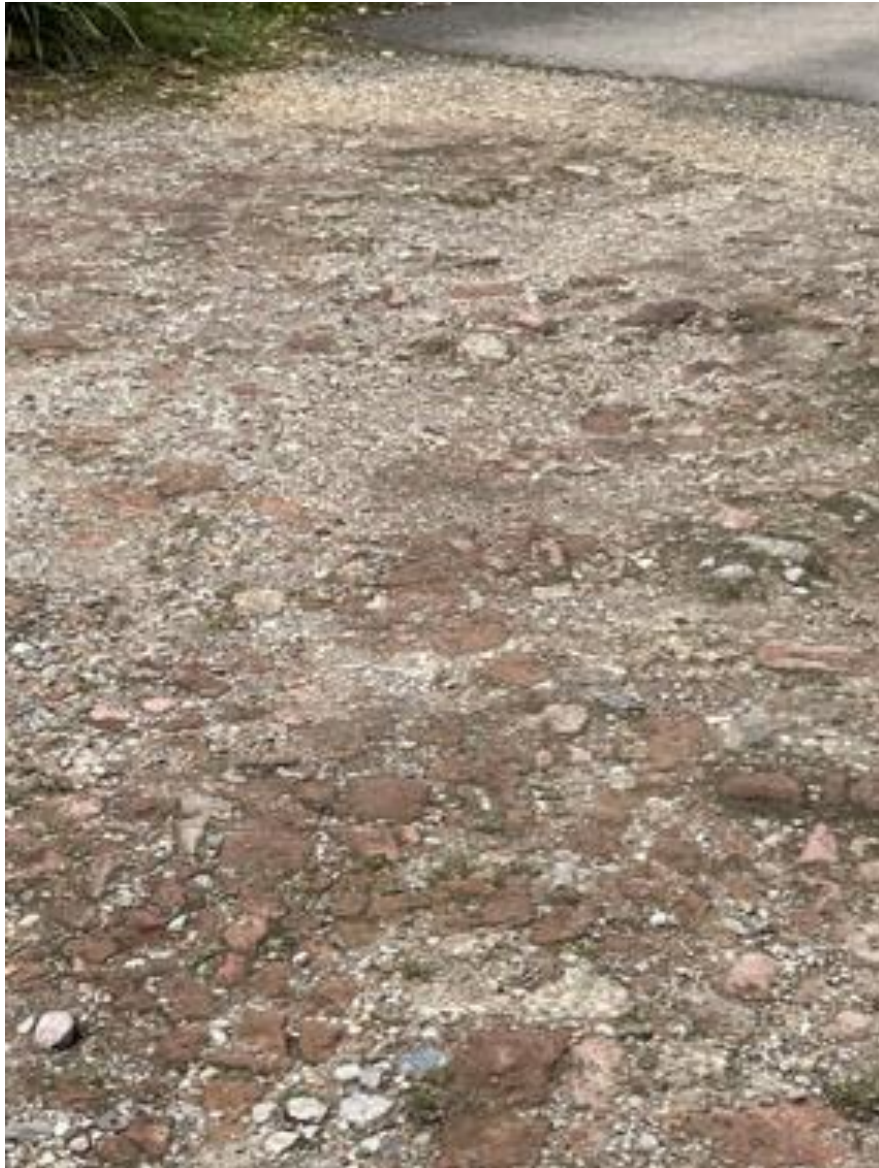
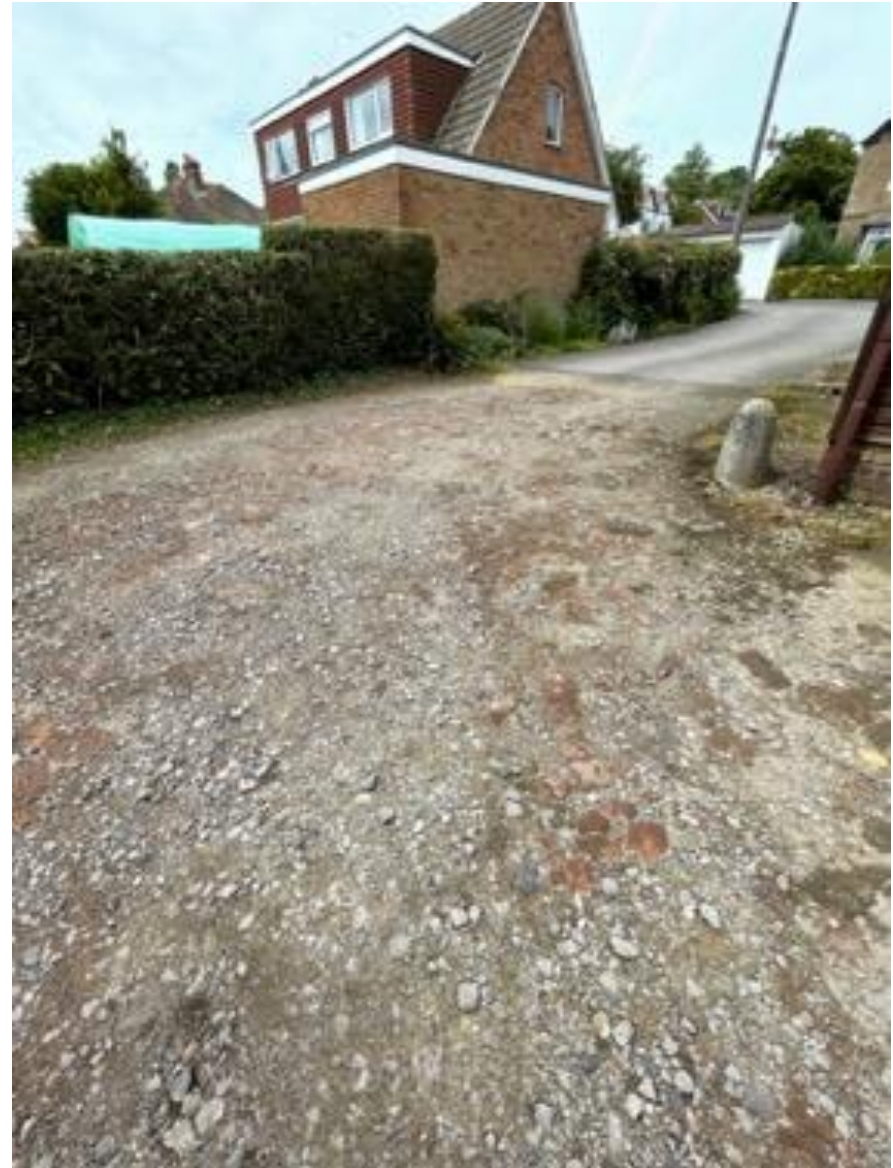
The major trip hazard is the car park, because of the slope it is recommended that rather than adding more roadstone that the tarmac area is extended by c15-20 feet.

Entrance to carpark at transition from Tarmac to hardcore - eroded hardcore and uneven surface due to heavy use – suggest to tarmac 20-25ft extension
