# Hawkhurst Parish Council Health and Safety Report

June 2022

Observations from audit of HPC facilities using HSE Slips and trips hazard spotting checklist and HSE Checklist for village and community halls.

Conducted by Cllr Paul Green and Cllr Simon Paish on Thursday 9<sup>th</sup> June 2022, conditions clear and dry, And 16<sup>th</sup> June 2022 conditions hot clear and dry.

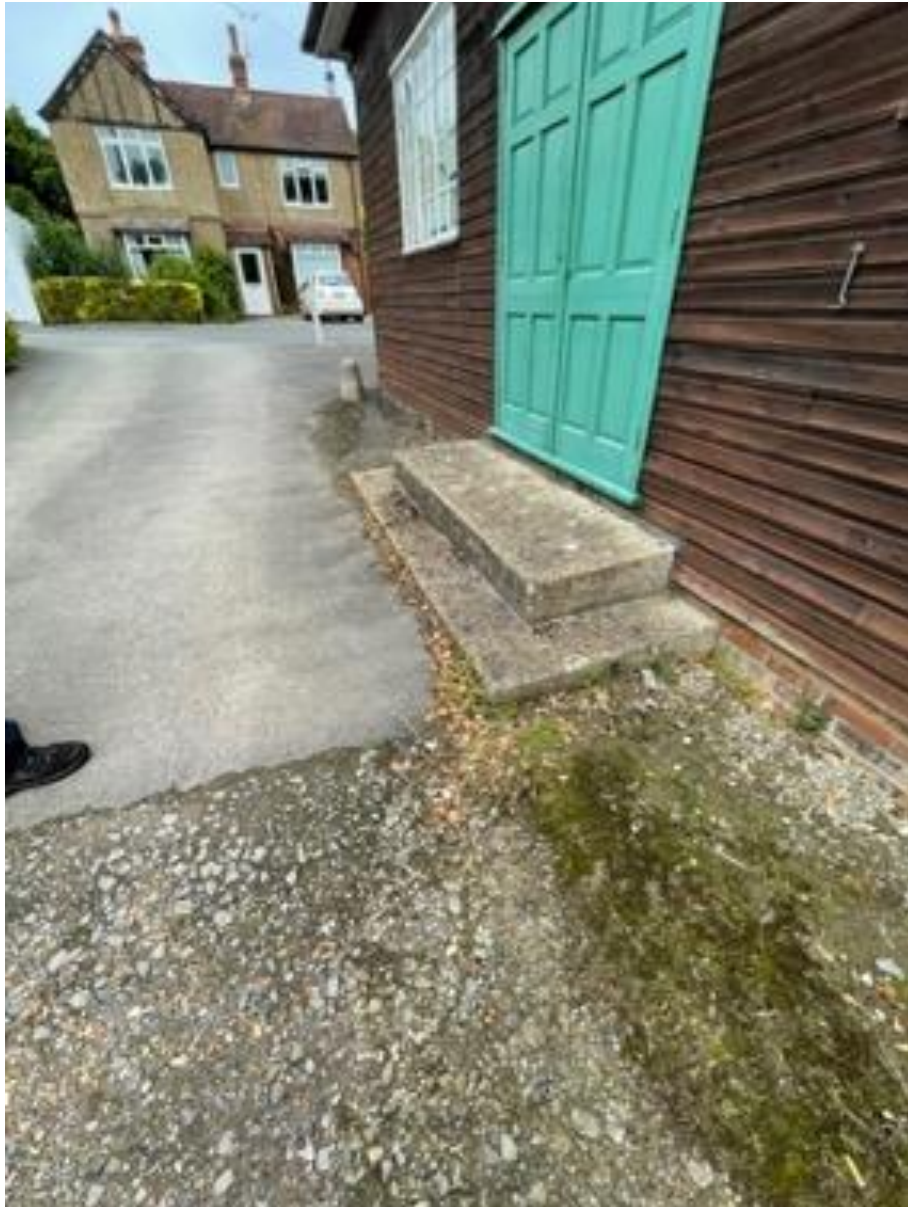
Fire exit on west end of building rough surface to sides and steps unequal height

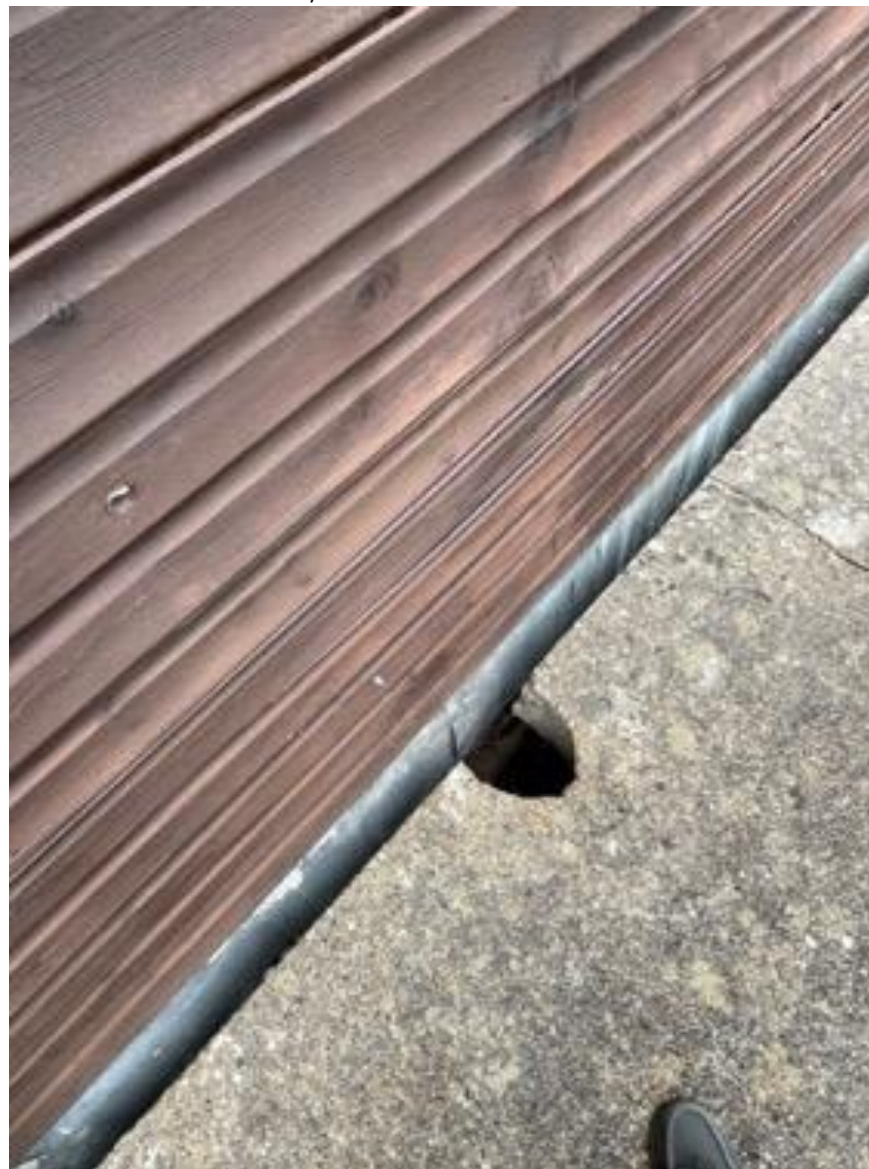
No handrail on building side and gap and hole between building and raised concrete footway

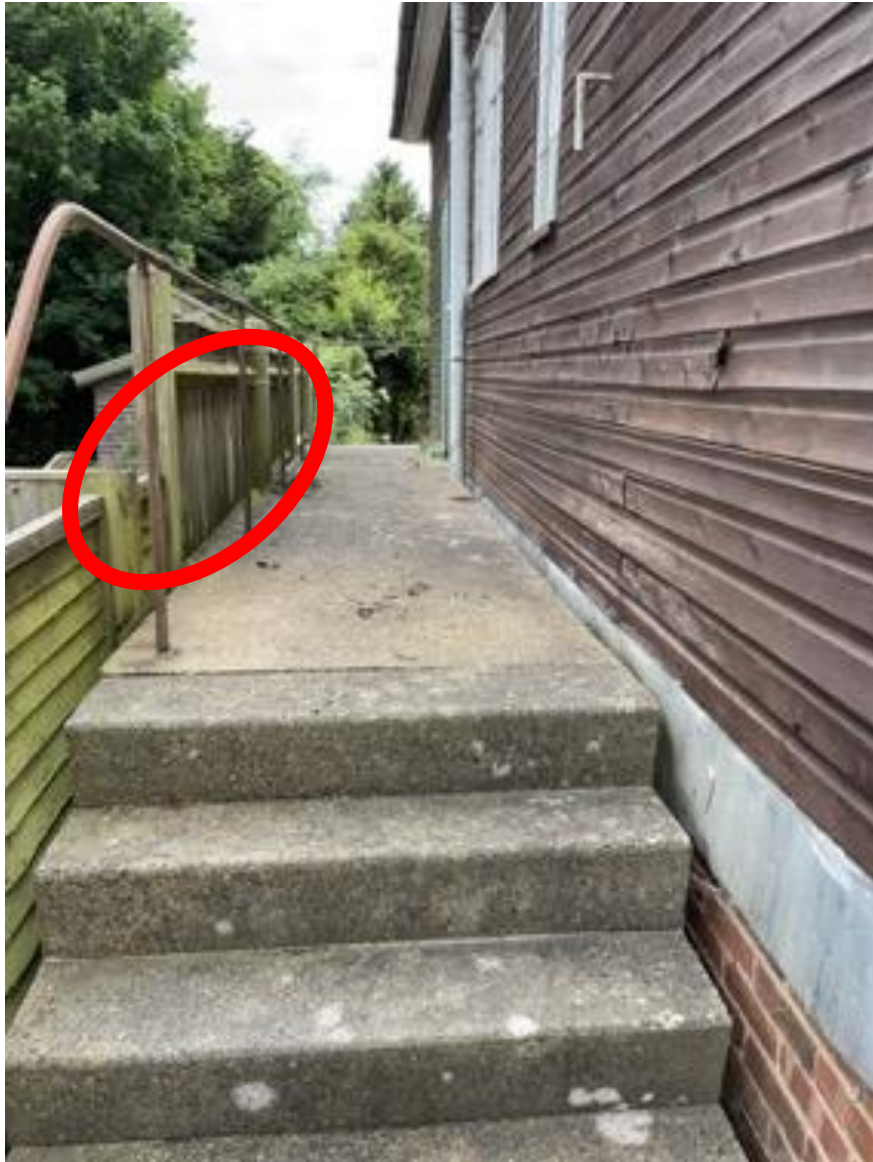
Existing handrail has no lower rail

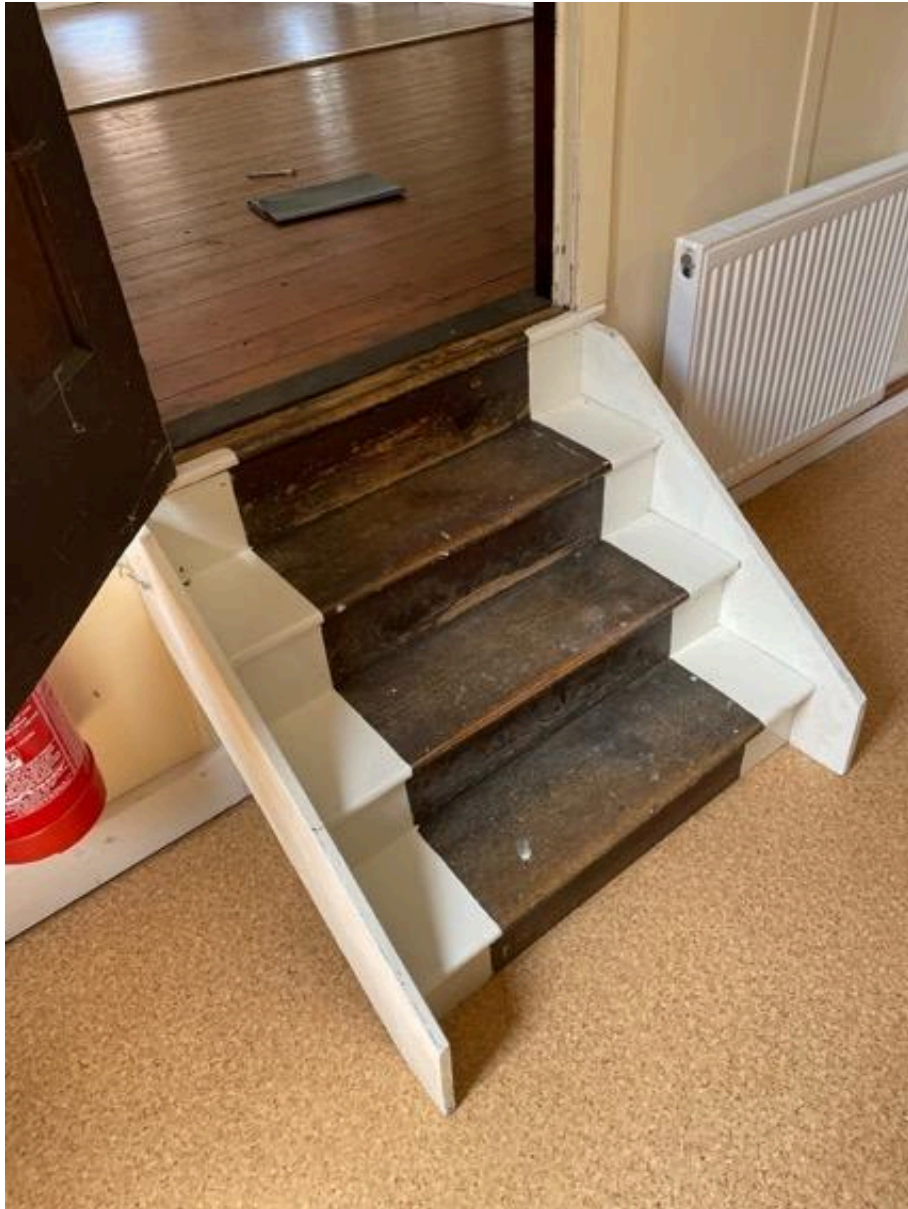
No Handrails for temporary stairs to stage

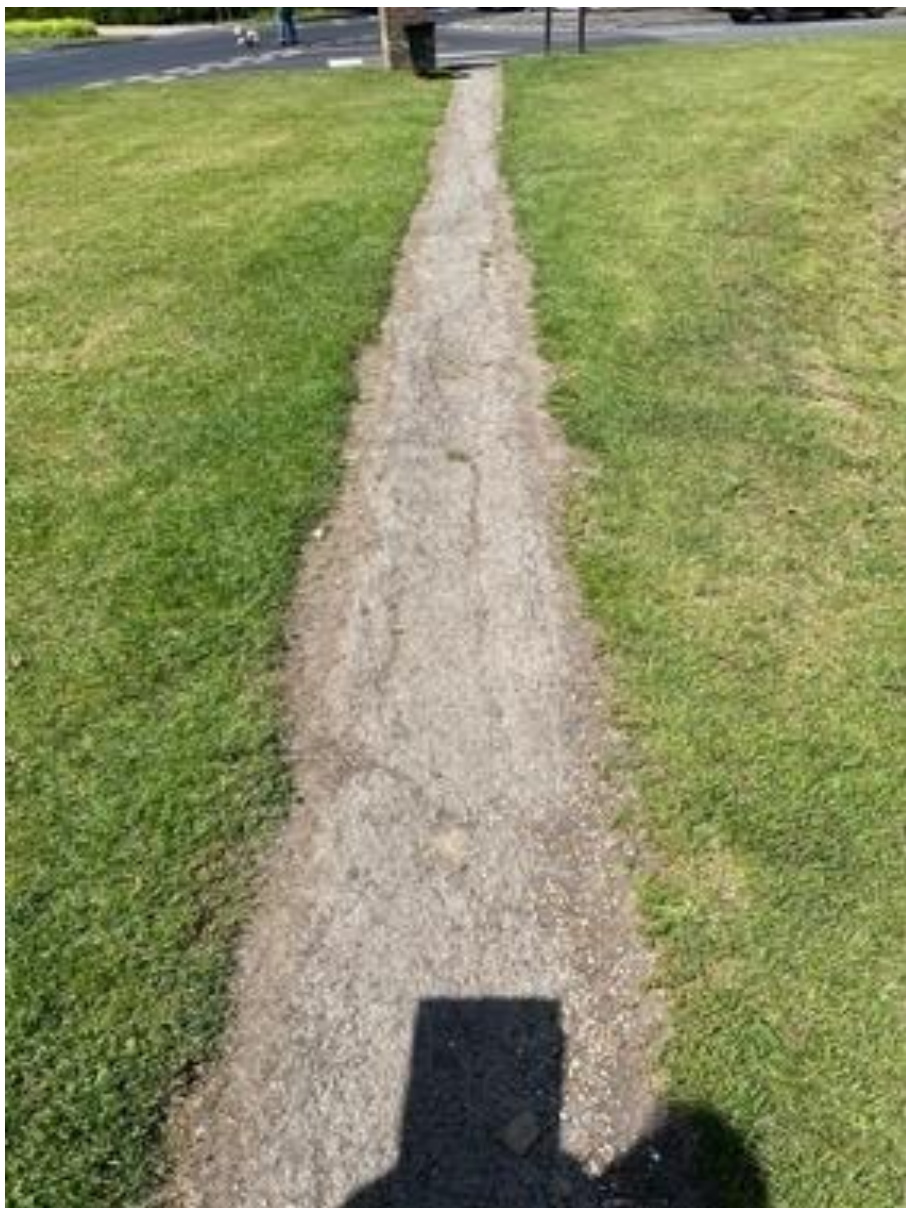
Southern corner of The Moor - Uneven path surface

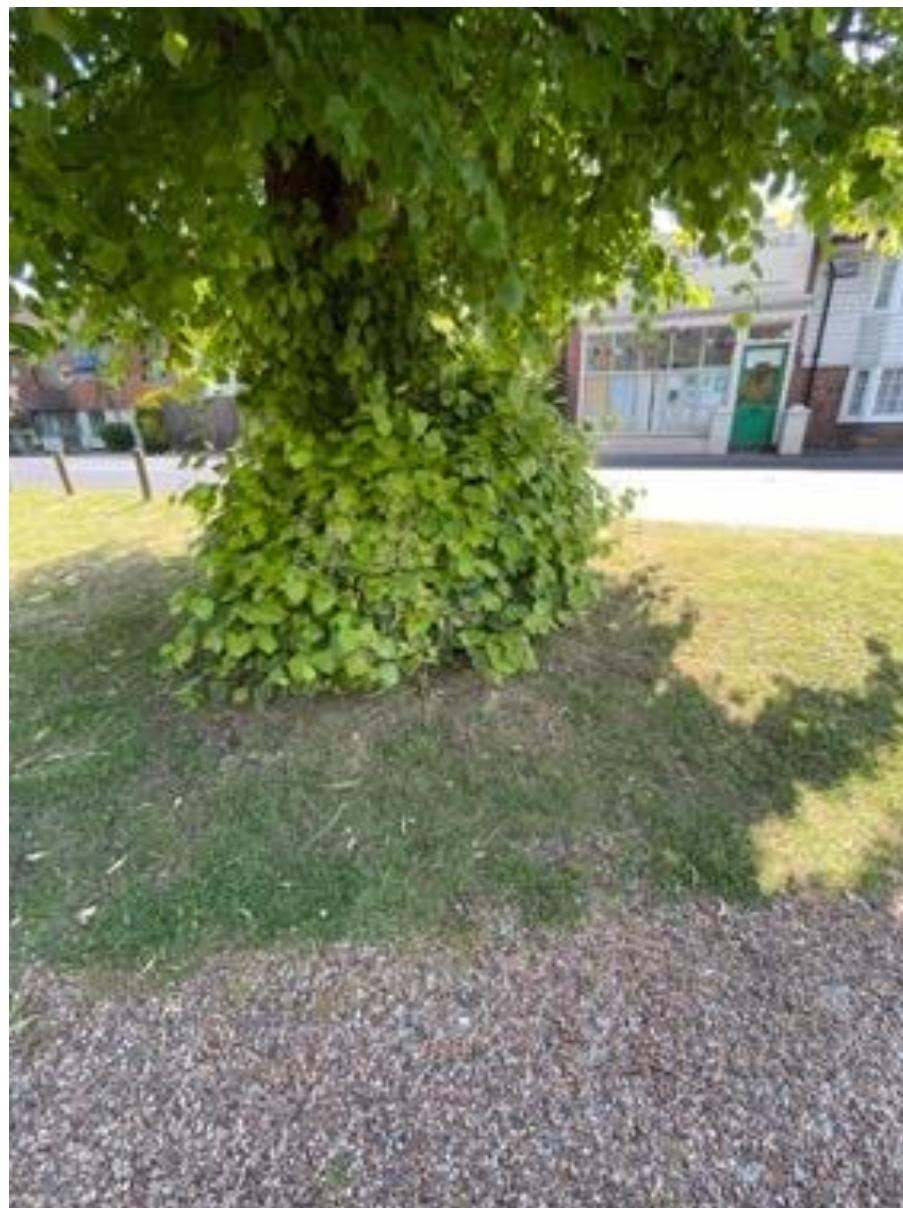
Low level tree growth on sightline of road junction

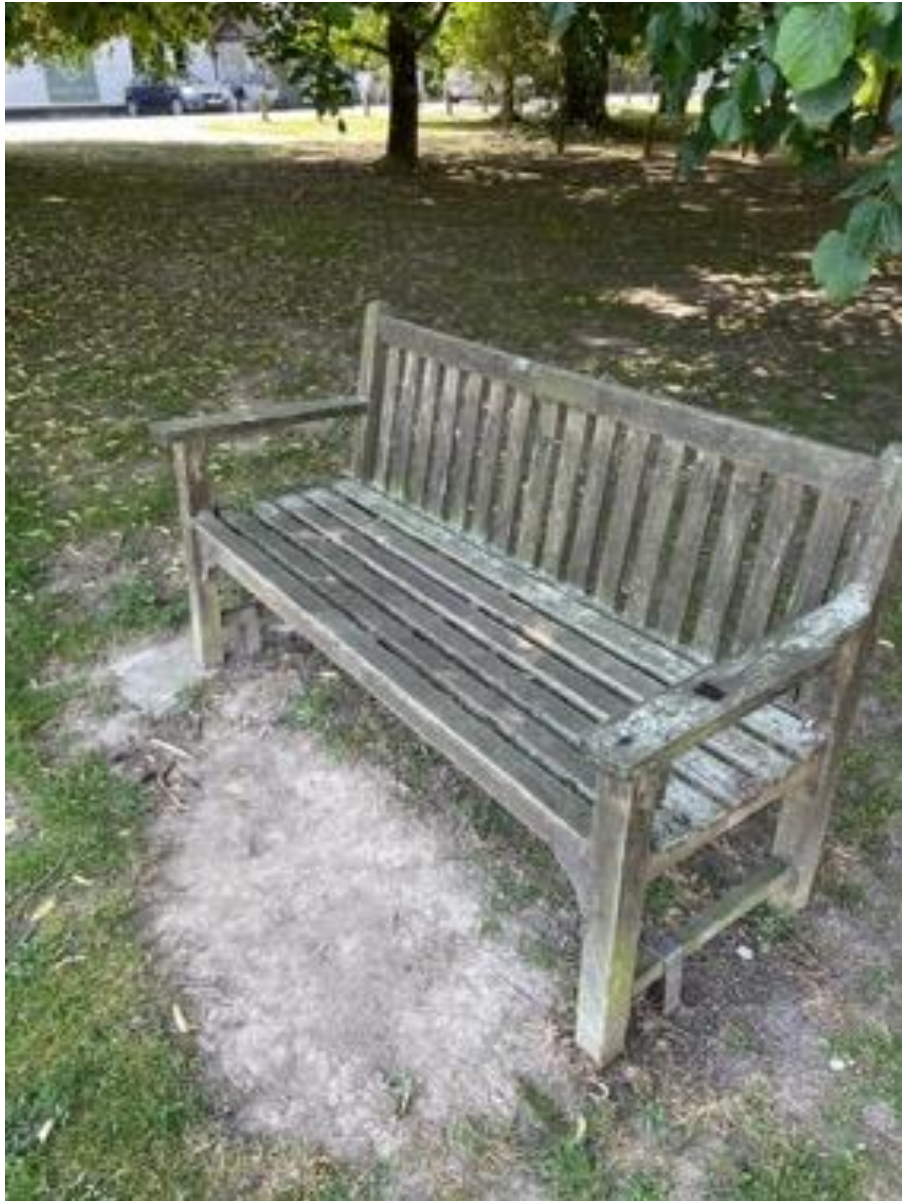
Bench Uneven surface

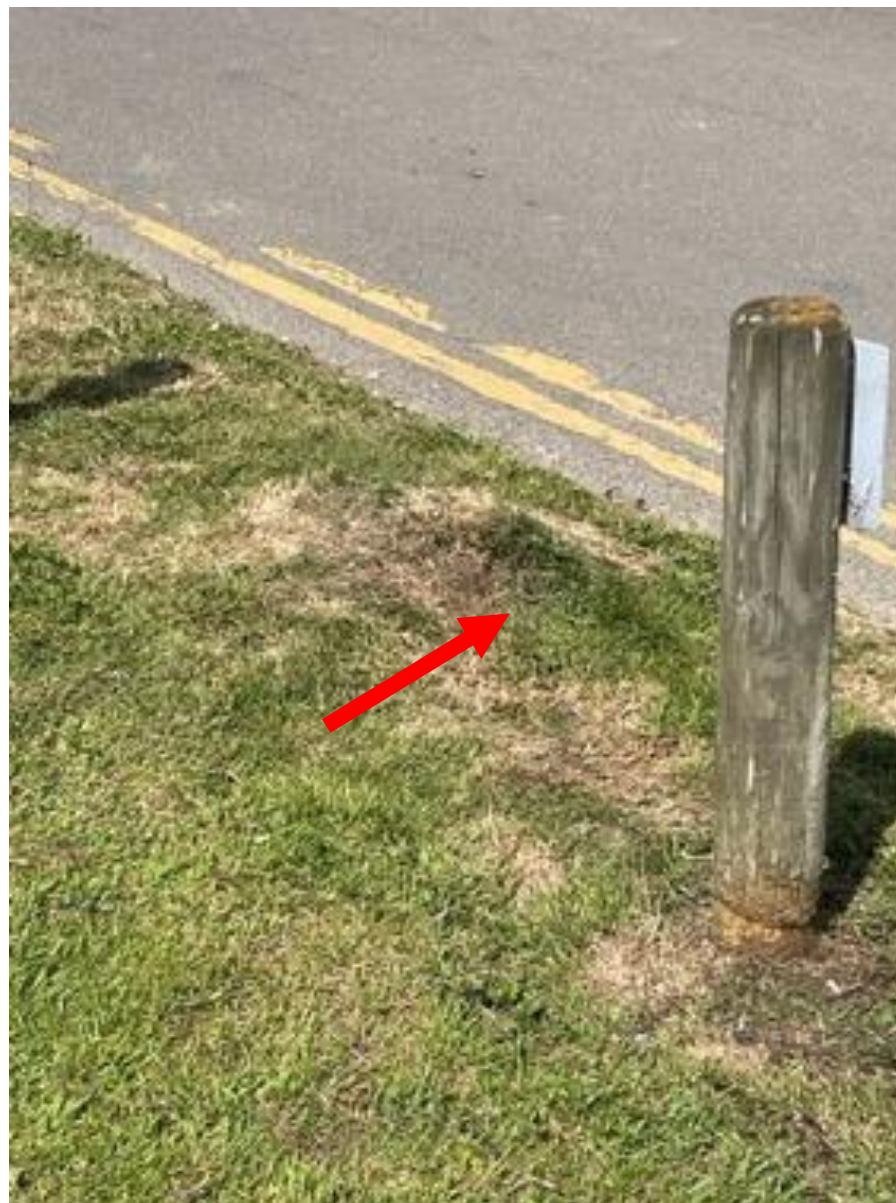
Mound at N boundary between posts

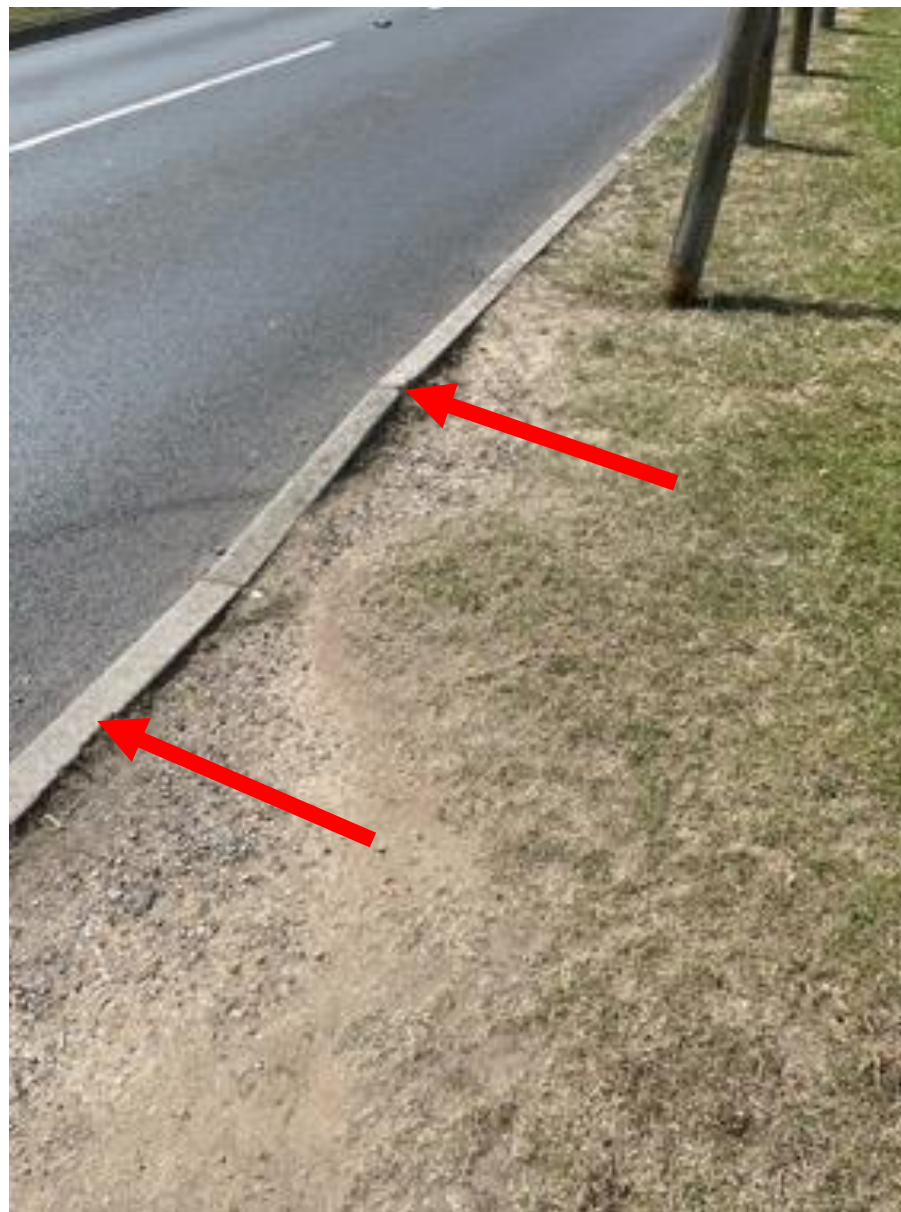
Entrance with A229 rear edge of curb raised above surrounding

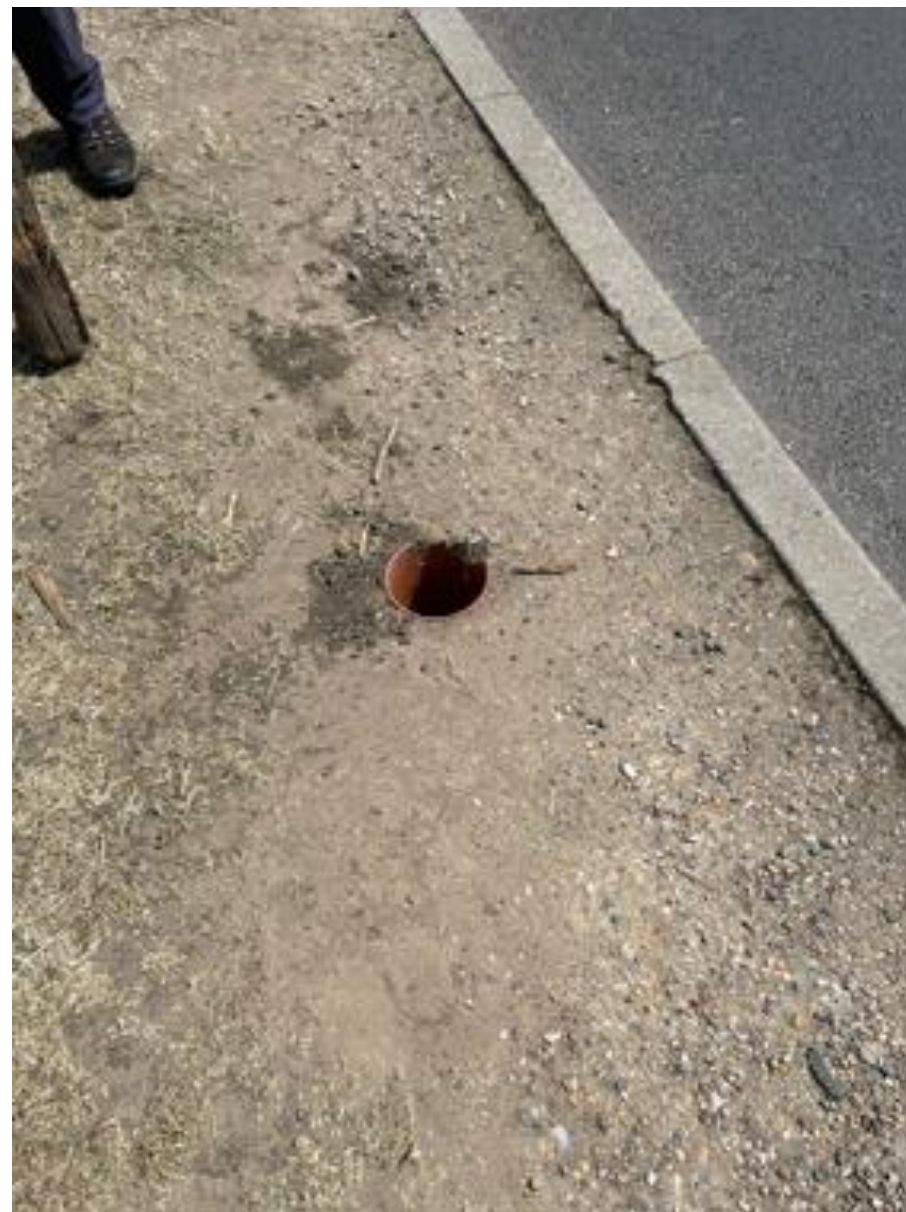
Hole where post is removed to allow access

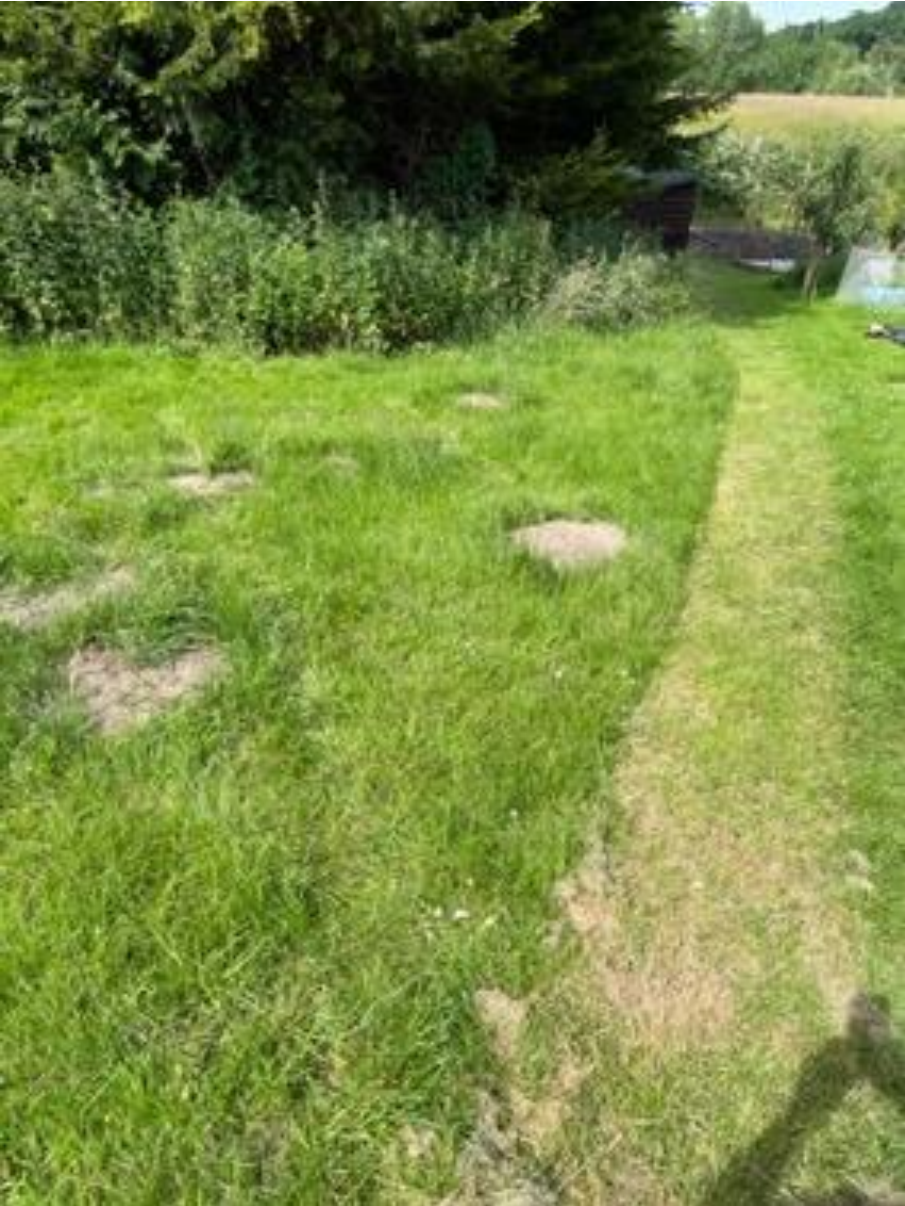
Mole hills

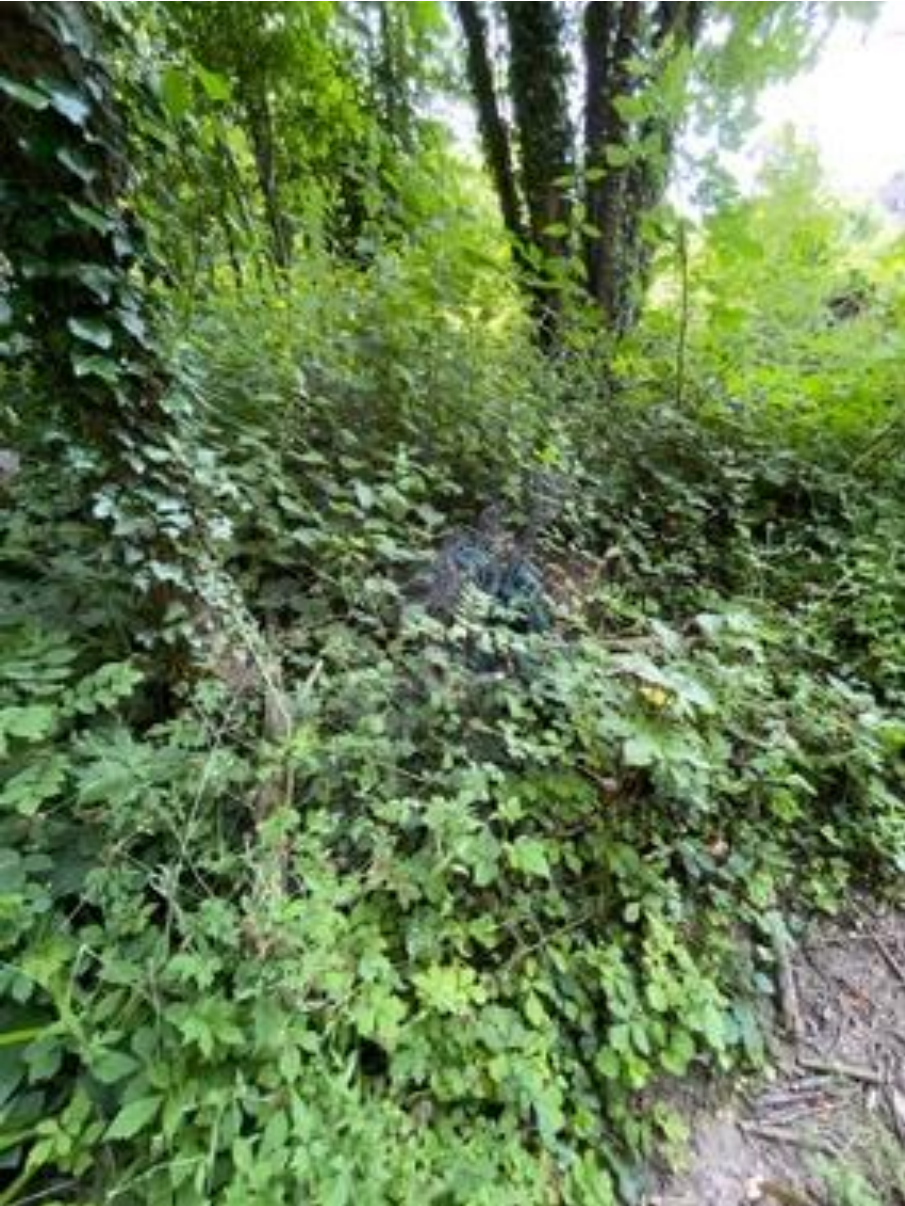
Rubbish in undergrowth

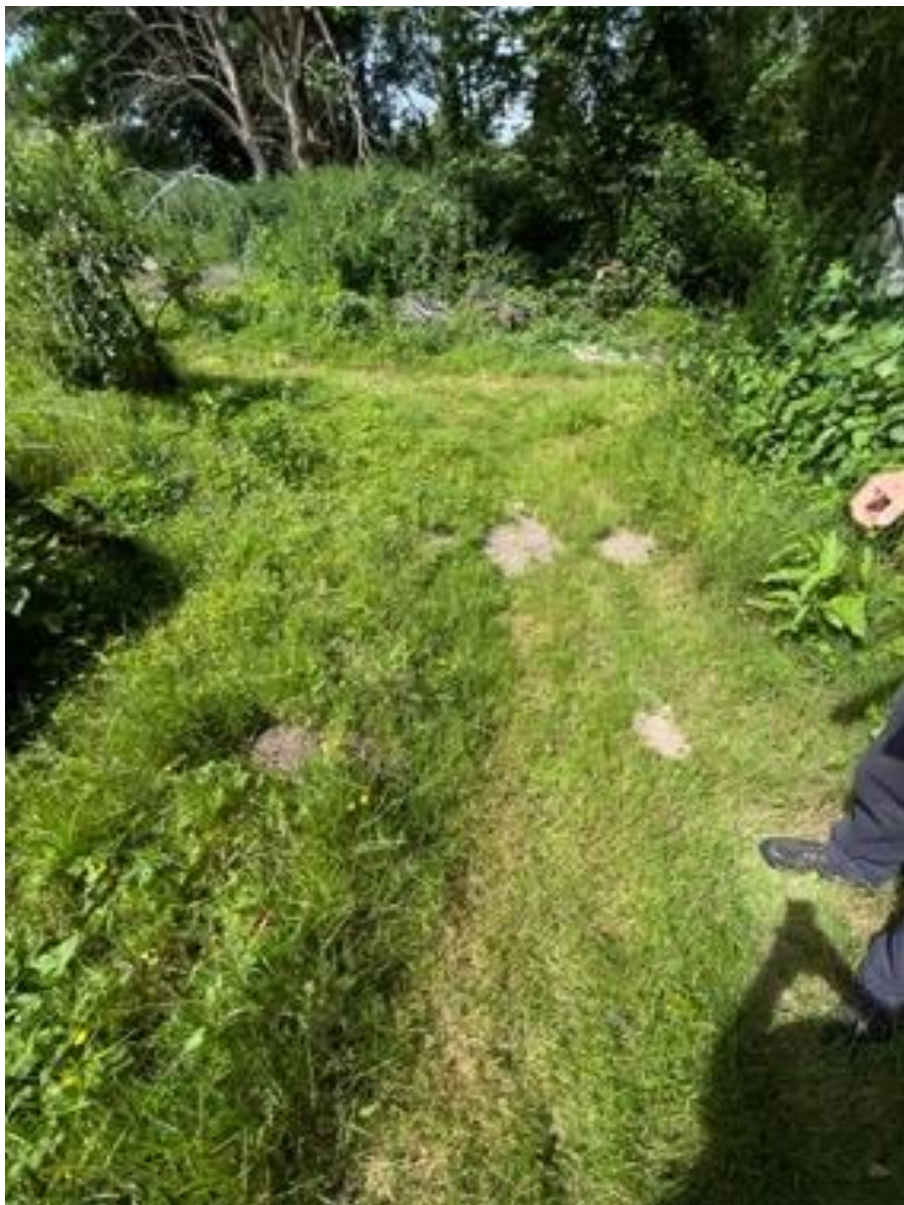
Mole Hills in footway

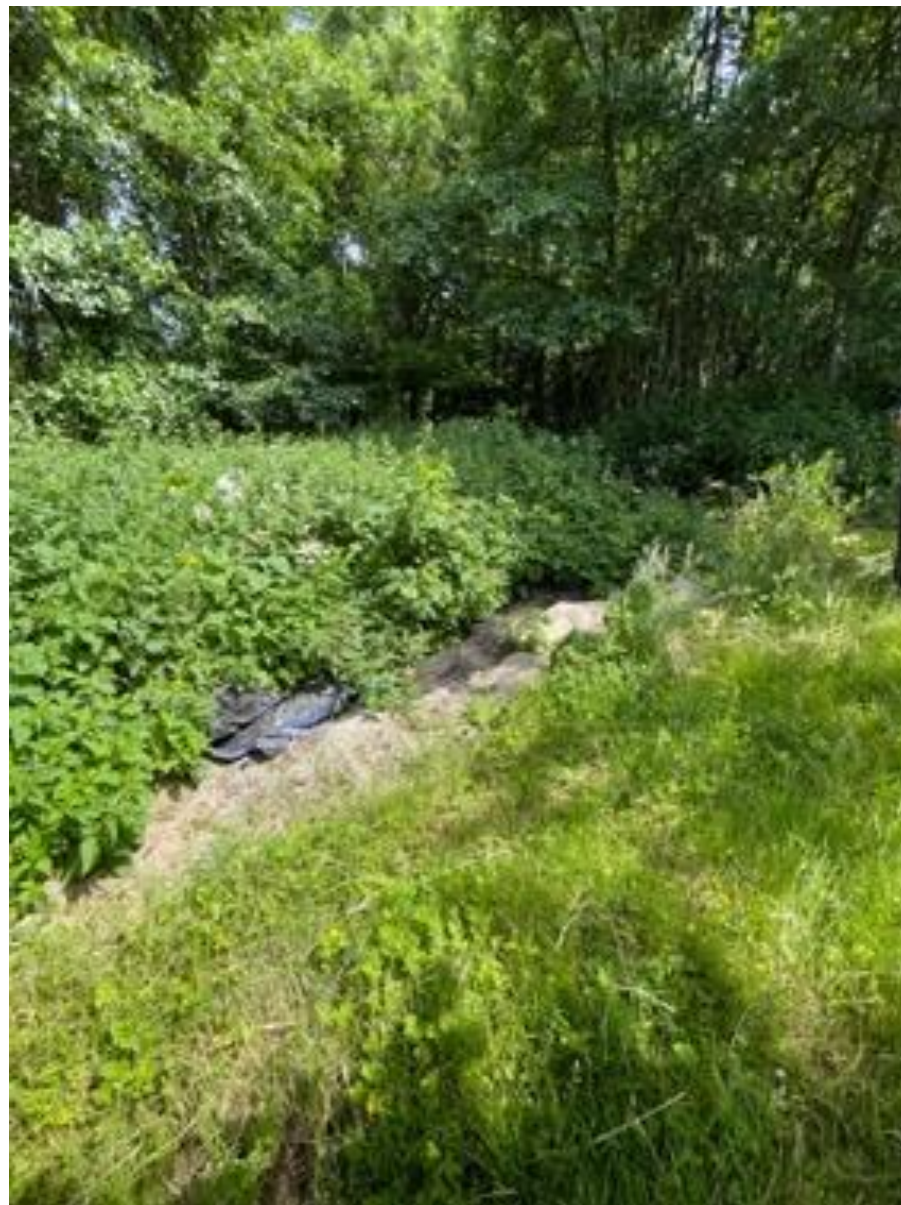
Matting in undergrowth

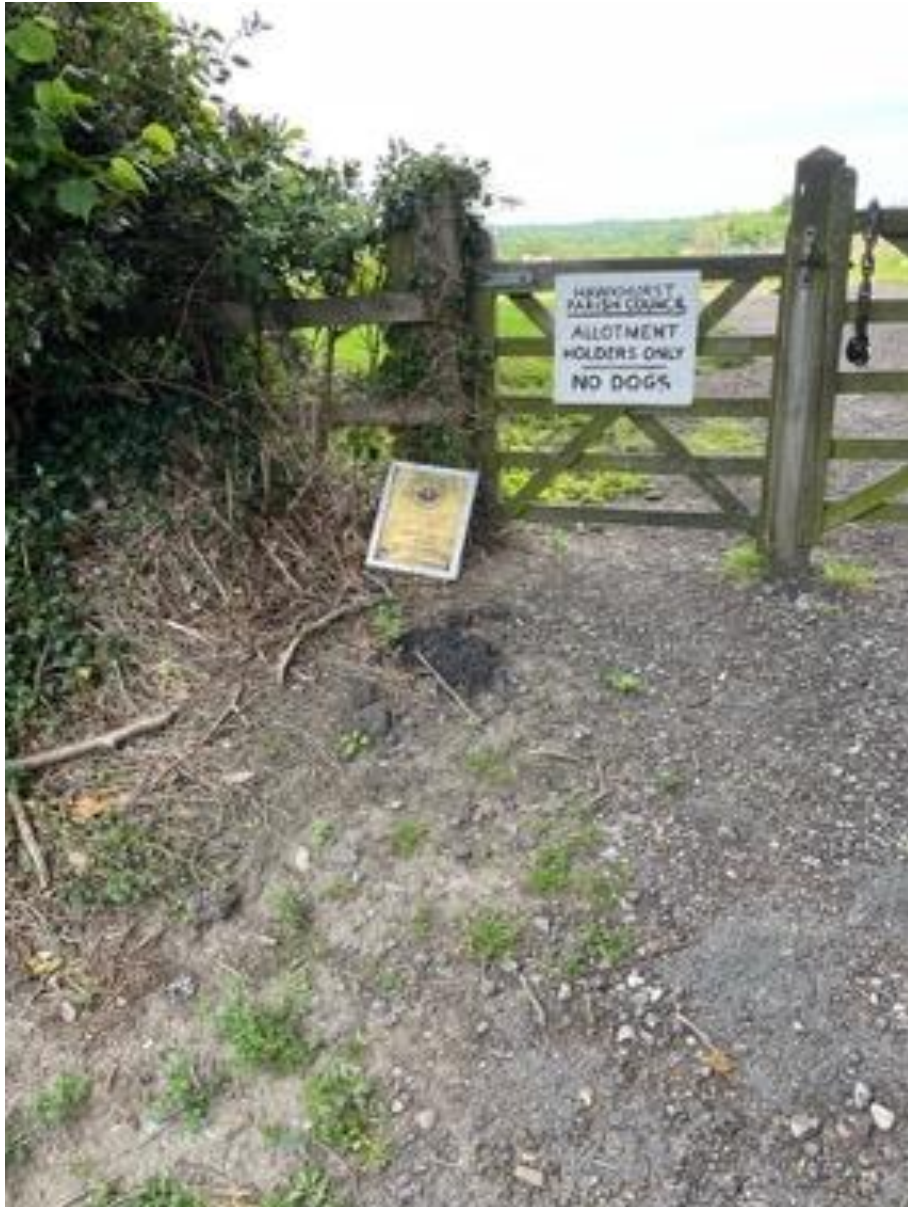
Rough surface/dip by carpark

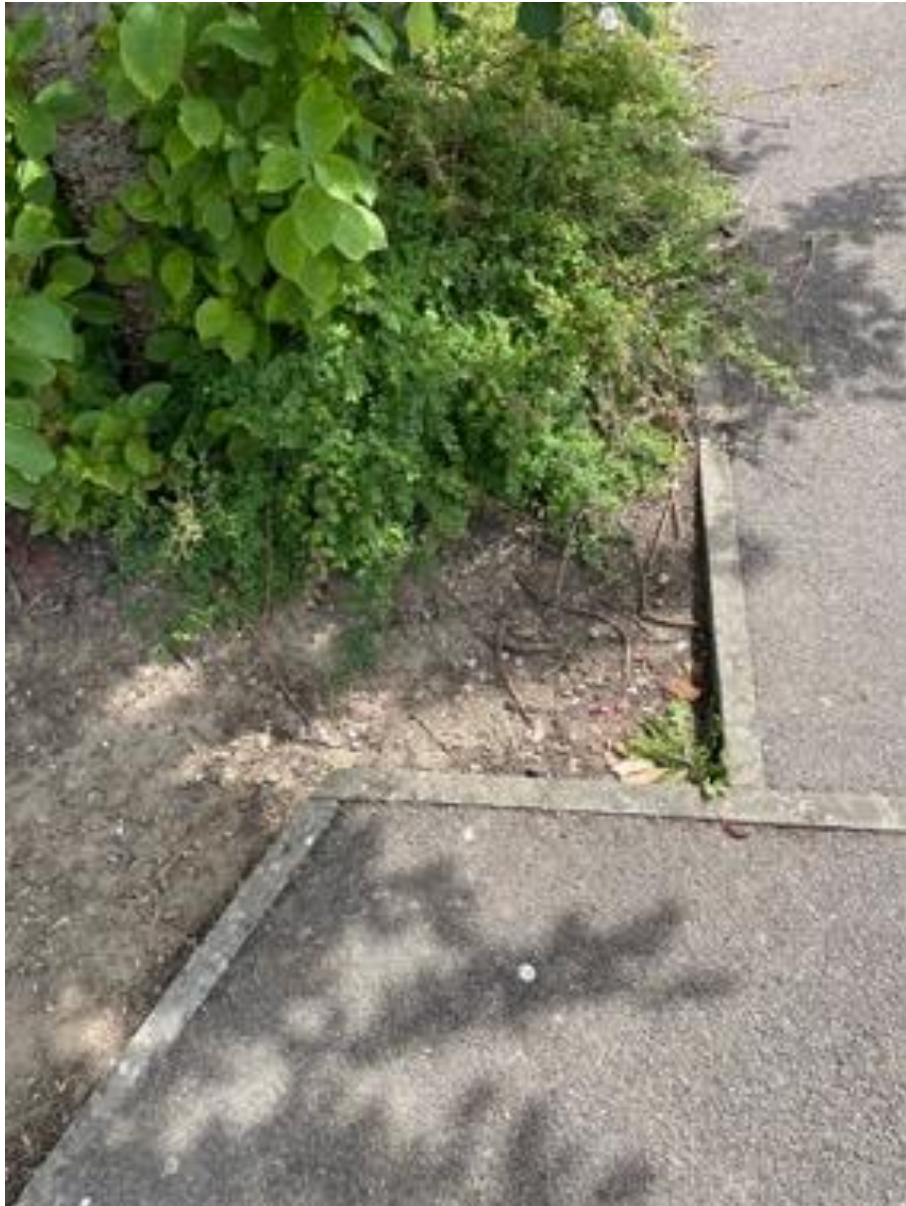
Rough surface and raised rear edge of curb in flowerbed by West entrance

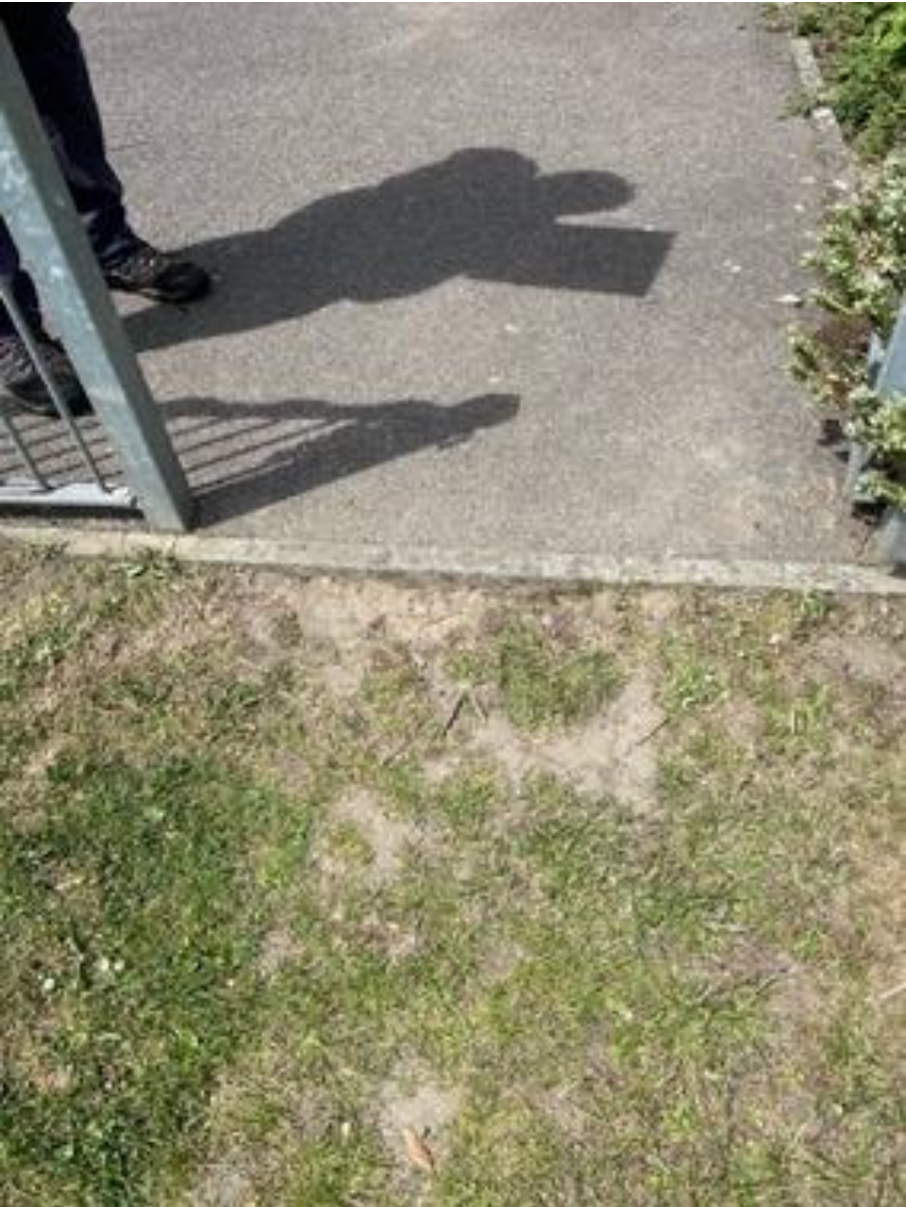
West entrance concrete edge open gate

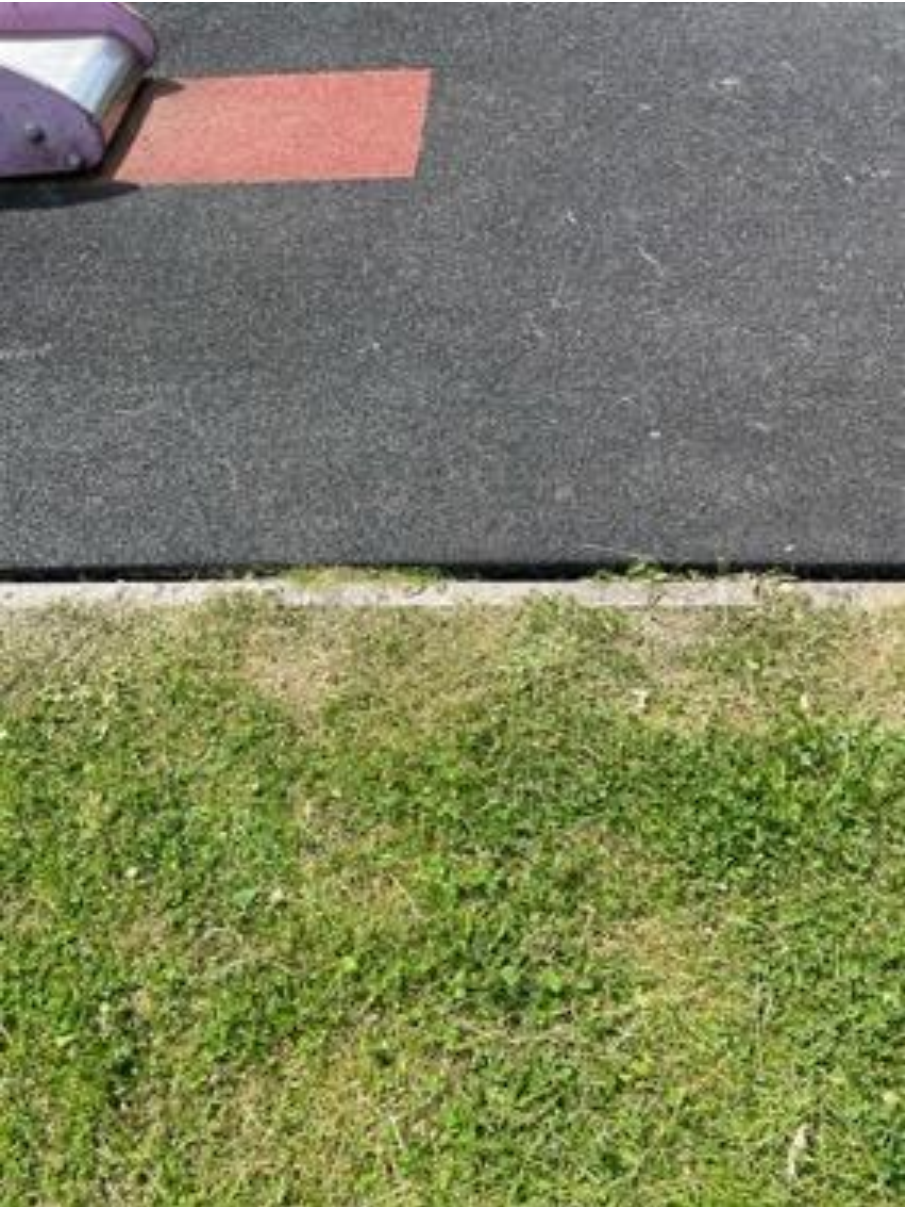
Raised edge to play surface – See RoSPA report

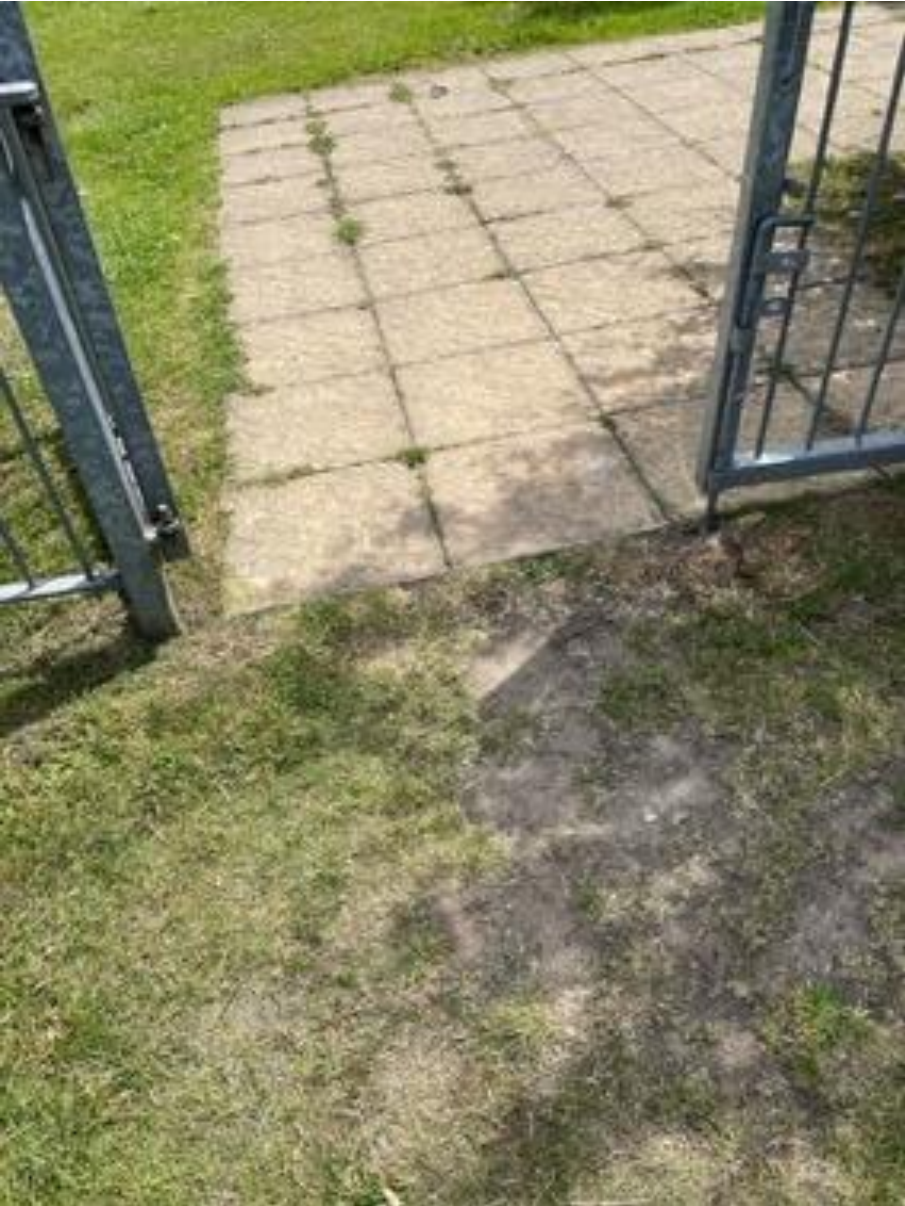
Ground in front of gate would be slippery when wet, raised slab edge to path

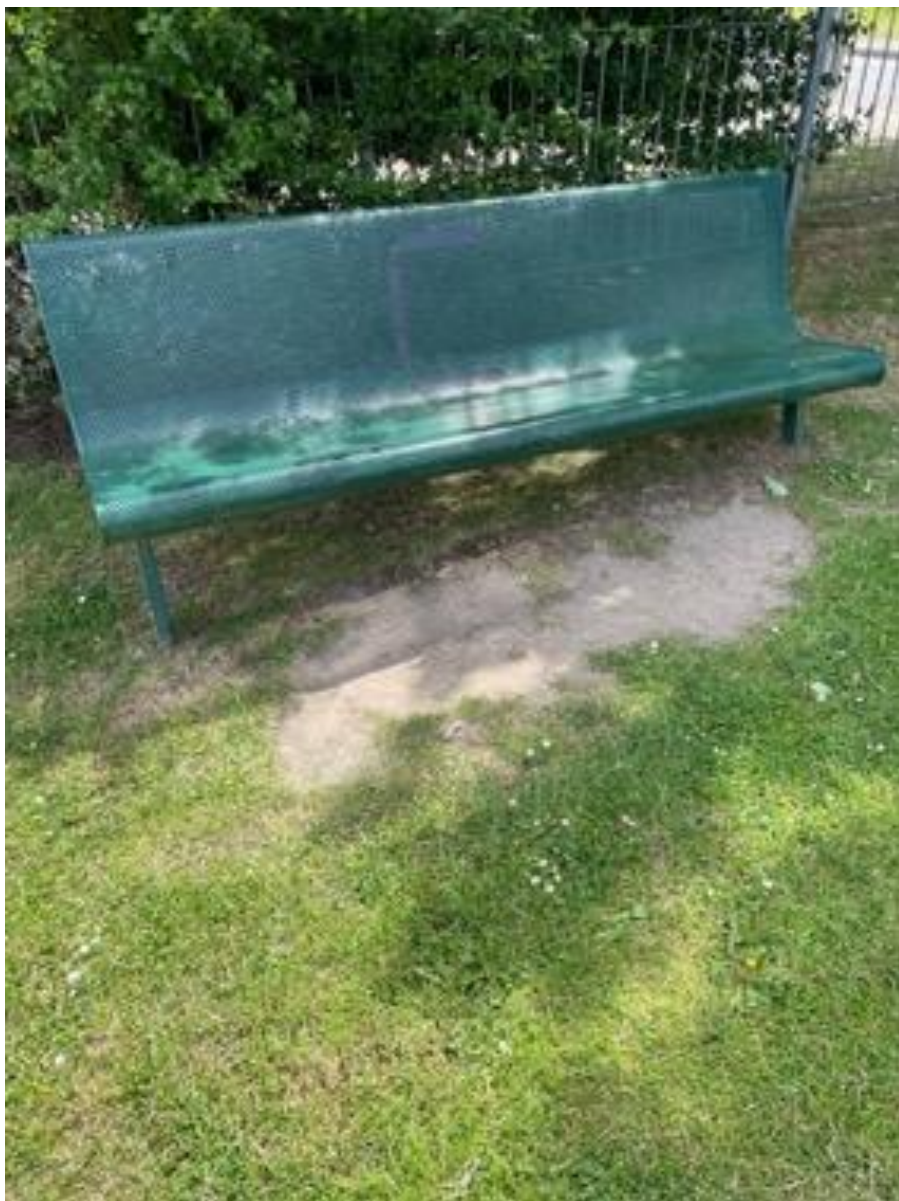
Area around bench uneven

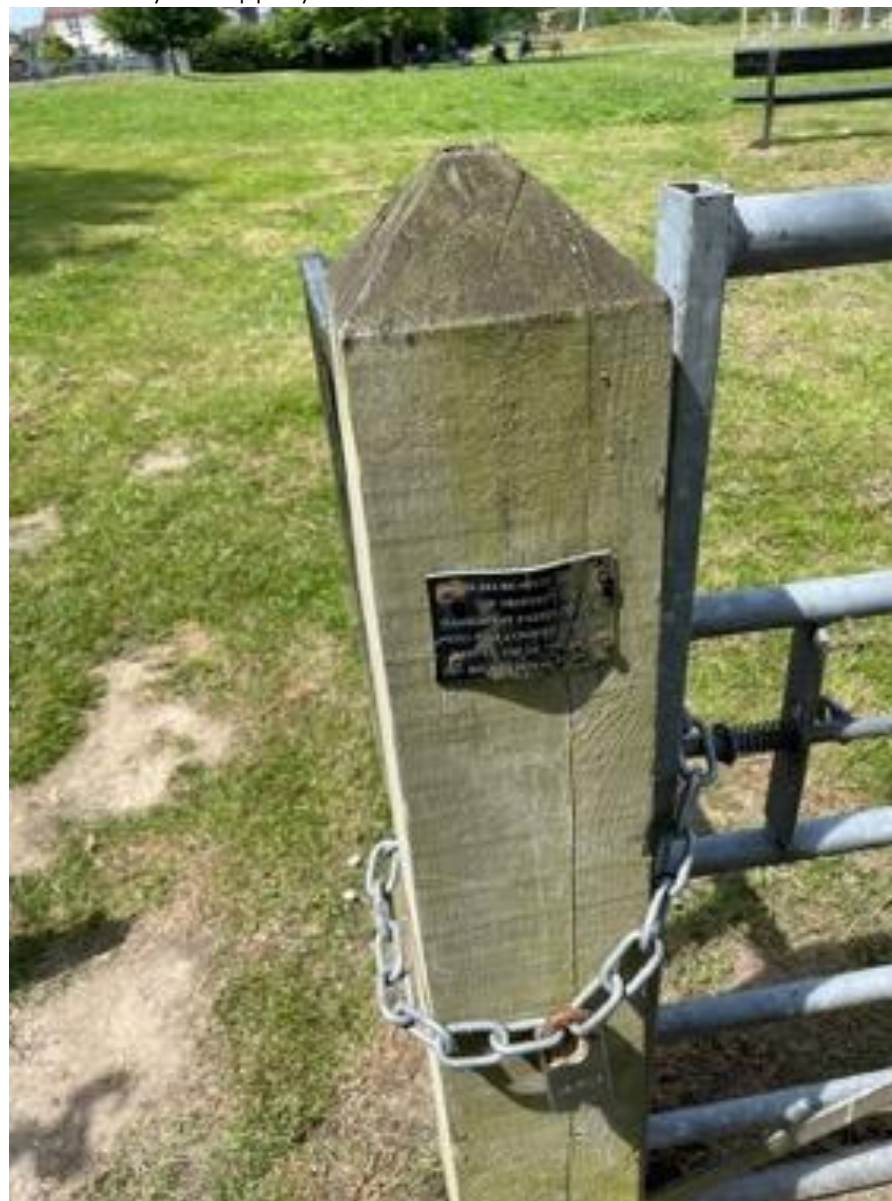
Entrance gate and track Tyre tracks and steep slope uneven exposed surface may be slippery when wet
