# Hawkhurst Parish Council Health and Safety Report

June 2022

Observations from audit of HPC facilities using HSE Slips and trips hazard spotting checklist and HSE Checklist for village and community halls.

Conducted by Cllr Paul Green and Cllr Simon Paish on Thursday 9<sup>th</sup> June 2022, conditions clear and dry, And 16<sup>th</sup> June 2022 conditions hot clear and dry.

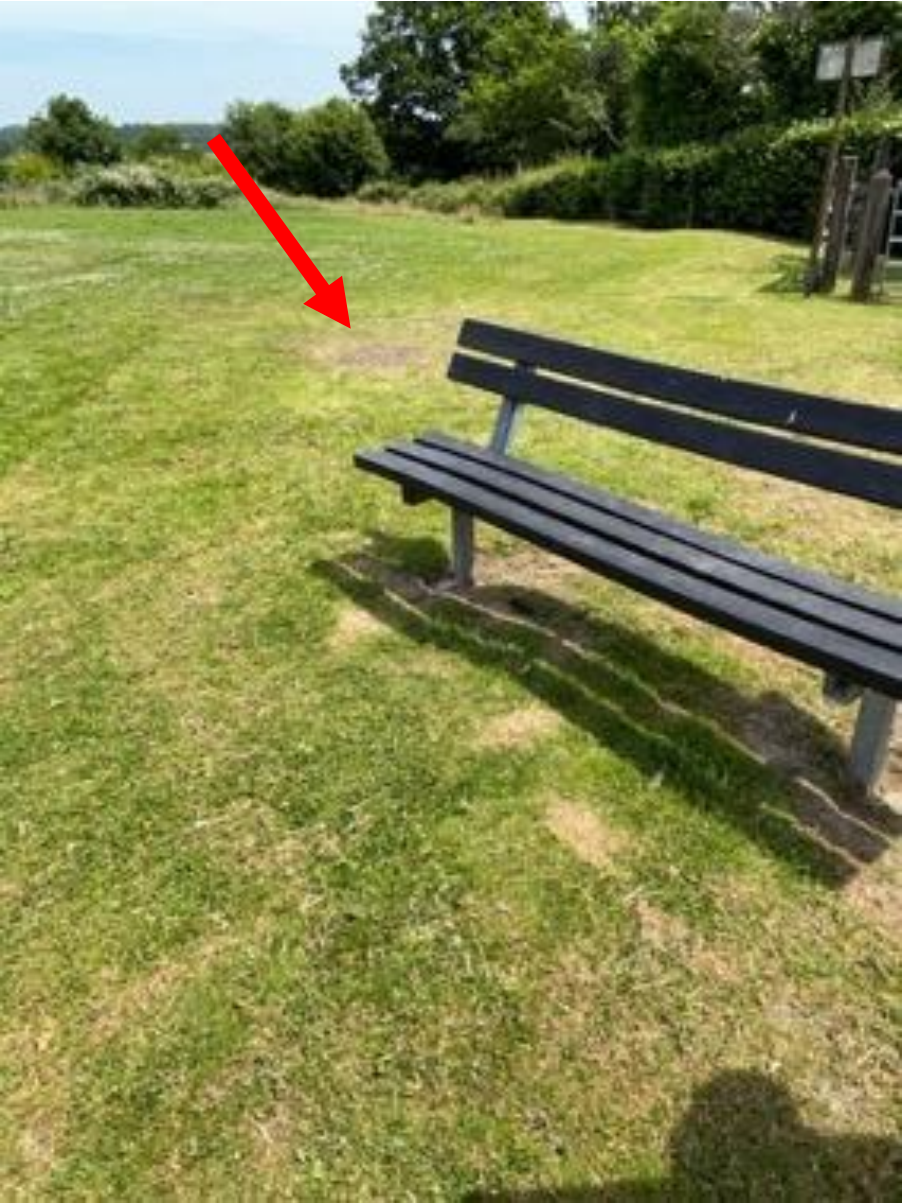
Slope and manhole cover  
Area around bench uneven

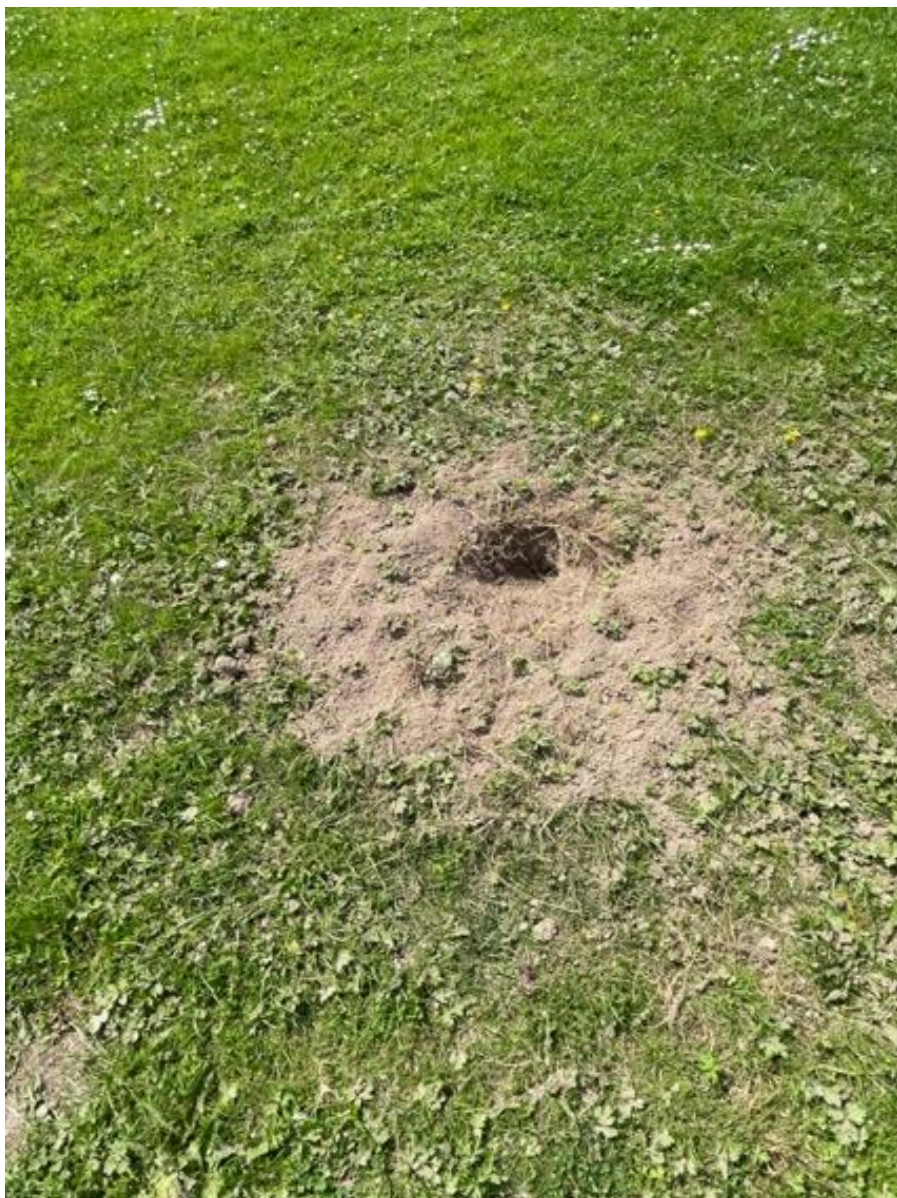
Mole hills

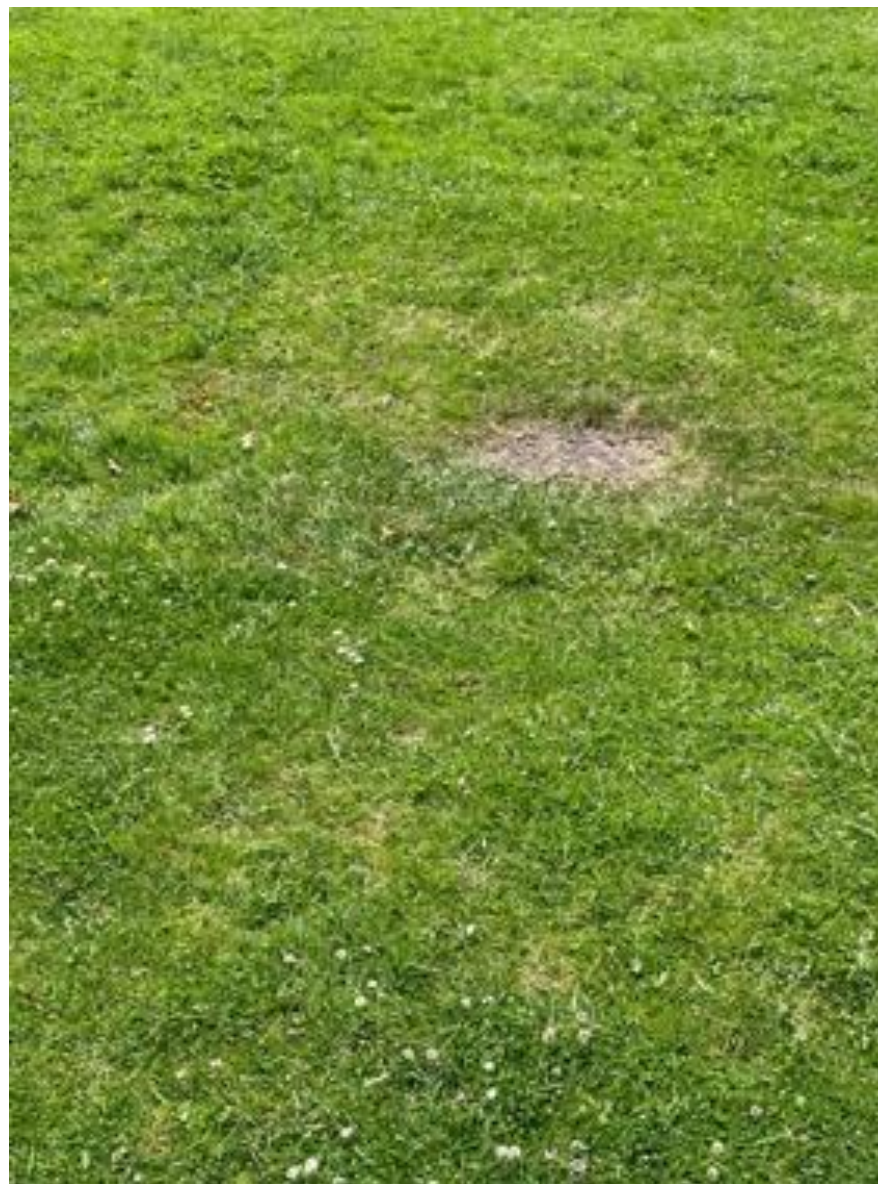
Deep dip from sunken services trench and raised manhole cover

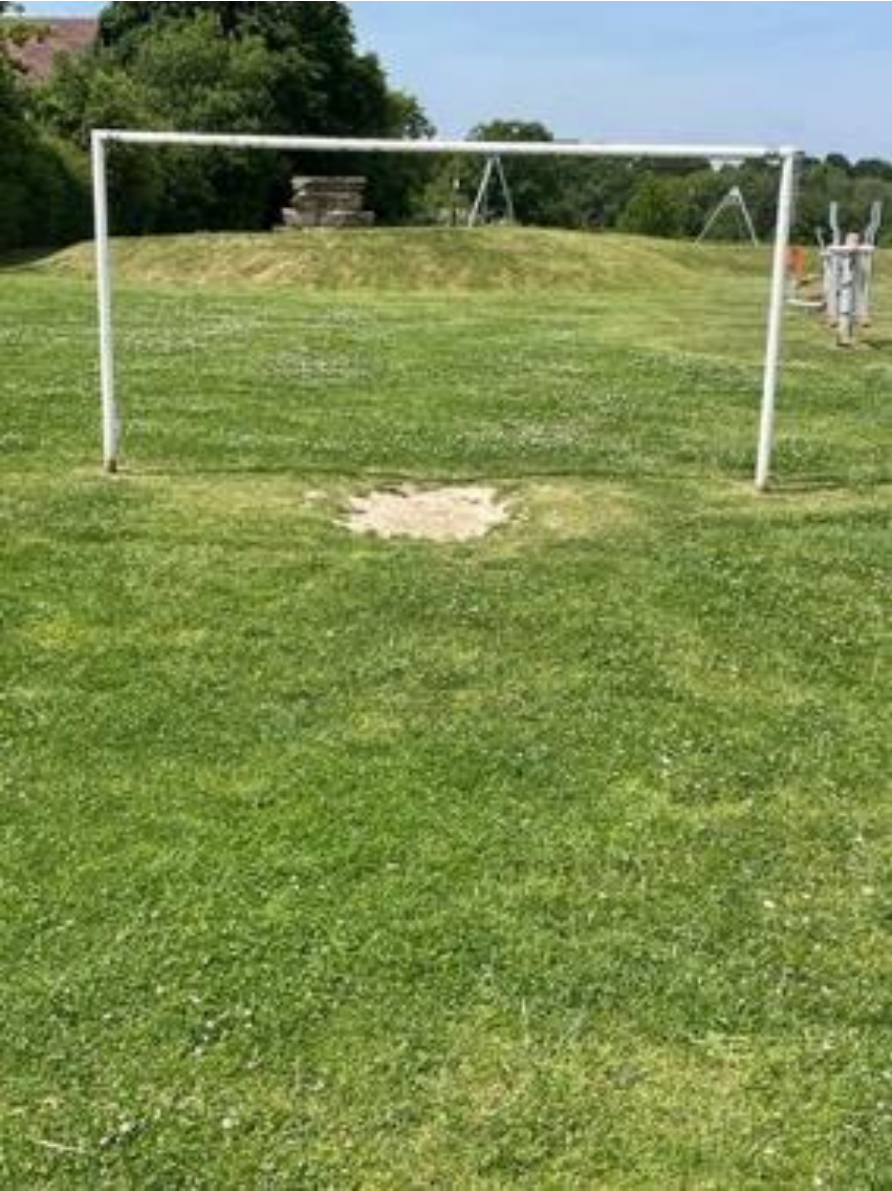
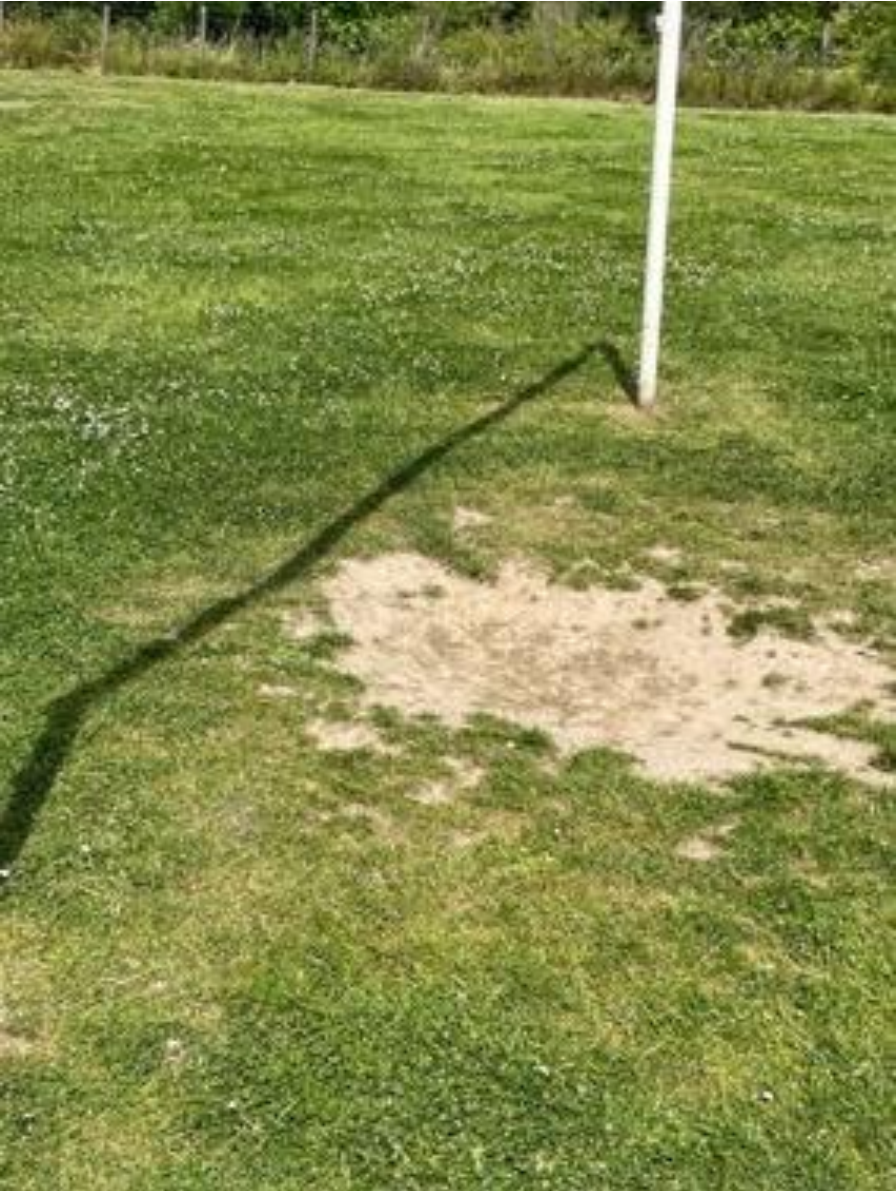
Large dip and uneven surface in front of goal will puddle when wet

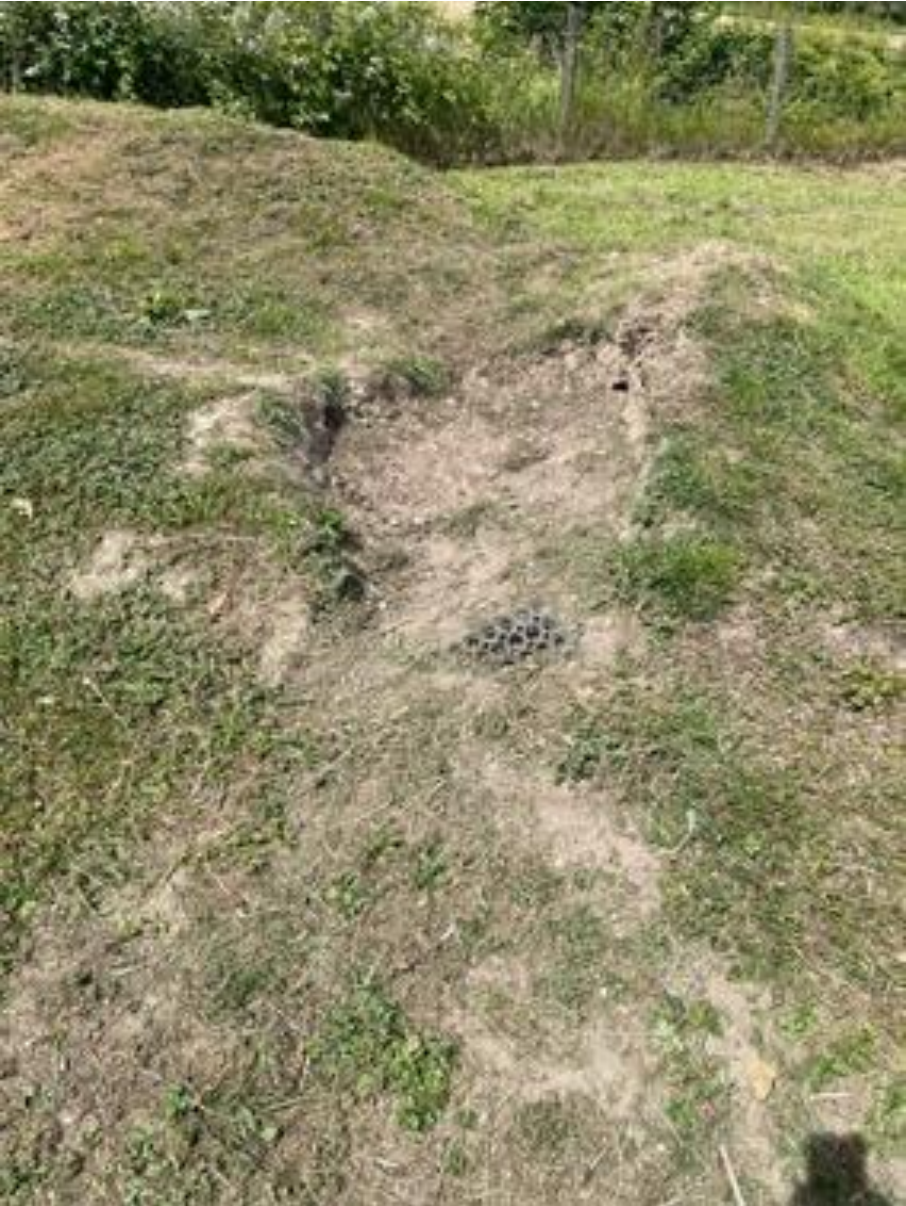
Large hole and erosion on earth mound

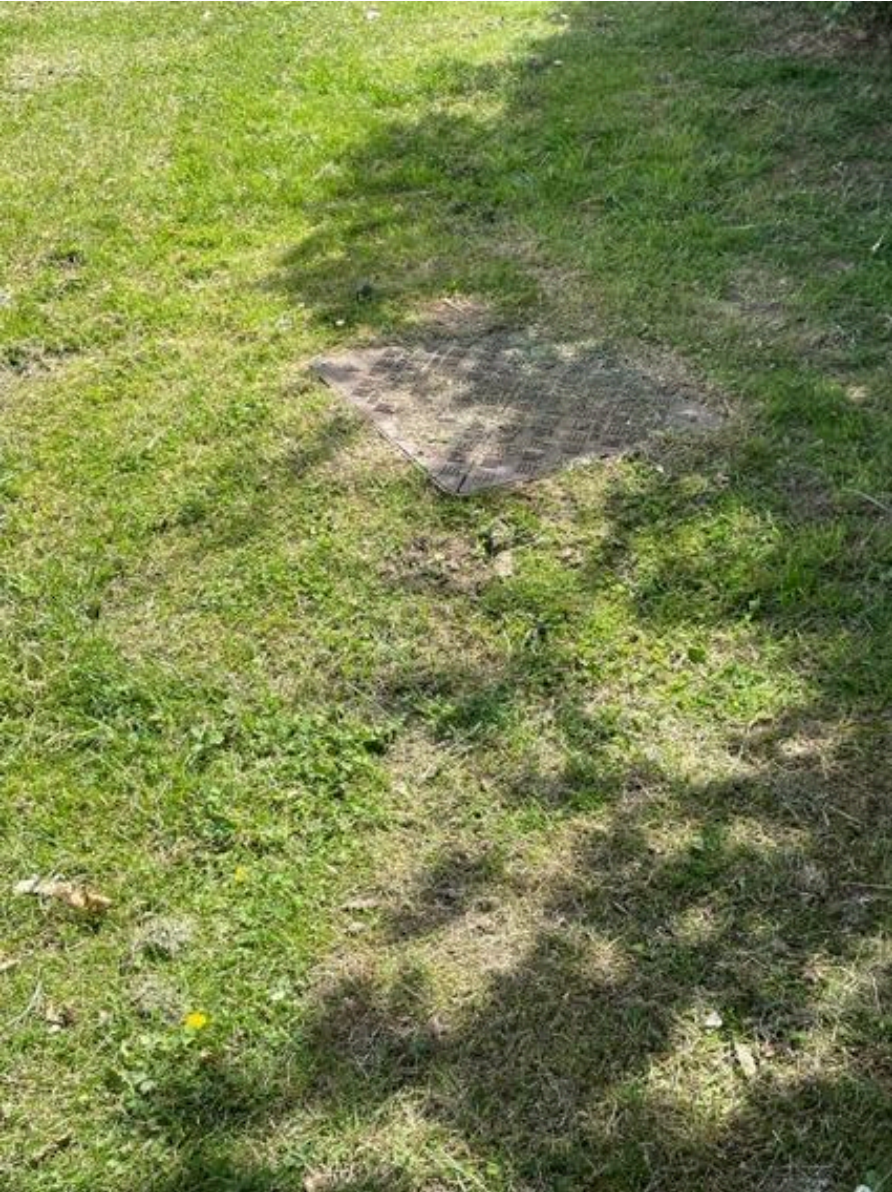
Manhole cover

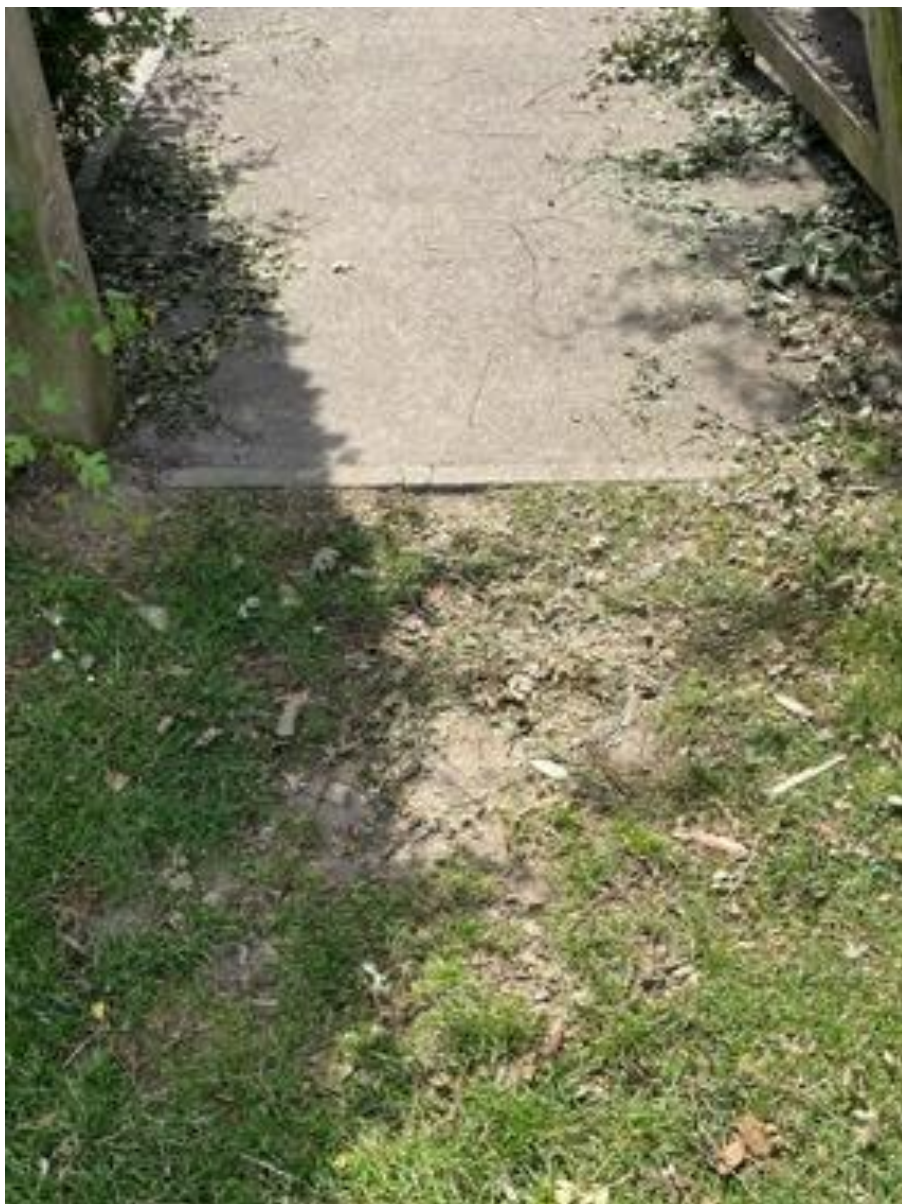
Raised edge at exit gate

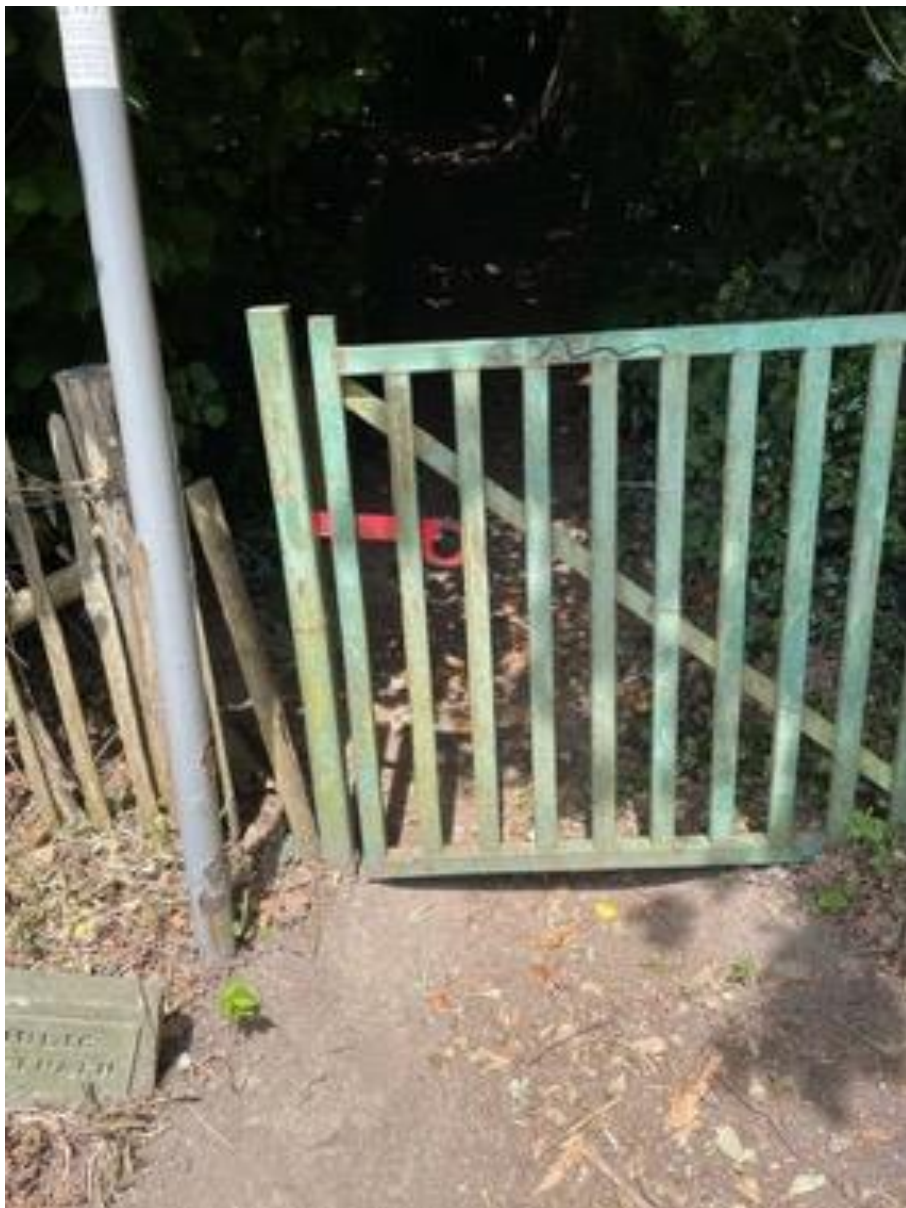
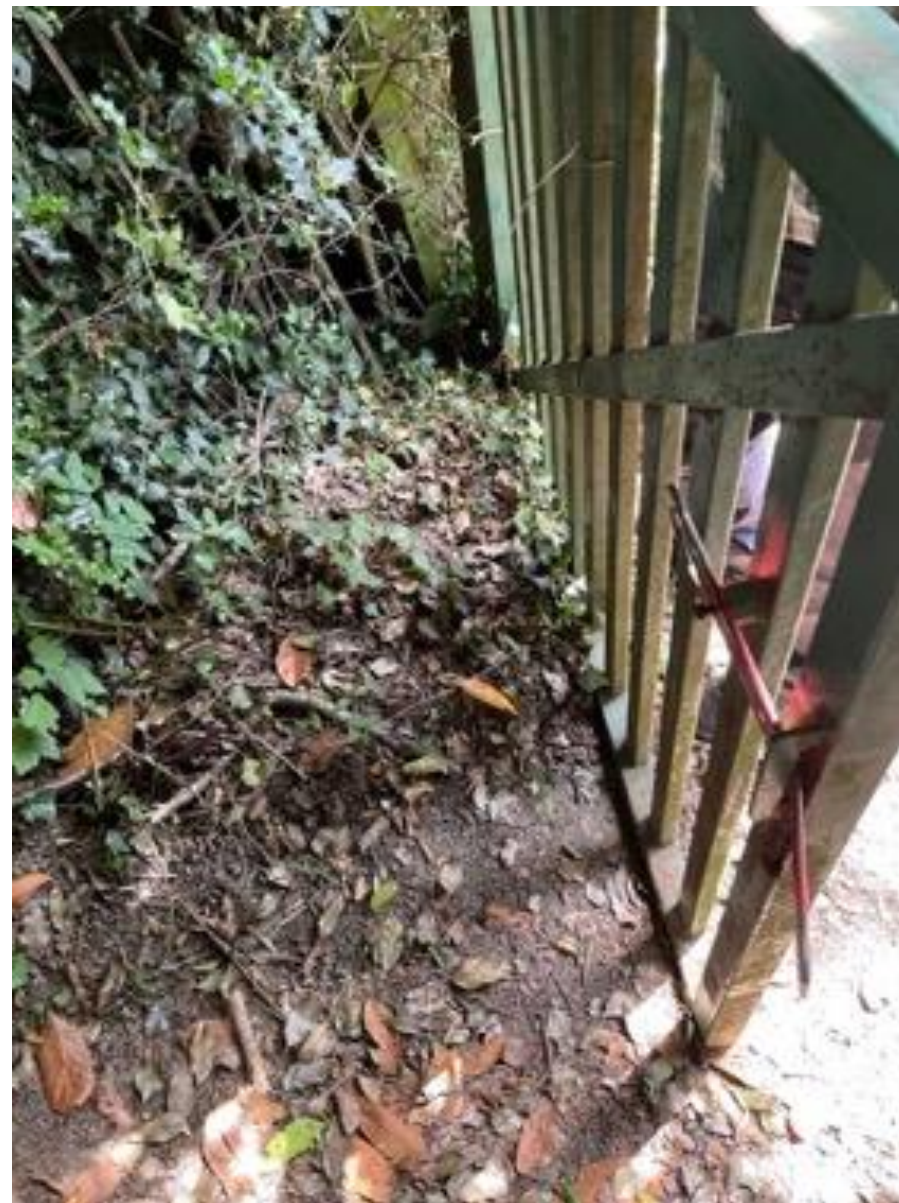
Gate doesn't open fully

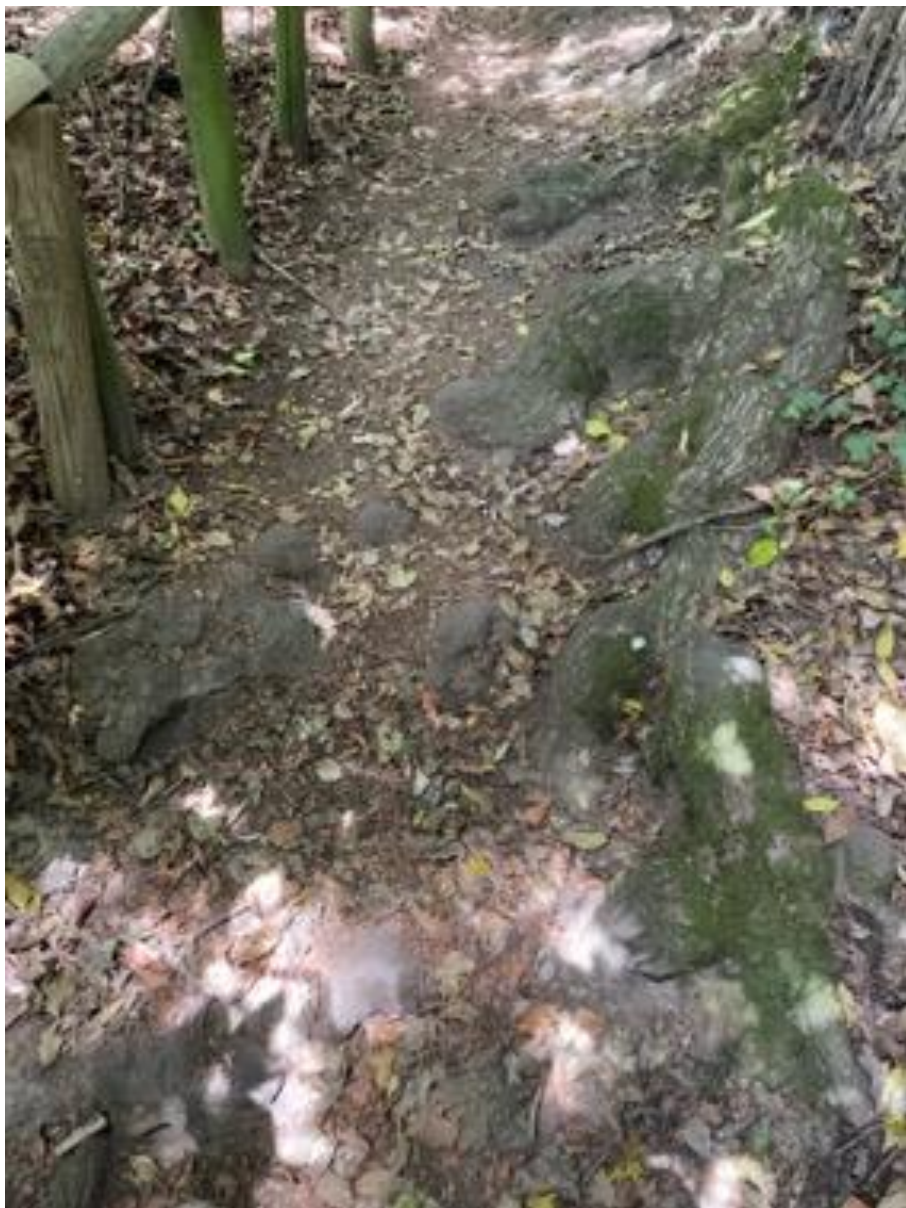
Tree roots

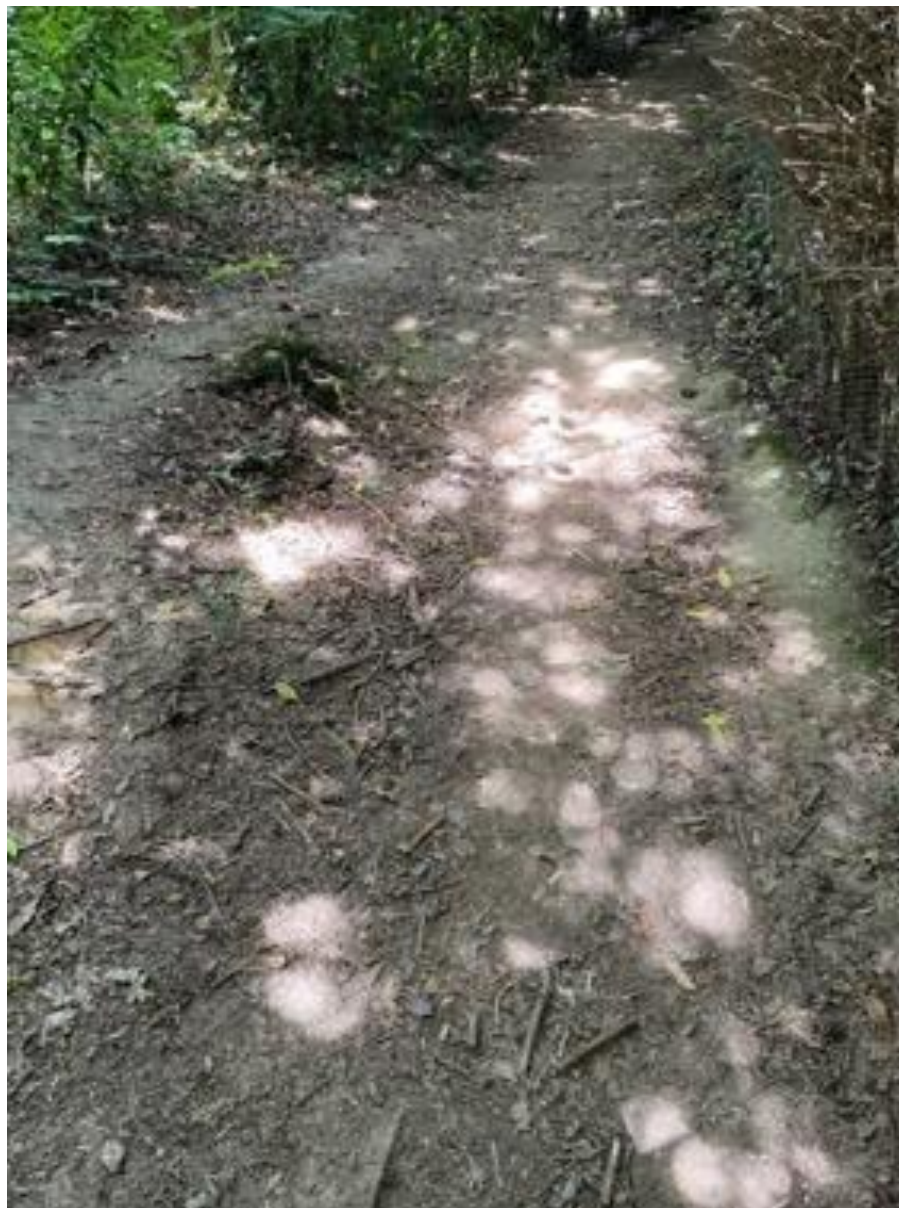
Large dip in footpath that puddles when wet

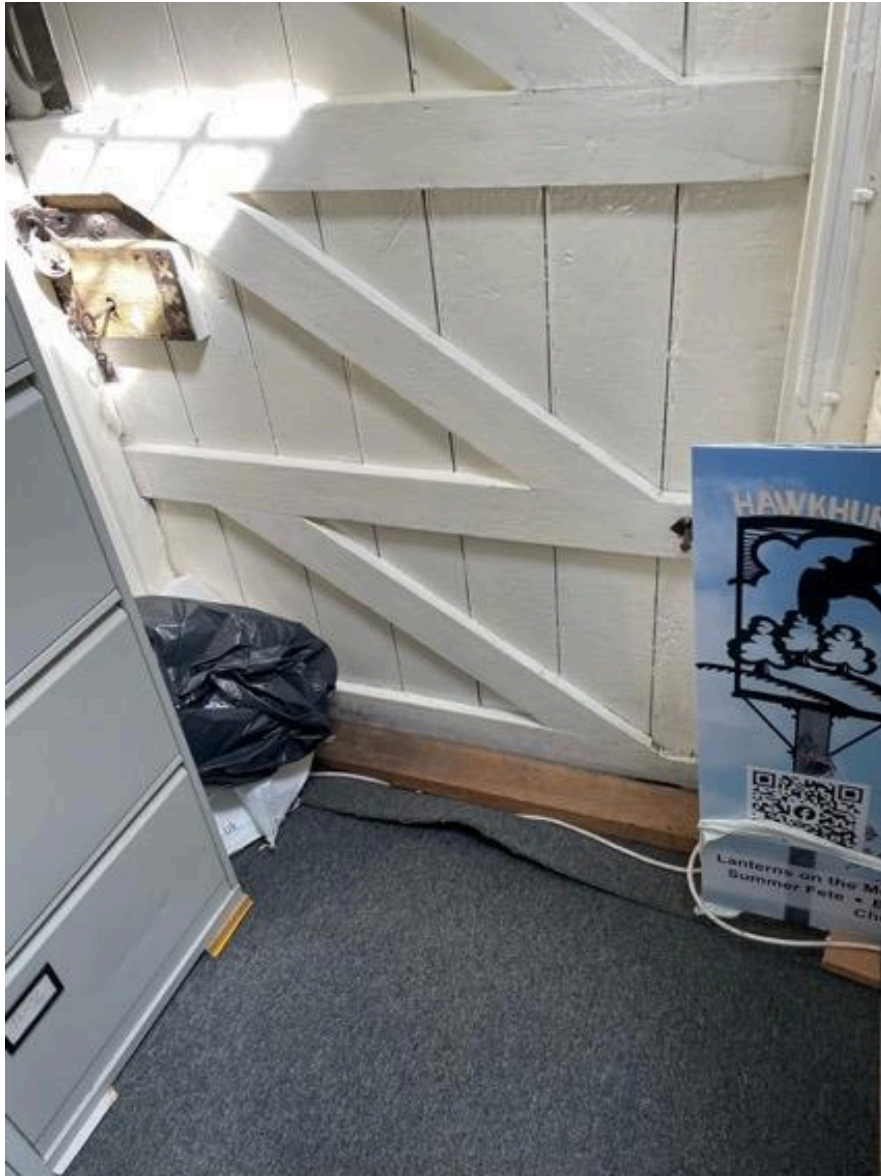
Back door threshold raised, trailing cable on surface, bin and poster in exit, uneven floor

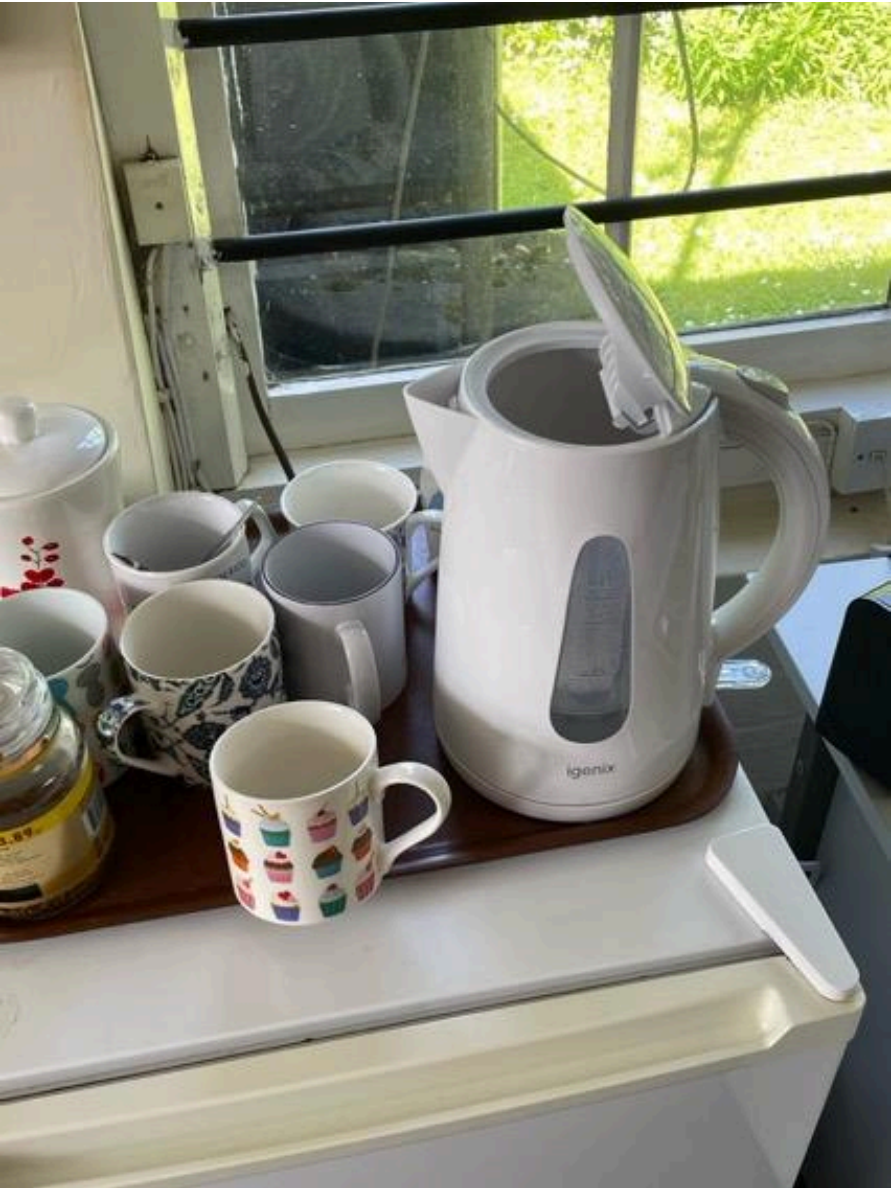
Kettle precariously positioned on top of fridge with other items

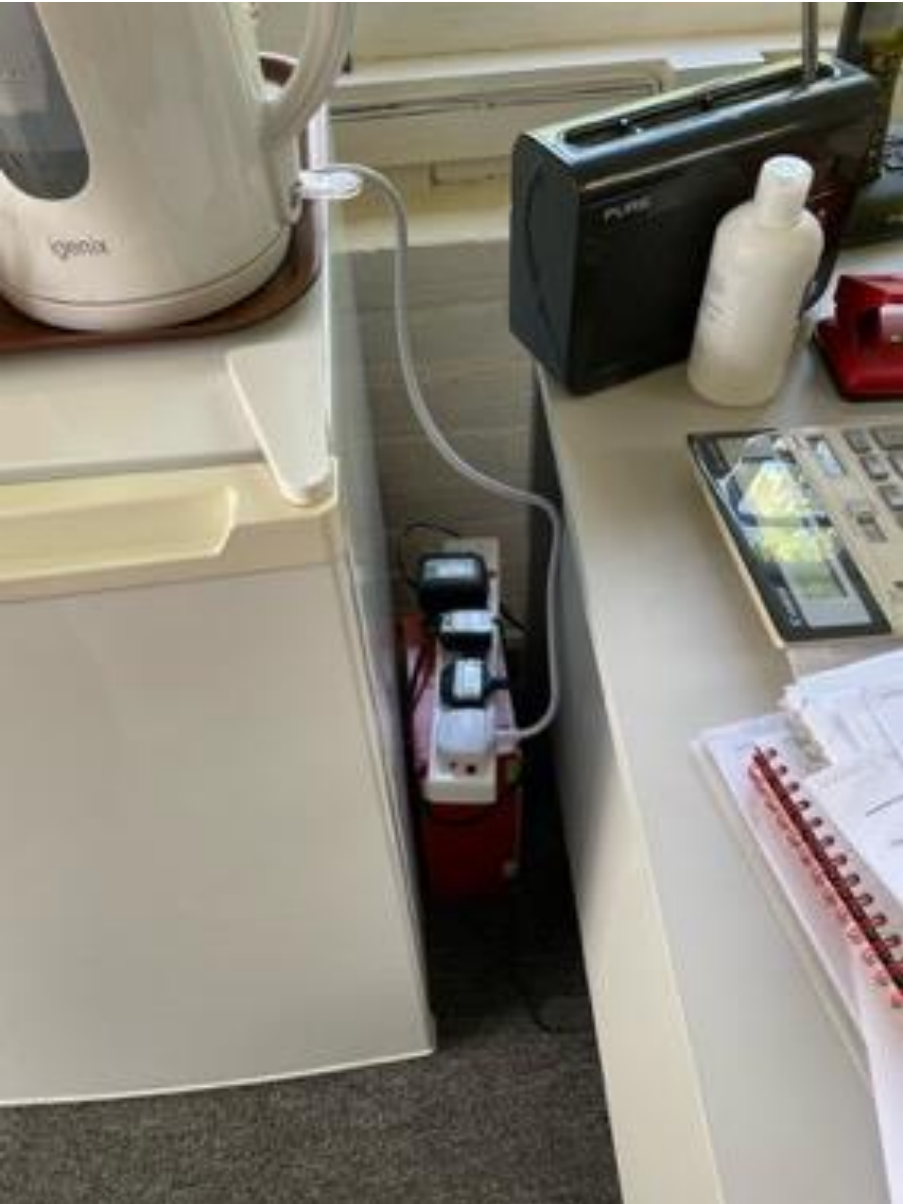
Daisy chain of electrical cables

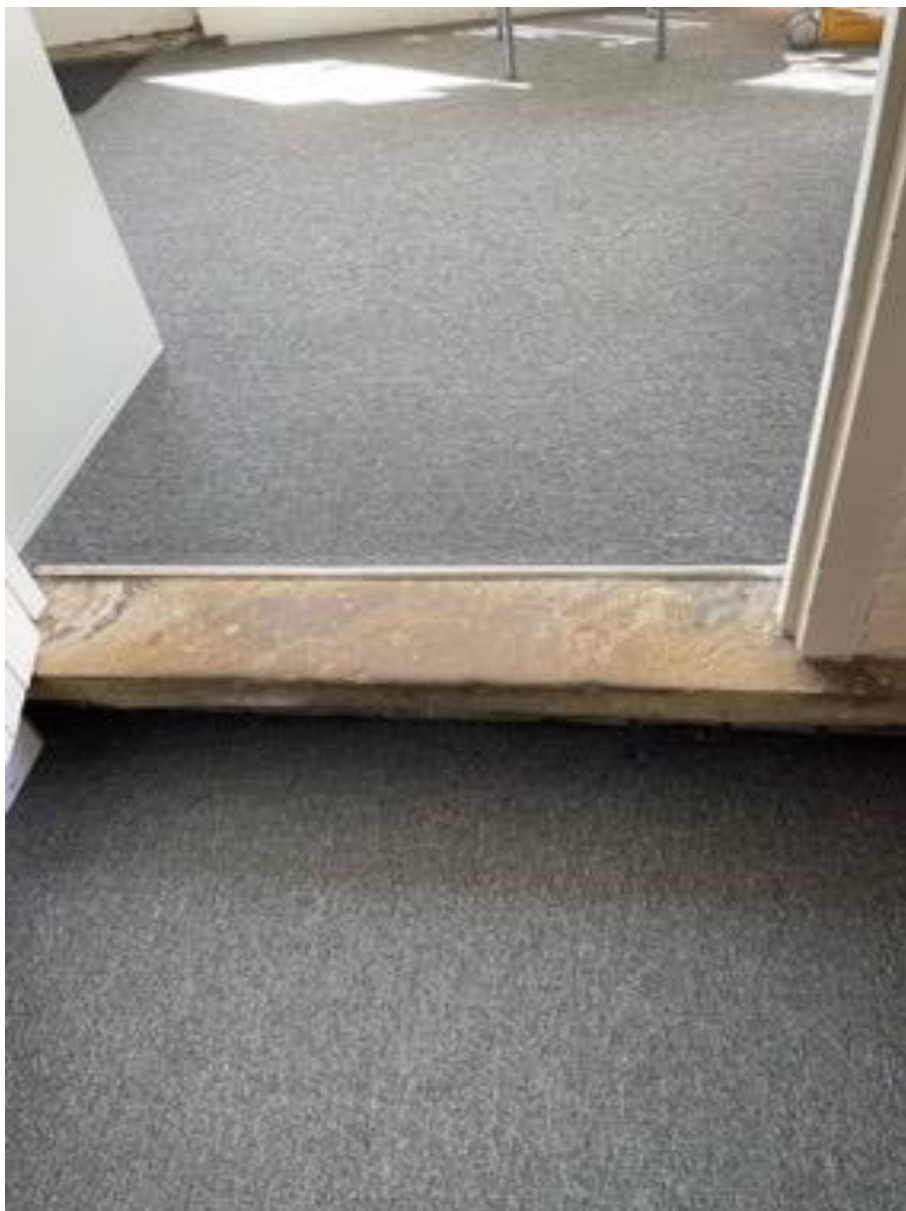
Step for change of level between offices

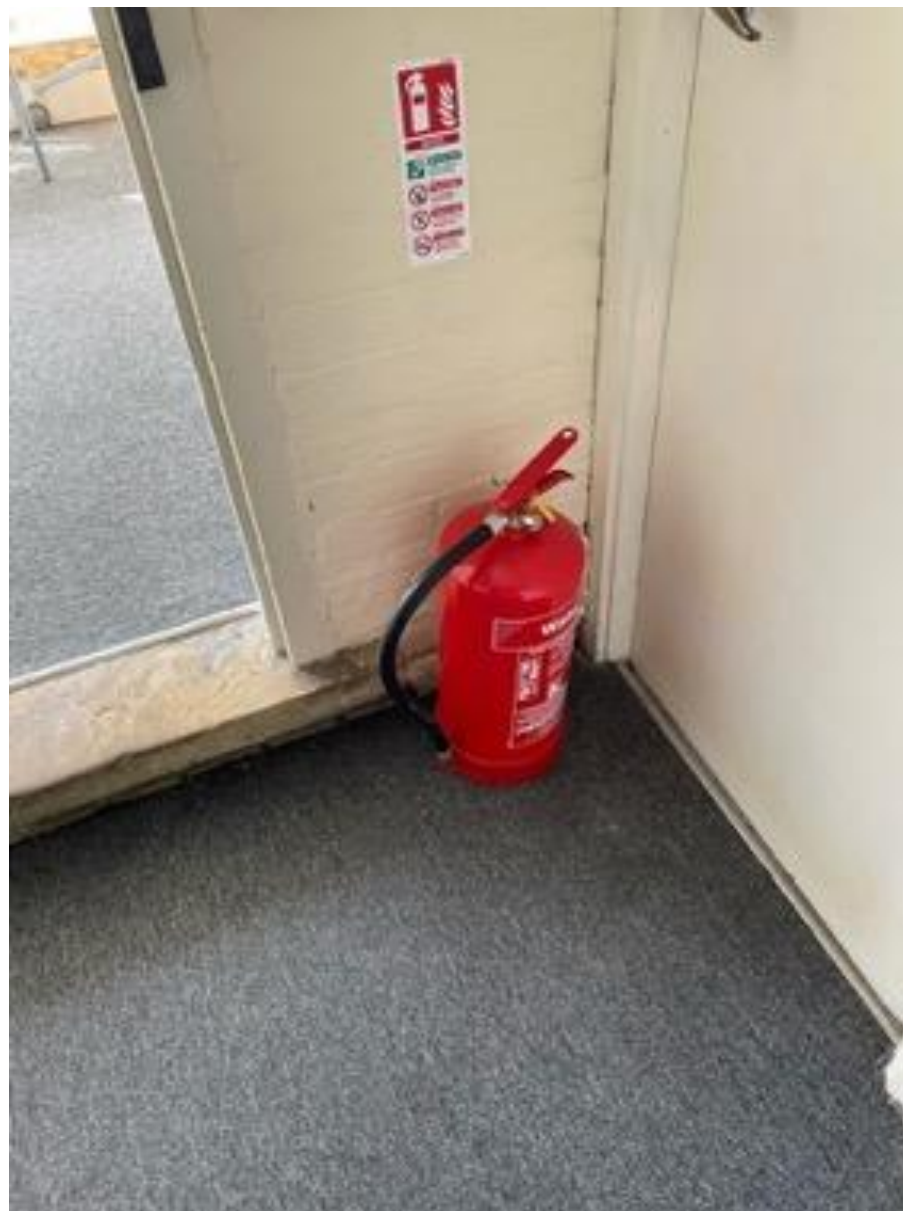
Fire extinguisher not wall mounted

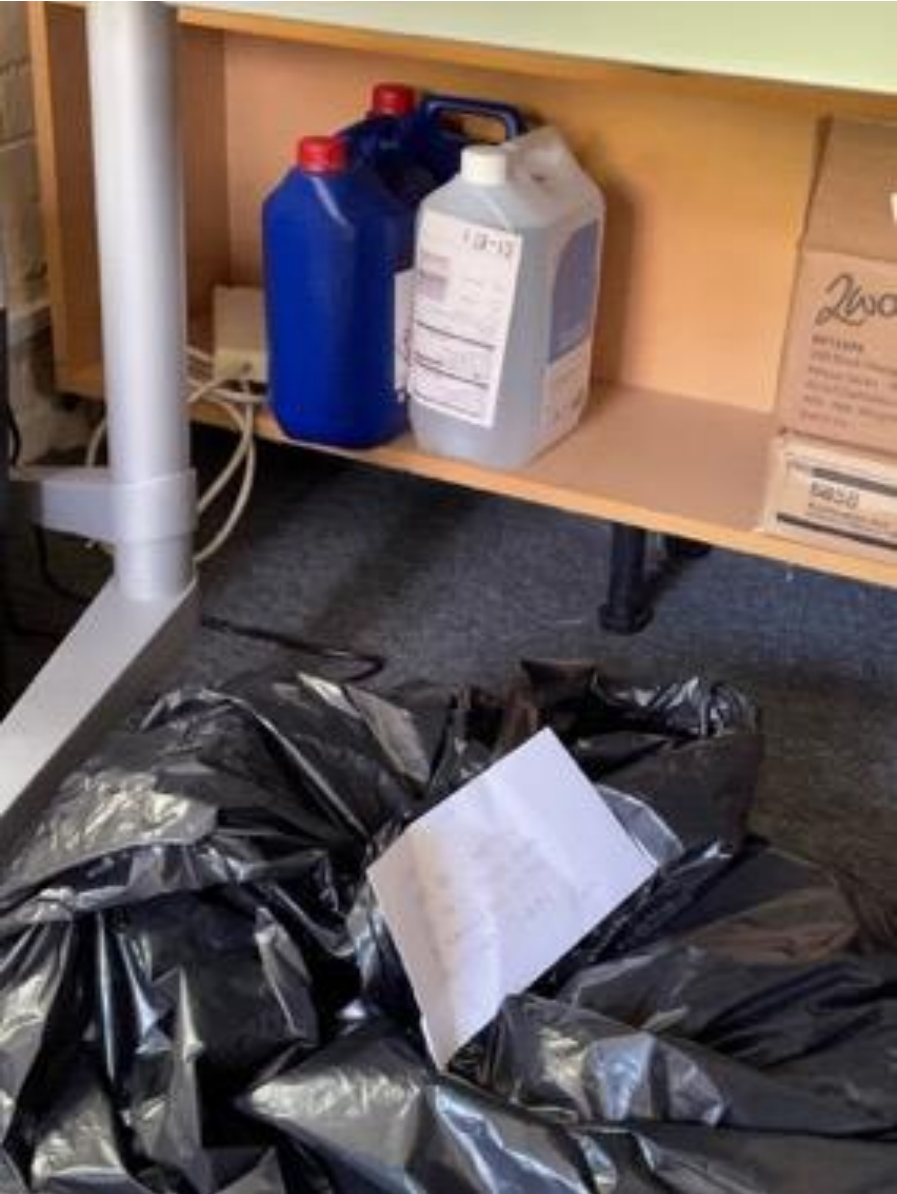
Toilet chemicals incorrectly stored  
Items stored on floor

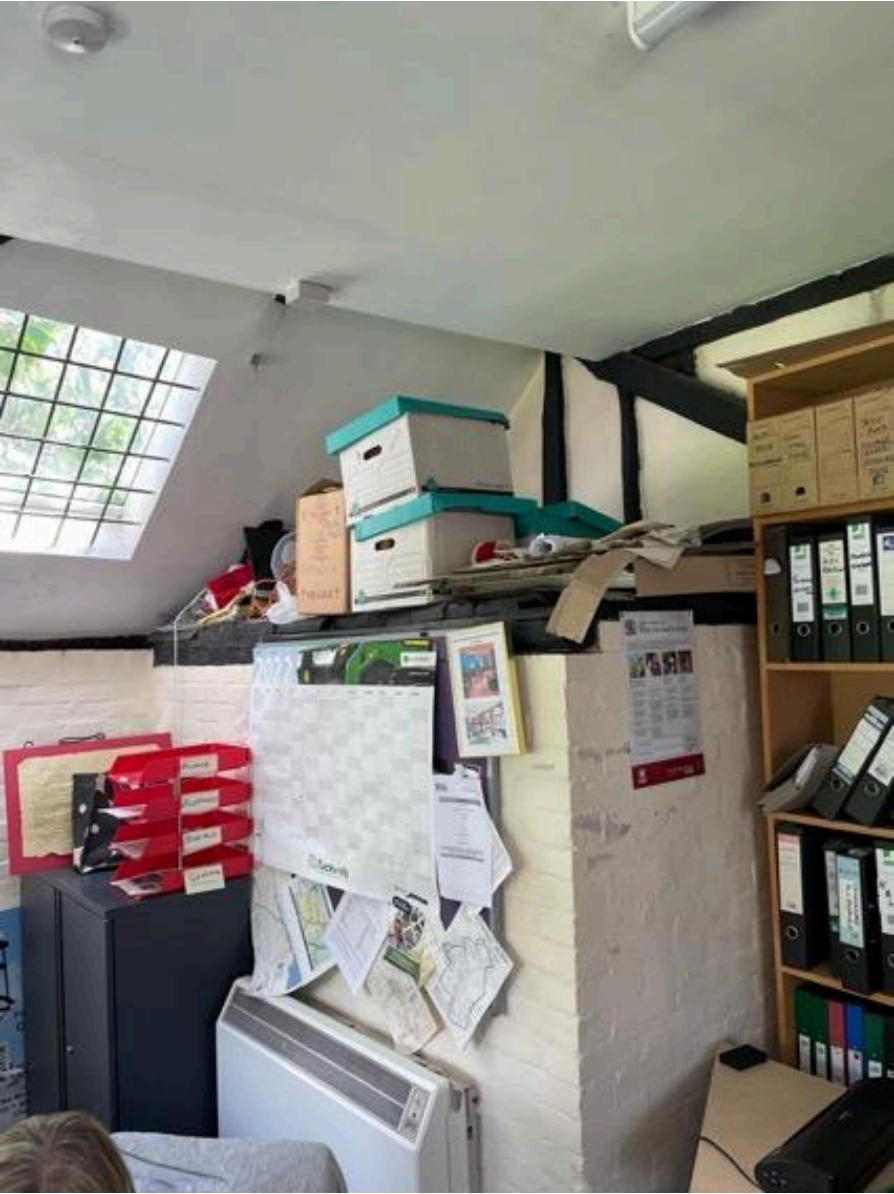
Boxes and other items stacked and insecurely stored

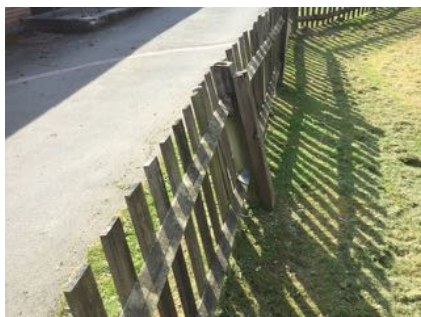
# Fencing

There is decay to timber components which may affect structural integrity. We do not recommend replacing rotten supports with timber posts which are directly set in the ground due to the increased problem of timber rot, especially in posts in contact with the ground.

Rot in supports - A new fence is recommended.

Replace decayed components where possible and plan replacement of item. Check on a routine basis, especially at ground or foundation level.

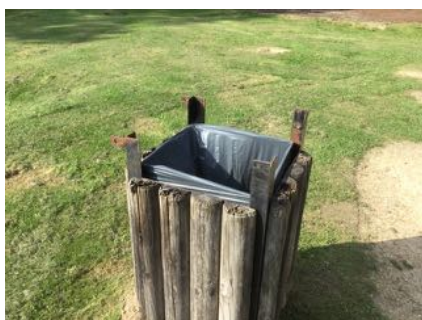
# Litter Bins

Item has some parts missing.

Replace the missing parts.

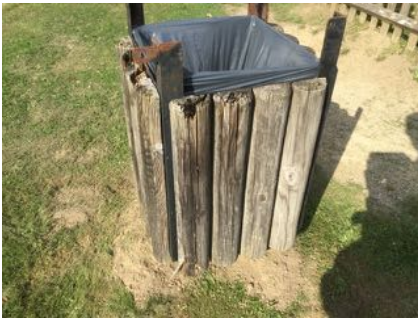
Bin near gate, top logs rotten and missing.

Replace.

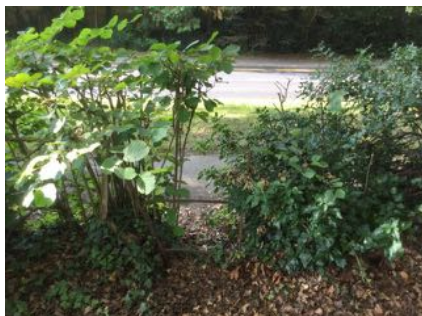
# Hedgerow

Holes allowing access to road. Vehicle sped noted as being quite fast. The inspector recommends installing a new additional barrier.

Repair.

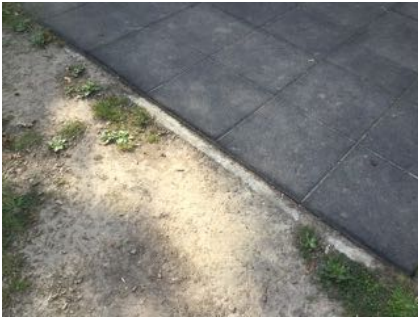
The safer surface has hard edging / foundation within the impact area.

Modify to remove the hazard.

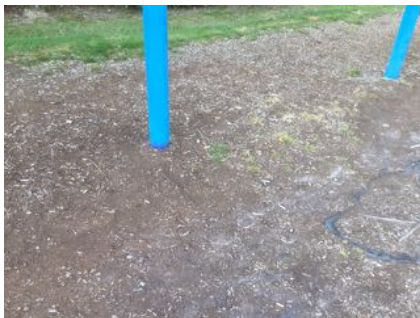
Loose fill levels are too low to provide adequate protection.

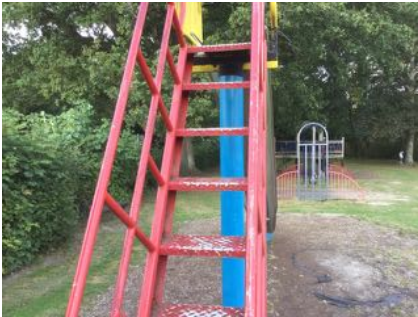
Access fails the entrapment requirements.

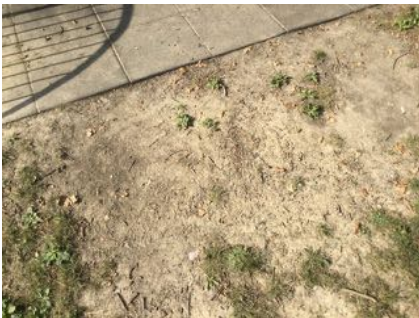
Worn ground areas.

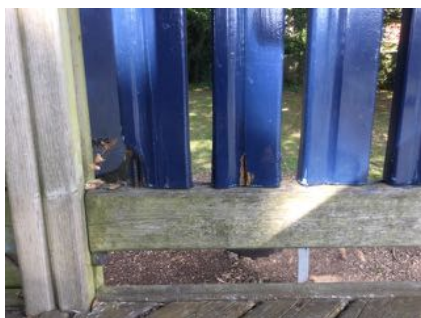
Rot and expansion damage due to internal corrosion.

Replace rotten timbers.

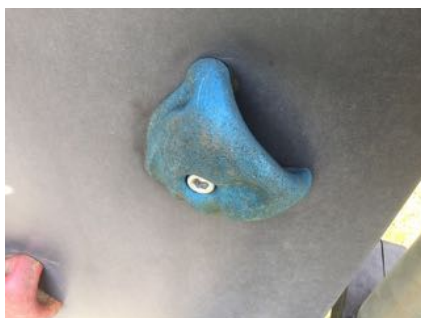
Fixtures loose or missing.

Tighten/replace.

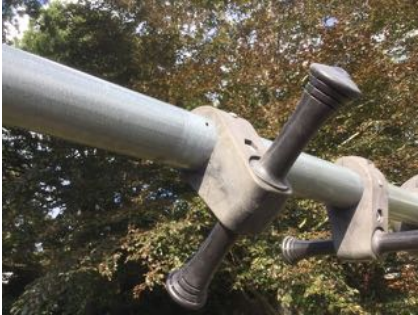
Rivets are missing.

Replace.

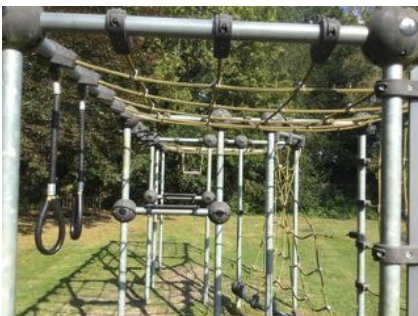
The protective surface under all bars and rings must be kept in good condition.

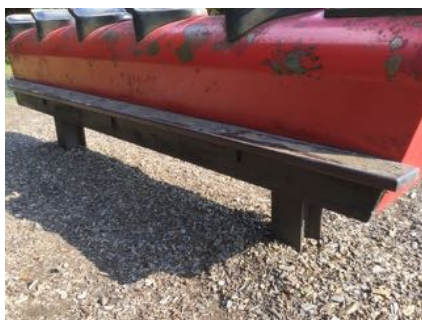
Missing skirt beneath allowing access to the mechanism.

Repair.

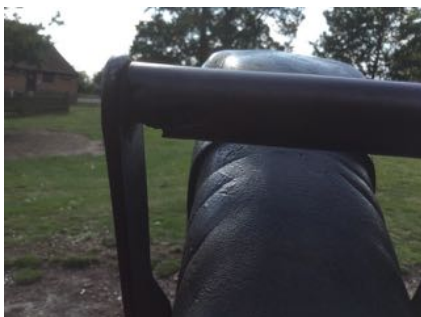
There is significant corrosion on this item.

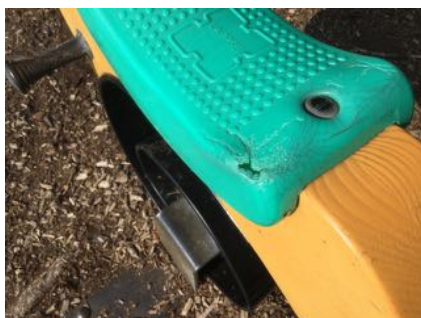
Item is cracked.

Repair.

Replace seat.

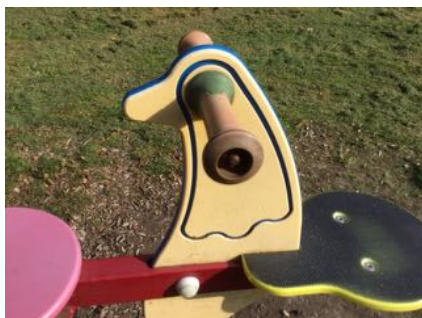
Cap missing.

Replace.
