# Hawkhurst Parish Council Health and Safety Report

June 2022

Observations from audit of HPC facilities using HSE Slips and trips hazard spotting checklist and HSE Checklist for village and community halls.

Conducted by Cllr Paul Green and Cllr Simon Paish on Thursday 9<sup>th</sup> June 2022, conditions clear and dry, And 16<sup>th</sup> June 2022 conditions hot clear and dry.

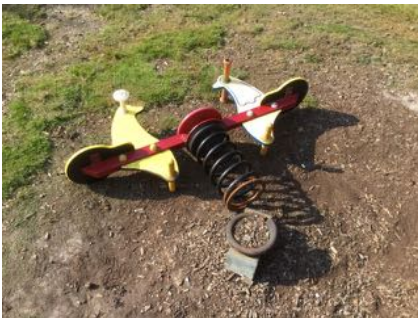
Asset can be rotated off its base plate. Asset left in position as found.

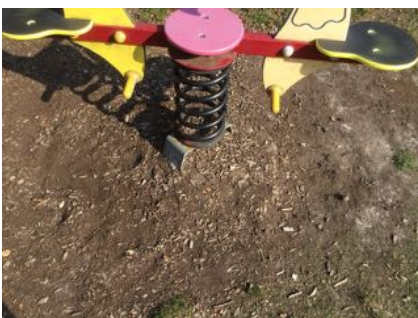
Exposed foundations.

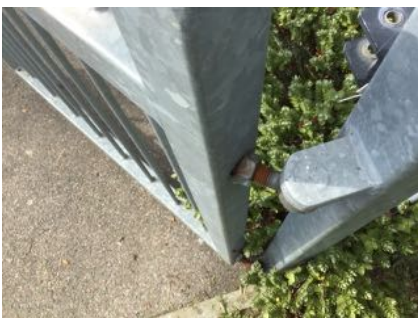
Item has some parts missing.

Replace the missing parts.

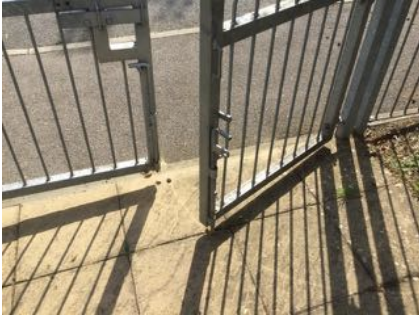
Minor repairs are needed.

Repair.

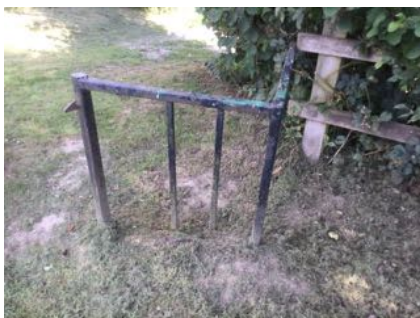
# Gate - Pedestrian (to Hartenoak Lane)

Item broken.

Replace.

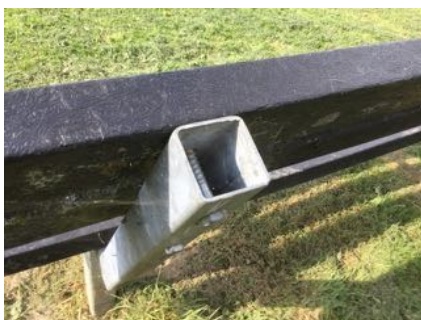
# Seating - Frames - Metal - Slats - Plastic

Cap missing.

Replace.

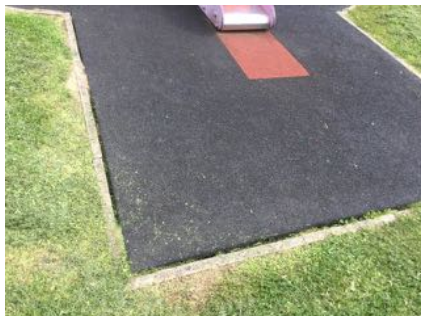
Shrinkage / separation of the surface. This may give a trip hazard.

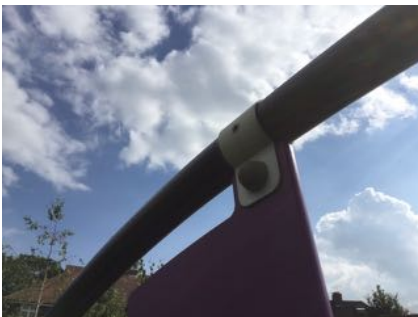
Rivets are missing.

Replace.

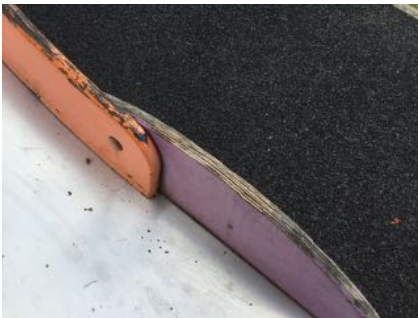
Laminate damaged.

Rub down and treat damaged edges.

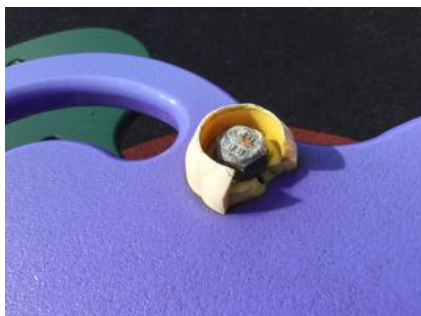
Bolt cap damaged.

Replace.

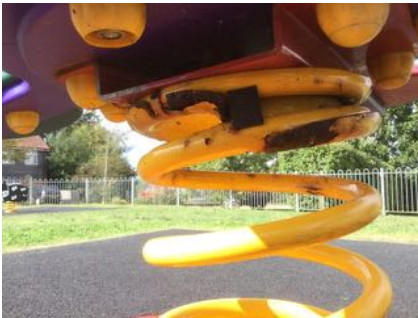
Paintwork is in poor condition.

De-scale back to good base material and coat with lead free paint, using appropriate precautions. Repairs may be necessary where corrosion is severe.

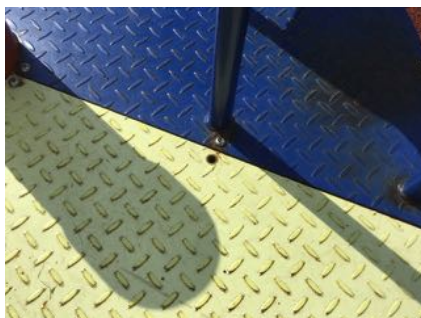
Bolt(s) missing.

Replace missing bolt(s).

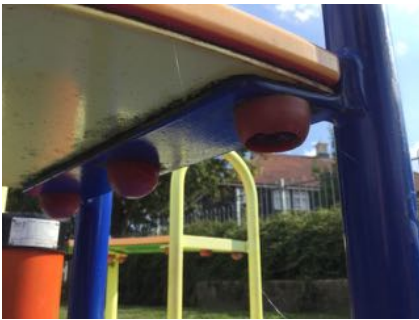
Cap missing.

Replace.

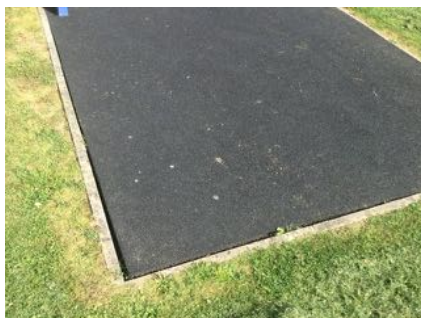
Shrinkage / separation of the surface. This may give a trip hazard.

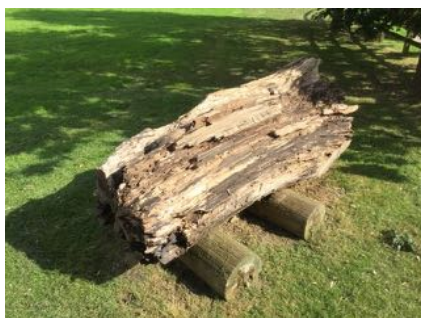
Timber is decayed.

Monitor and plan to replace / remove.

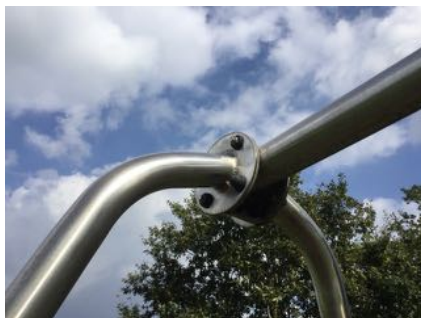
Cap missing.

Replace.

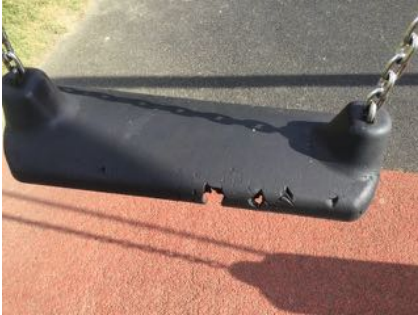
The swing seat has been damaged, but does not require immediate replacement.

Monitor and replace when hard material is exposed.

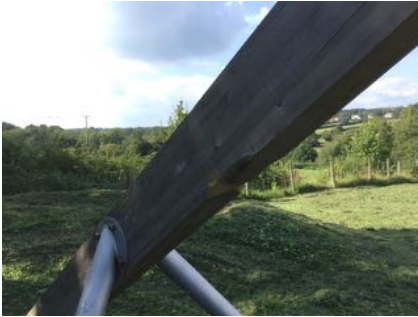
Item has some parts missing.

Replace the missing parts.

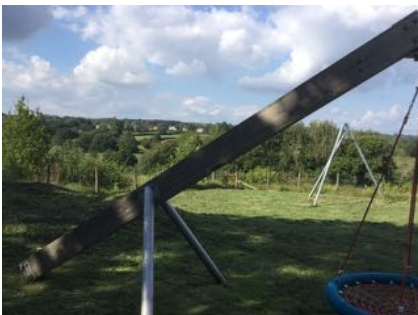
This equipment relies on one post for its stability. Special attention should be paid to maintenance (e.g. by monitoring degradation) and if necessary decommissioning the item before the end of its operating life.

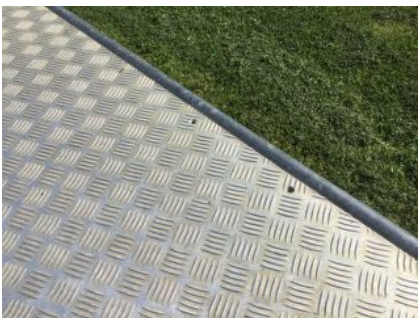
Fixtures loose or missing.

Replace.

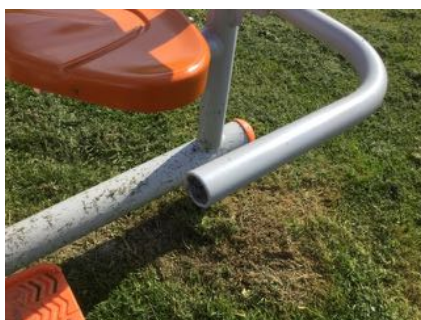
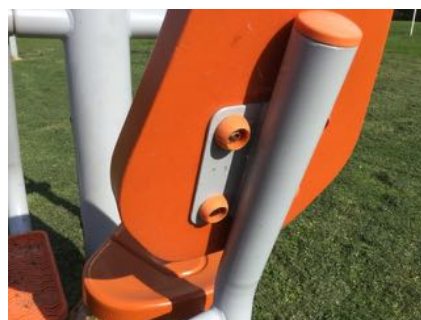
Cap missing.

Replace.

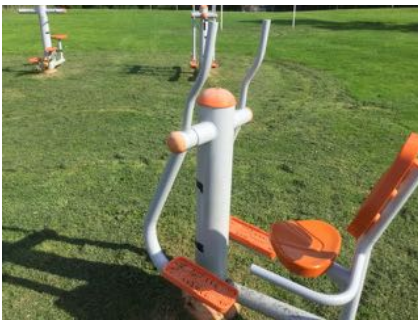
Asset retaining water which may result in internal corrosion - Drain and prevent future accumulation.

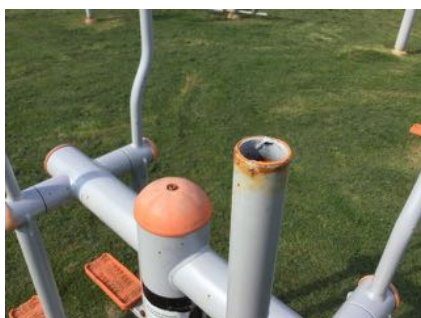
Cap missing.

Replace.

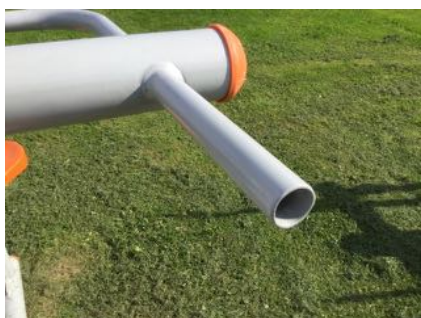
Cap missing.

Replace.

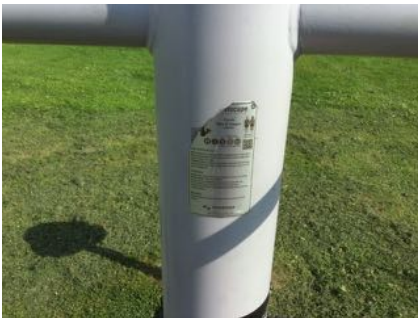
Item is damaged.

Replace.

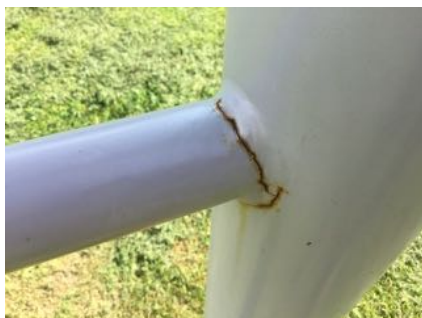
Welds are cracked.

**Risk score:**  
6

Repair.
